APA Technical Note - Western Outer Ring Main - Environment Effects Statement

TECHNICAL NOTE NUMBER: TN10

SUBJECT: Specialist Area: Contamination
Additional contamination investigations following EES
exhibition and response to RFI# 77.

To	APA	Ref. No.	12529997
From	GHD		
Subject	APA WORM – Contamination Investigations Technical Memorandum

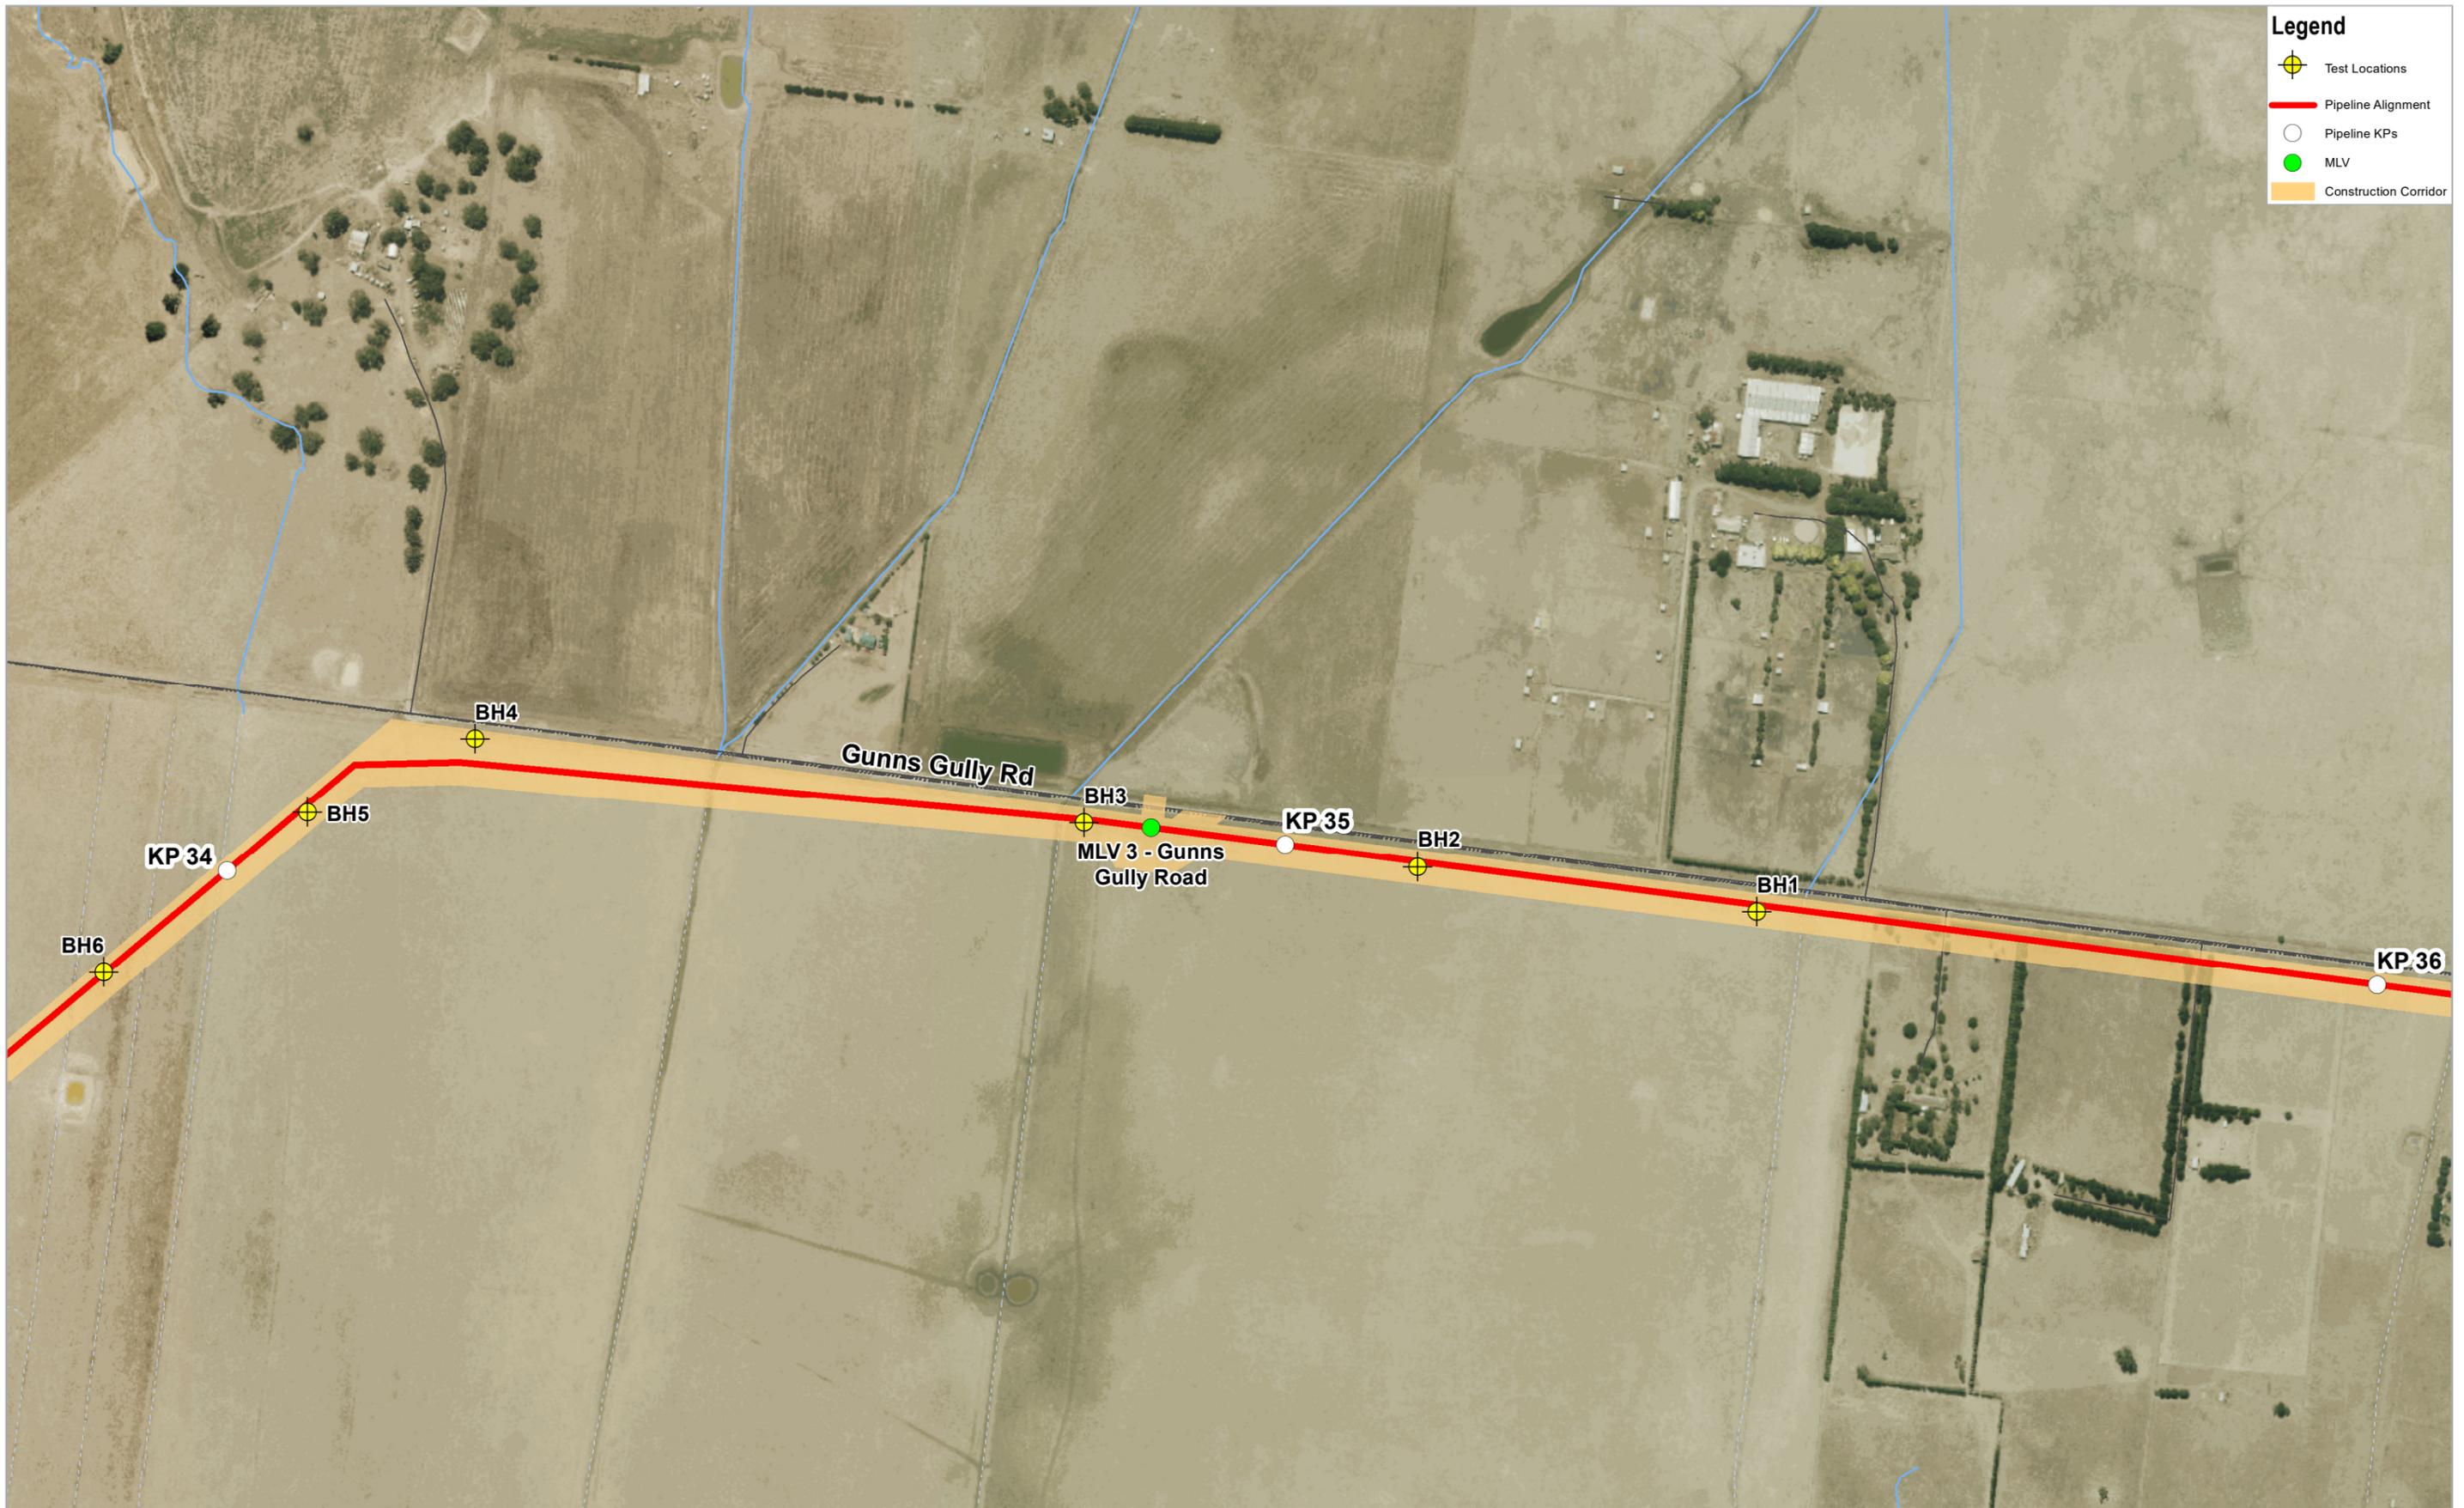
FIGURE 1

A total of 12 samples were collected and analysed from six boreholes advanced along the project alignment at the Kalkallo retarding basin (refer to Attachment 1, Figure 1). Based on the field observations and analytical results reported from soil samples:

- All sample results were below the upper threshold for Fill Material as defined in Environment Protection Authority Victoria (EPA Vic) Publication 1828.2 – ‘Waste disposal categories – characteristics and thresholds’ (2021).
- PFAS was not detected above the laboratory limit of reporting (LOR), for all 12 samples and therefore were below the reuse criteria in EPA Vic Publication 1669.4 – ‘Interim Position statement on PFAS’ (2020).
- Concentrations of potential contaminants of concern were below adopted commercial/industrial health guidelines. As such, soil at the Site can be managed so as to minimise the risks of harm to human

Retarding Basin

health of the workers undertaking construction activities so far as reasonably practicable (to comply with the duties outlined in section 39 of the EP Act 2017), through implementation of standard health, hygiene, safety and environment practices such as:

- Minimising direct physical contact with soil through the use of appropriate PPE (e.g. long sleeves, and gloves).
- Personal hygiene during and following activities involving contact with the soil (e.g. washing of hands before eating and/or drinking).
- Providing first aid, washing and toilet facilities away from work areas.
- Using dust suppression techniques, such as spray water on exposed soil and stockpiles to control dust generation as required during intrusive works.
- Providing suitable stockpile controls to prevent erosion and sedimentation as required.

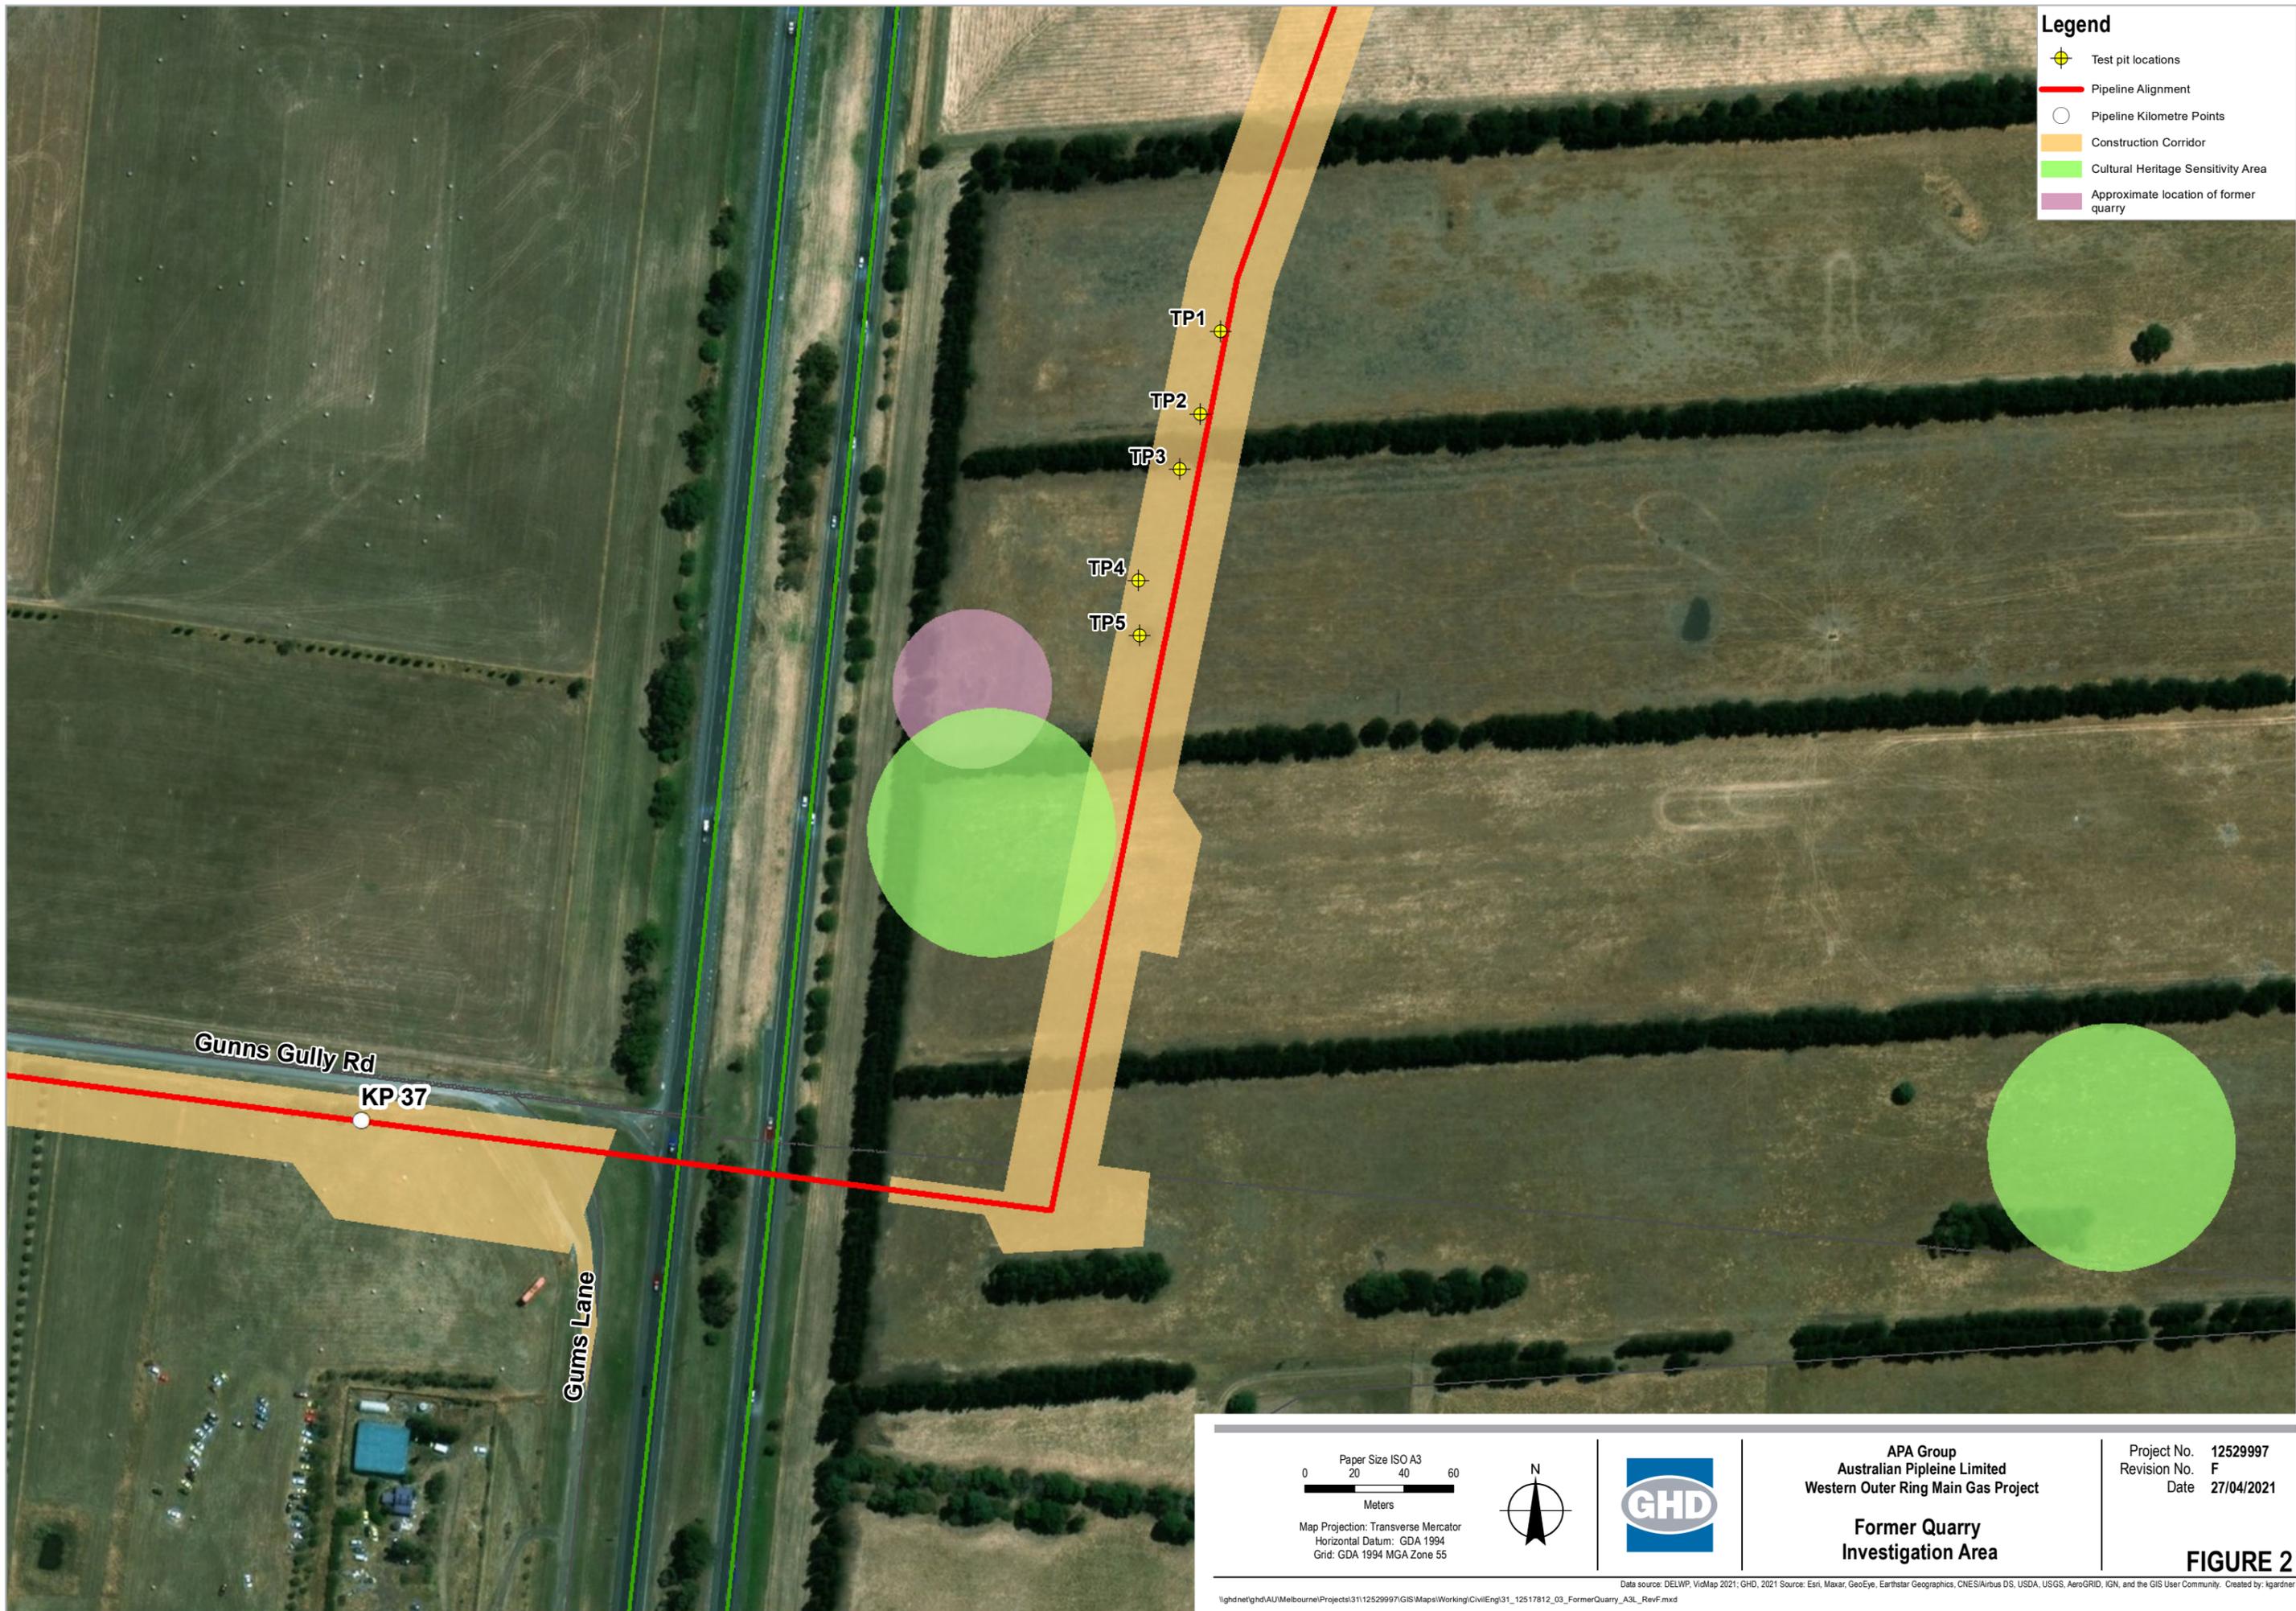
FIGURE 2

A total of 14 samples were collected and analysed from five test pits advanced along the project alignment at the Beveridge site (refer to Attachment 1, Figure 2). Based on the field observations and analytical results reported from soil samples:

- No evidence could be found of the existence of the inferred former quarry within the construction boundary of the Project at this Site based on the five test pits (14 samples) collected and analysed. Given this, an additional five test pits originally planned for the area were not deemed necessary.

- Concentrations of fluoride and nickel exceeded the upper threshold for Fill Material as defined in EPA Vic Publication 1828.2. The *Environment Protection Act 2017* (EP Act 2017) defines that land is contaminated if '*waste, a chemical substance or a prescribed substance is present on or under the surface of the land, and the waste, chemical substance or prescribed substance is present in a concentration above the background level; and creates a risk of harm to human health or the environment*'. Therefore, given the concentrations are considered to represent natural background concentrations, they are not considered a risk to the project. The soil is likely to be reused to backfill the trench and is unlikely to be removed to an offsite location.

**Former Quarry
 Investigation Area**

- Should offsite soil disposal be required then an application can be made to EPA Vic to issue a designation to change the classification of the soils to 'Fill Material' as the soil is sourced from areas that are naturally elevated. The application process has not yet been finalised by EPA Vic, but note that if the soil is reclassified as Fill Material, it still cannot be reused offsite where the nickel and fluoride concentrations create a risk of harm to human health or the environment under Section 35 of the *Environment Protection Act 2017*.

- Concentrations of potential contaminants of concern were below adopted commercial/industrial health guidelines. As such, soil at the Site can be managed so as to minimise the risks of harm to human health of the workers undertaking construction activities so far as reasonably practicable (to comply with the duties outlined in section 39 of the EP Act 2017), through implementation of standard health, hygiene, safety and environment practices such as those listed in section 3.1.

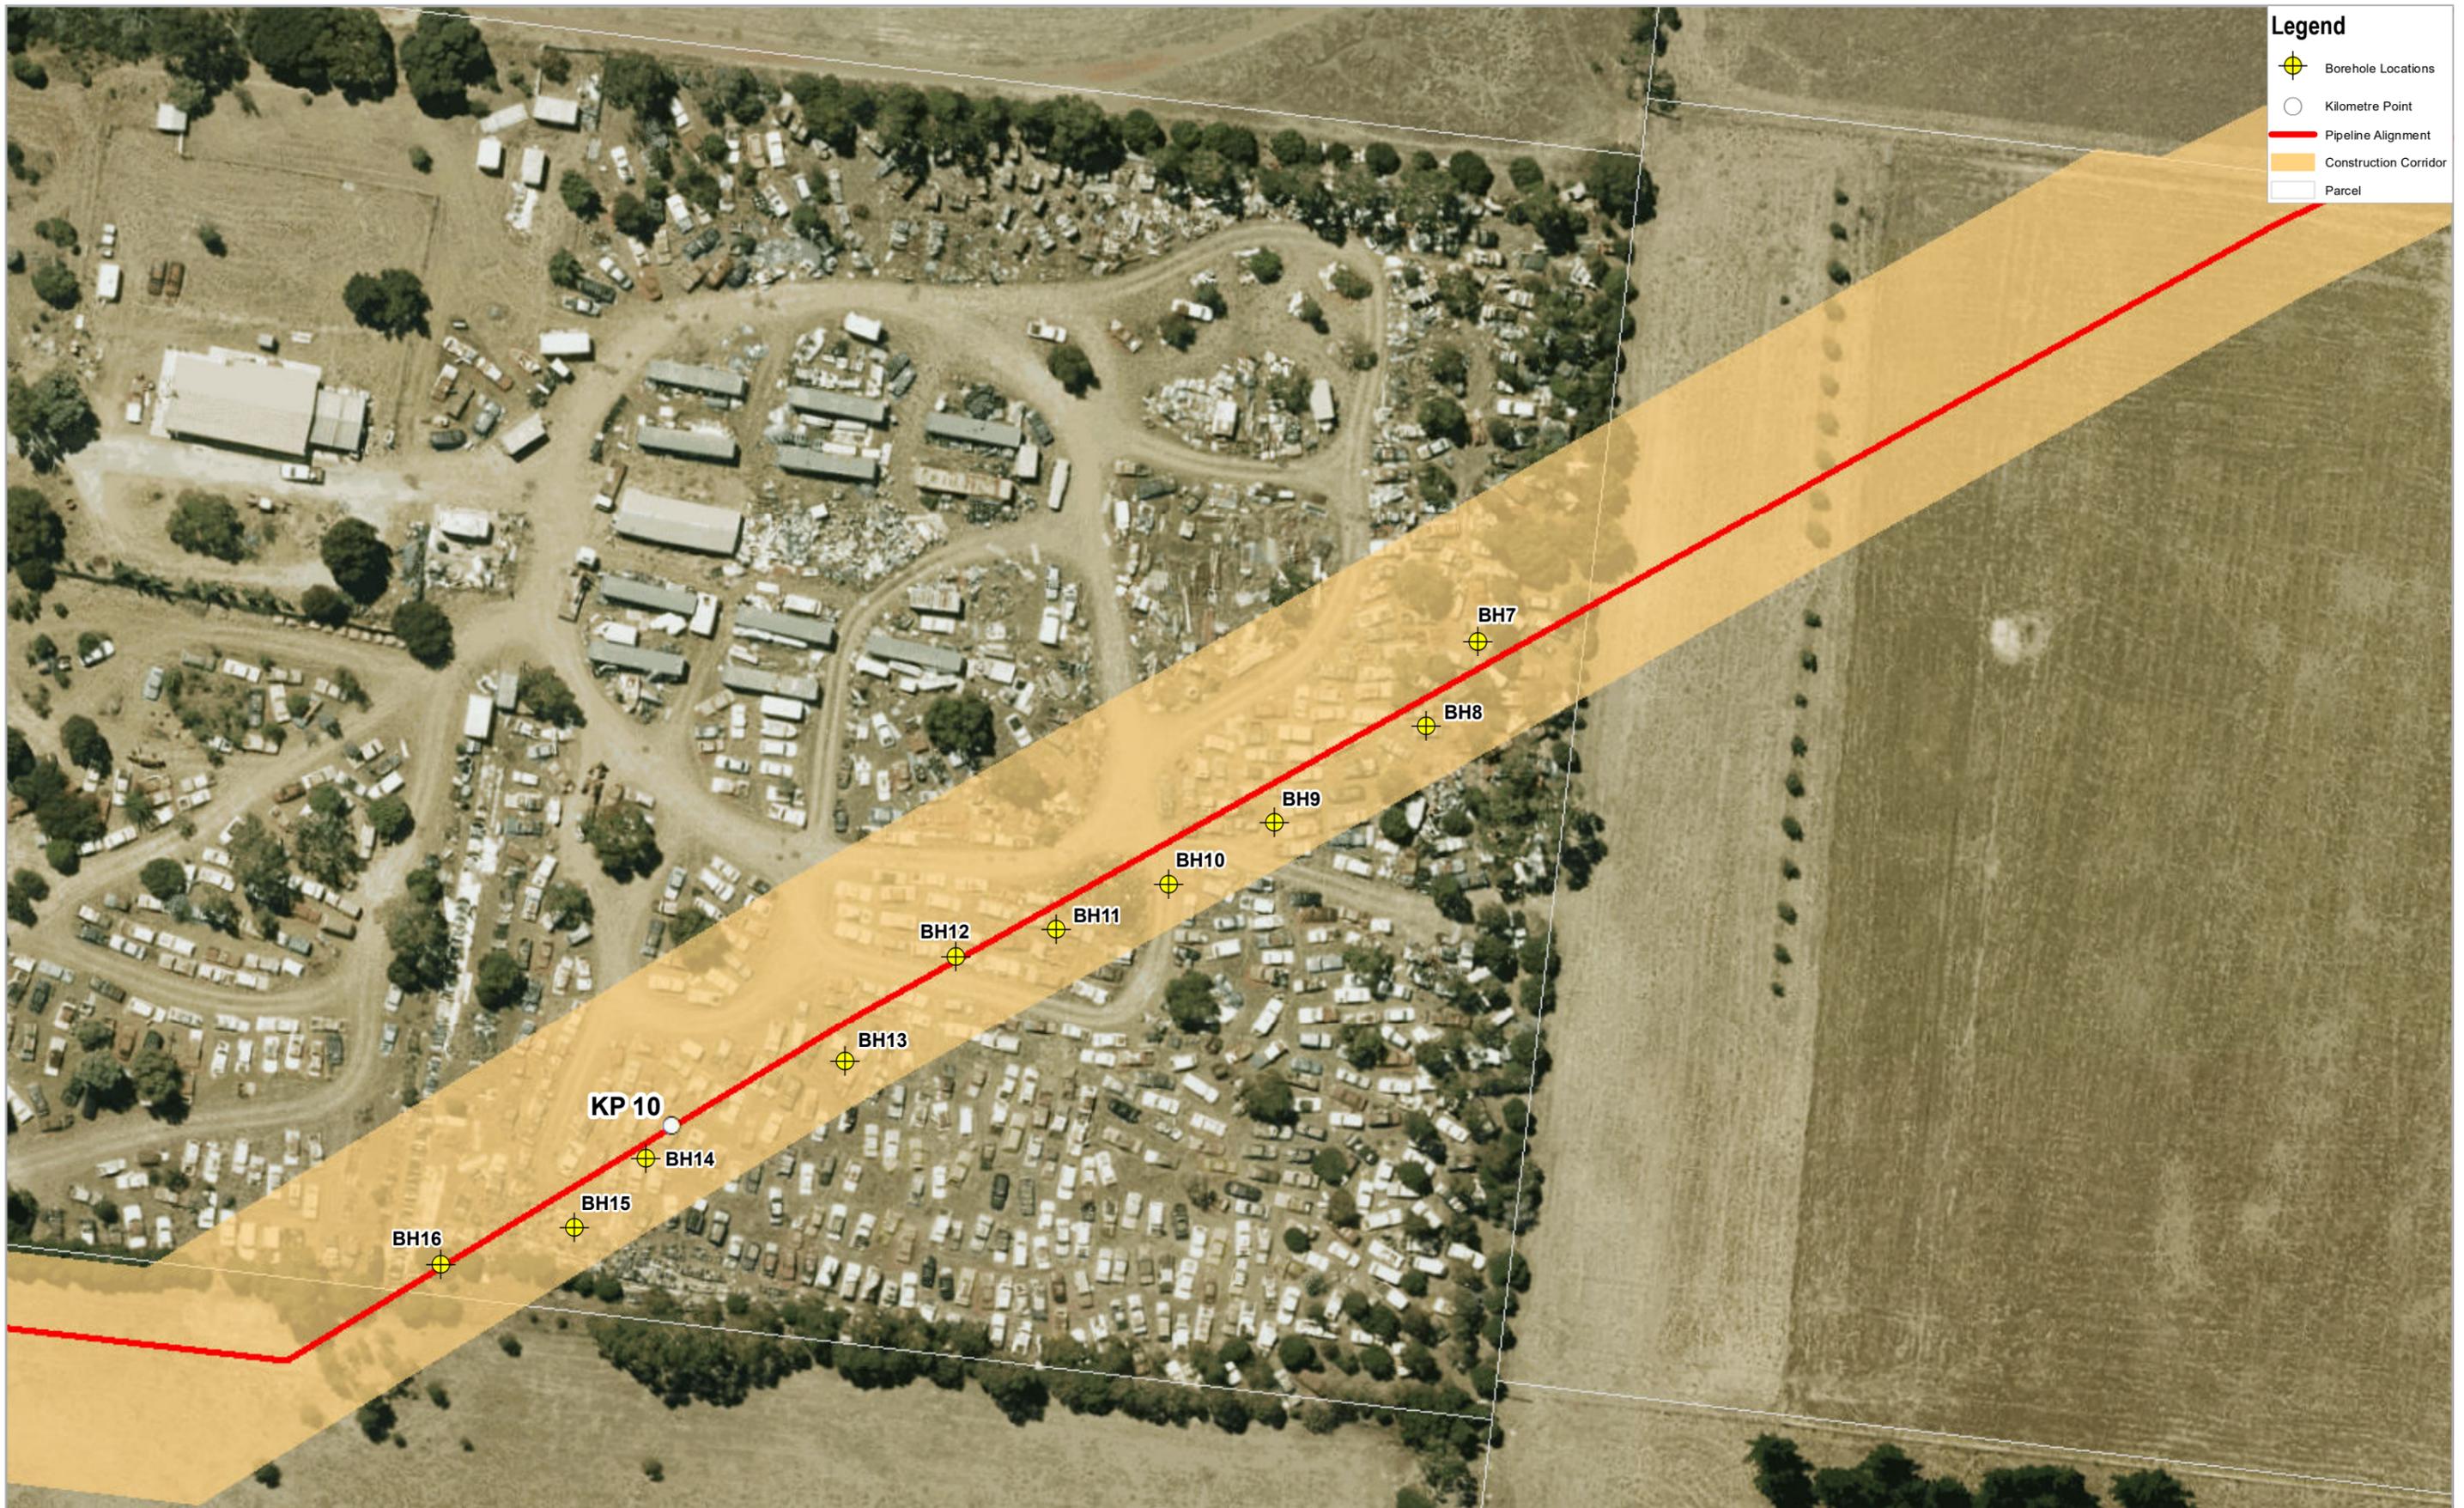
FIGURE 3

A total of 16 samples were collected and analysed from 10 hand auger boreholes advanced along the project alignment at the Diggers Rest property (refer to Attachment 1, Figure 3). Based on the field observations and analytical results reported from soil samples:

- All sample results were below the upper threshold for Fill Material as defined in EPA Vic Publication 1828.2 and therefore, the soil represented by these samples would be suitable for reuse on site. However, should contaminated material be observed at other locations along the trench (through visual or olfactory observations) during excavation works, further assessment may be required at that time.

- Concentrations of nickel exceeding the ASC NEPM² ecological investigation level (EIL) for Commercial/Industrial land use are considered to be naturally elevated and therefore are not considered a risk to the project.
- Concentrations of potential contaminants of concern were below adopted commercial/industrial health guidelines. As such, soil at the Site can be managed so as to minimise the risks of harm to human health of the workers undertaking construction activities so far as reasonably practicable (to comply with the duties outlined in section 39 of the EP Act 2017), through implementation of standard health, hygiene, safety and environment practices such as those listed in section 3.1.

**Diggers Rest Property
 Investigation Area**

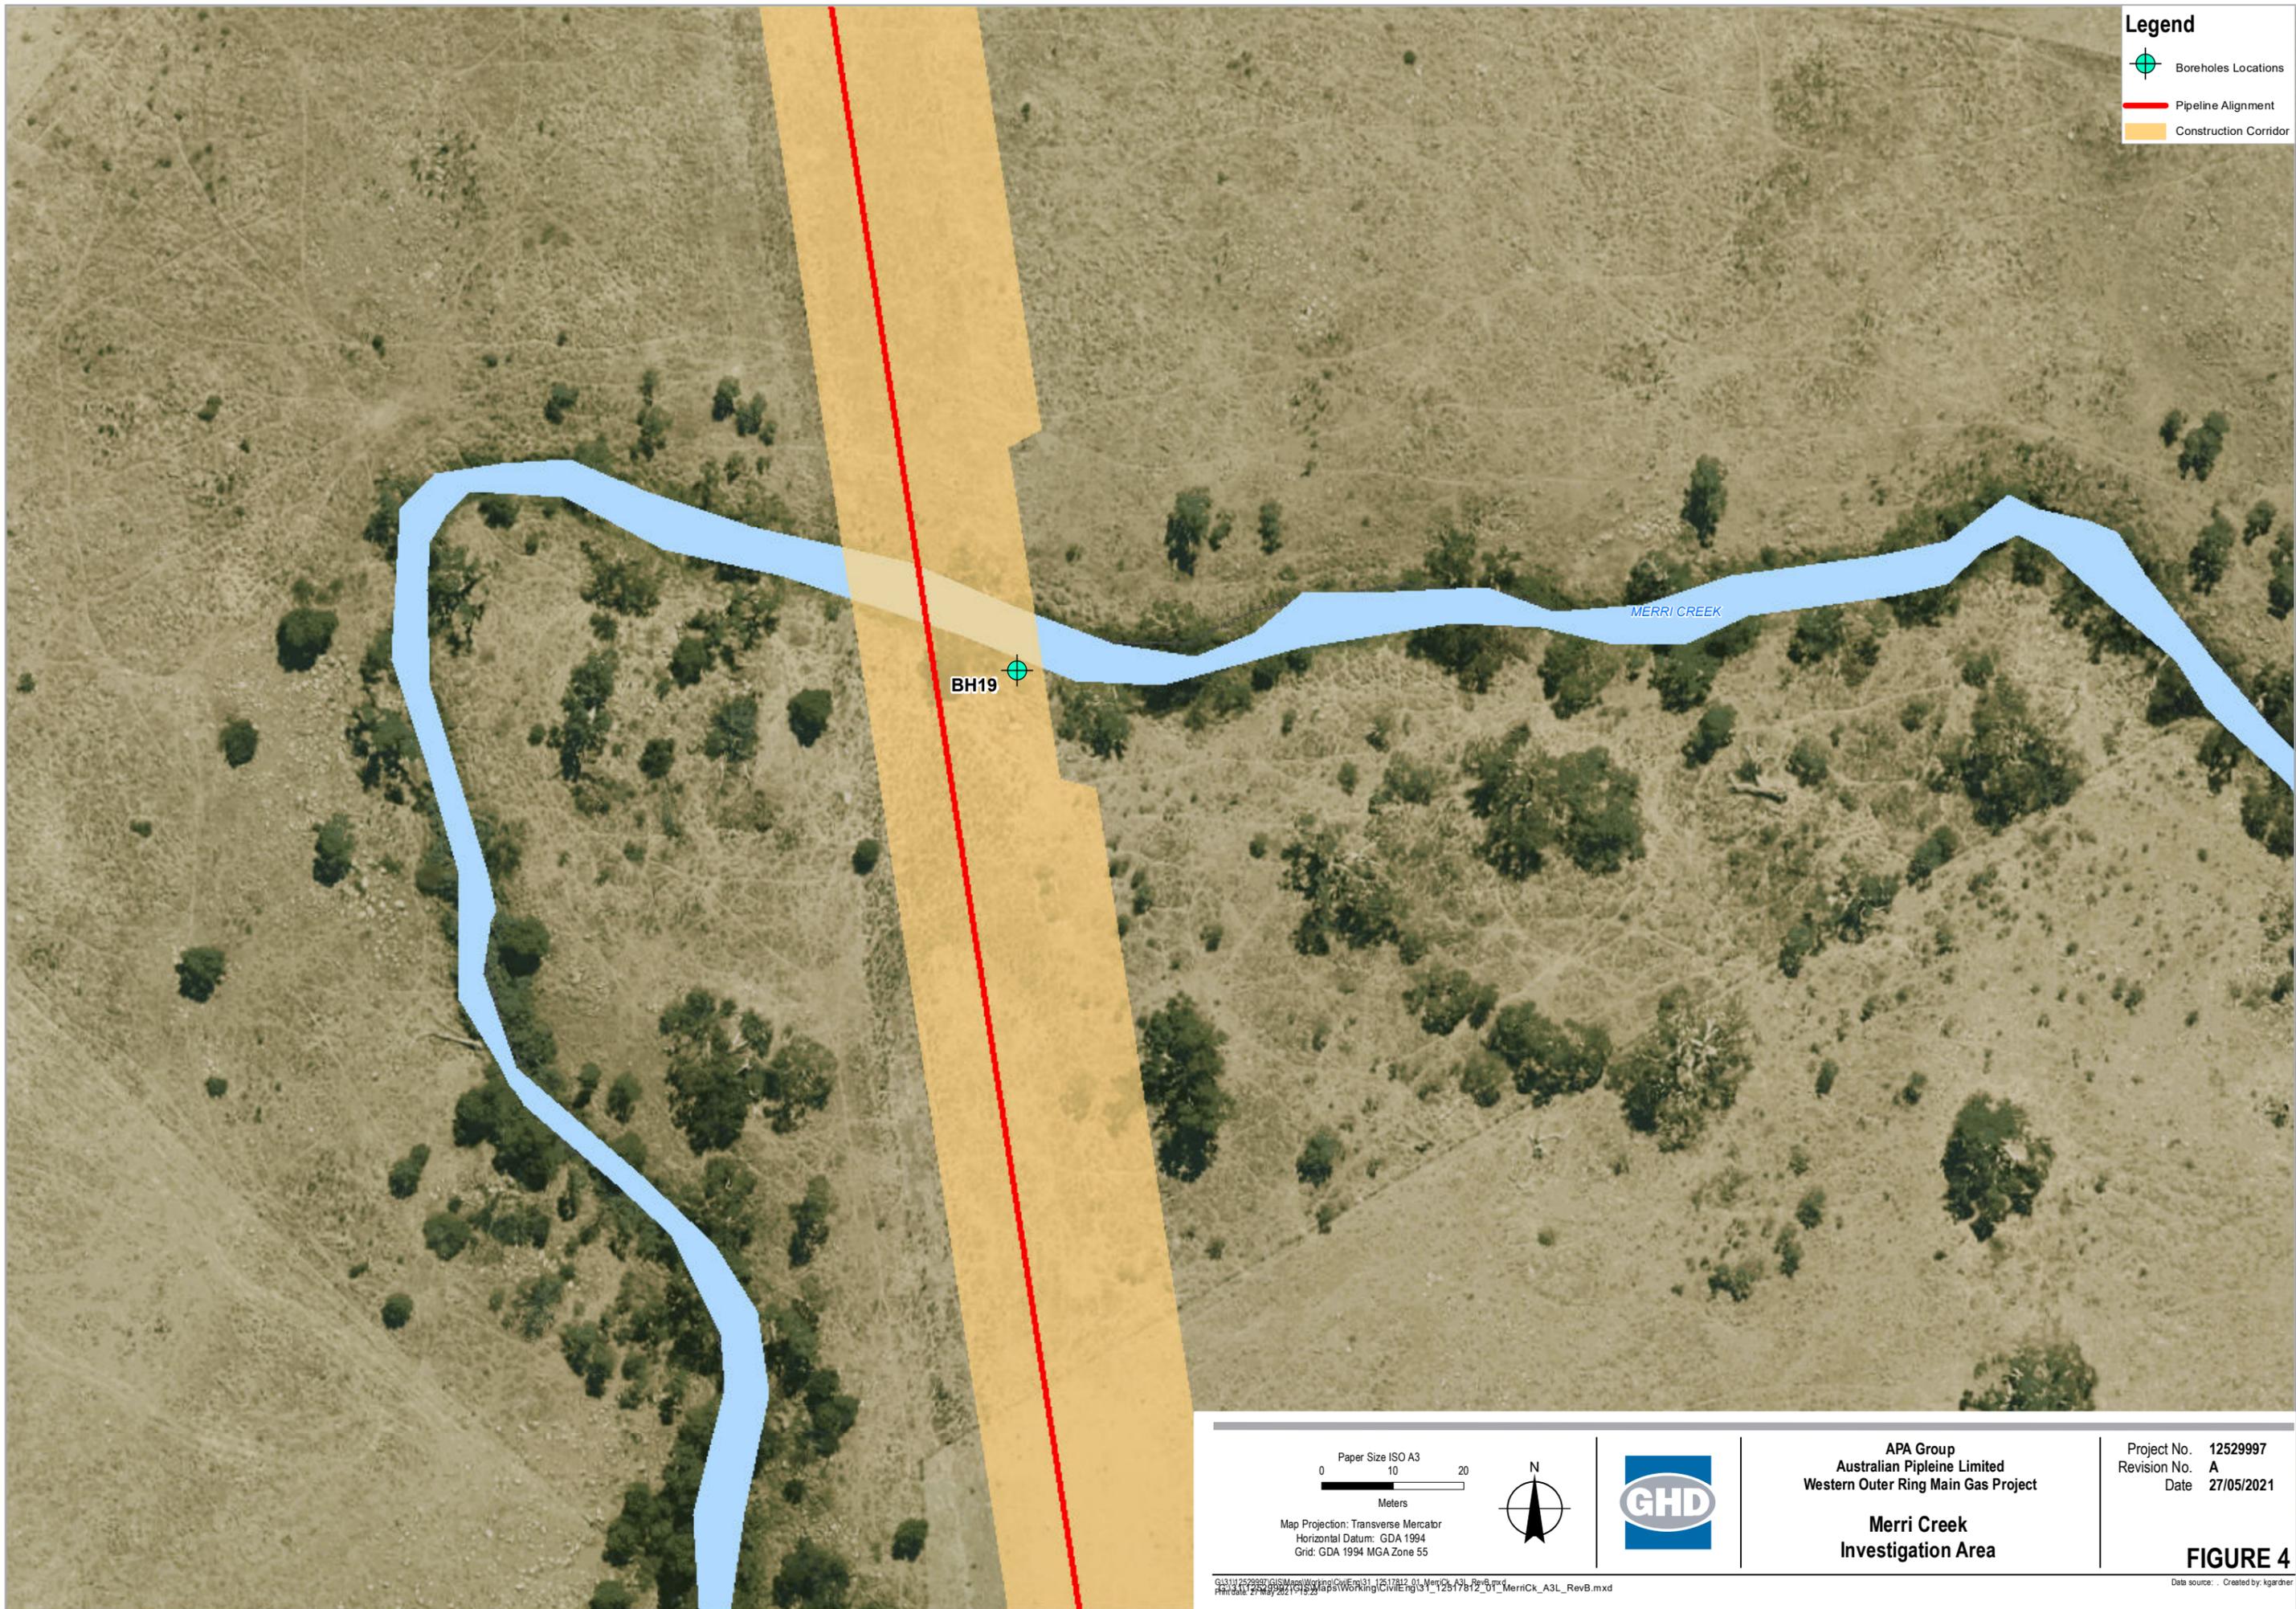
A total of two samples were collected and analysed from one hand auger borehole advanced at the project alignment at Merri Creek crossing (refer to Attachment 1, Figure 4). Based on the field observations and analytical results reported from soil samples:

- Potential or actual acid sulphate soils (PASS or AASS) associated with Quaternary creek sediments at the Site are not likely to be present
- No further actions or management measures with respect to PASS and AASS are required based on the current pipeline design.

<p>APA Group Australian Pipeline Limited Western Outer Ring Main Gas Project</p> <p>Merri Creek Investigation Area</p>	<p>Project No. 12529997 Revision No. A Date 27/05/2021</p>
<p>G:\31112529997\GIS\Map\Working\CivilEng\31_12517812_01_MerriCk_A3L_RevB.mxd Date: 27/05/2021</p>			<p>FIGURE 4</p> <p style="font-size: x-small;">Data source: . Created by: kgardner</p>
