technical report B  
**surface  
water.**

Environment Effects Statement | May 2021

**western outer  
ring main**

APA VTS (Operations) Pty Ltd  
Western Outer Ring Main Environment Effects Statement  
Surface Water Report

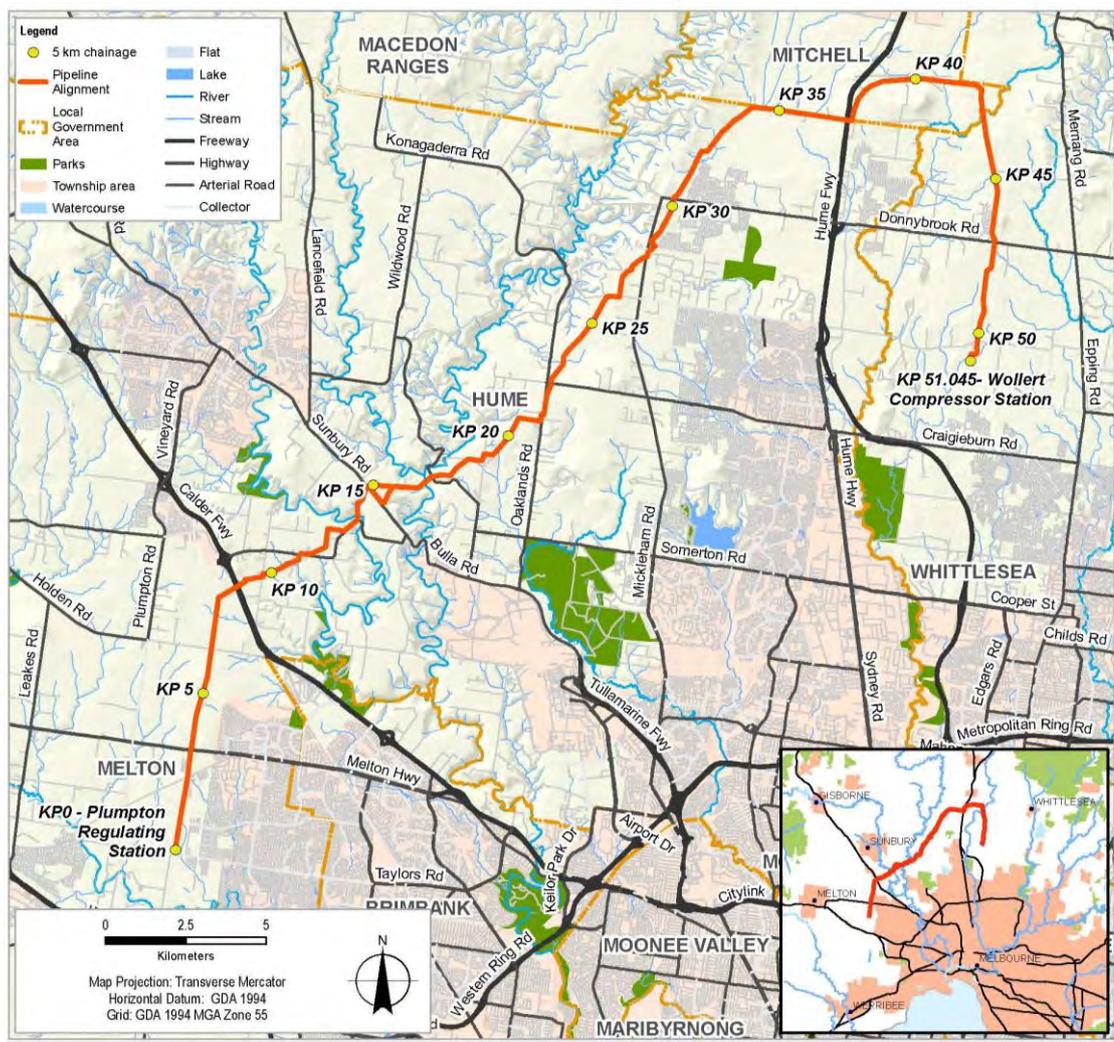
A schematic illustration of the Project context is shown in Figure 3-1.

Figure 3-1 Western Outer Ring Main (WORM) overview

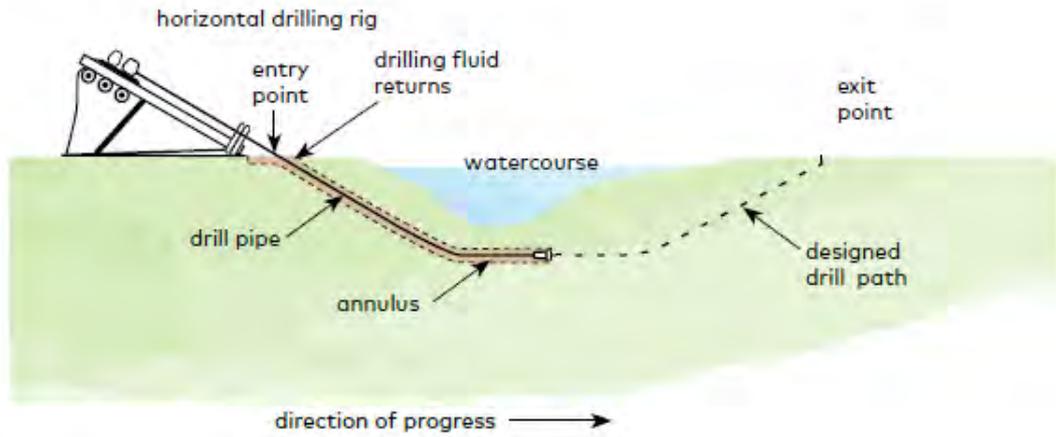
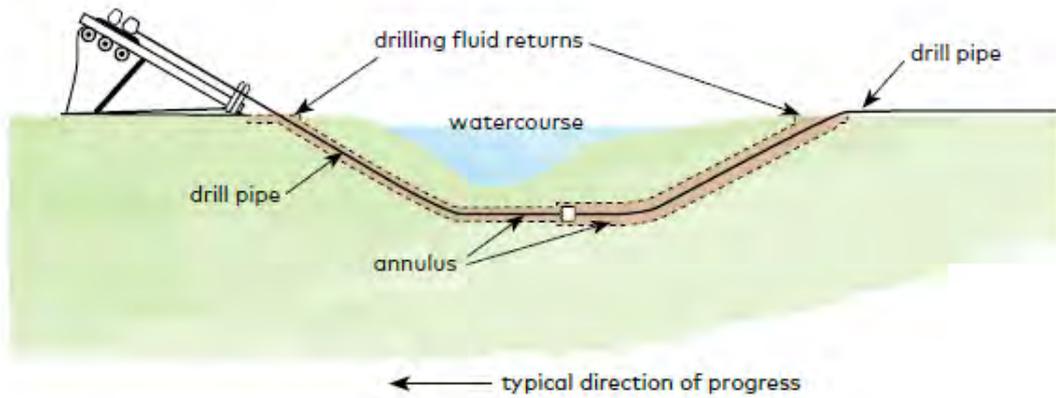
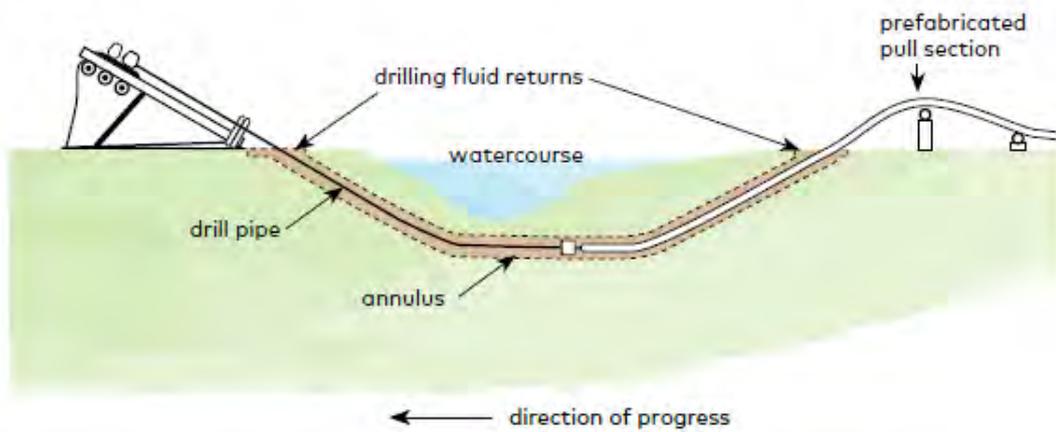
### pilot hole

### pre-reaming

### pullback

Figure 3-2 Typical HDD work area

HDD may be used in areas such as major transport corridors and major waterways. The use of a HDD methodology will be subject to geology, environmental topographical, construction constraints and land access requirements. The HDD construction methodology will require the excavation of entry and exit pits, typically an approximate size of three metres x three metres. The drilling will be conducted by a specific HDD rig which is operated by a specialist contractor. The size of the HDD rig and its associated footprint has been based on the size of the pipe, the nature of the subsurface geology and the length of the section to be drilled. A typical HDD work area set up is shown in Figure 3-2. Further details of HDD construction methodology, sequence and activities are outlined in EES Chapter 4 Project Description.

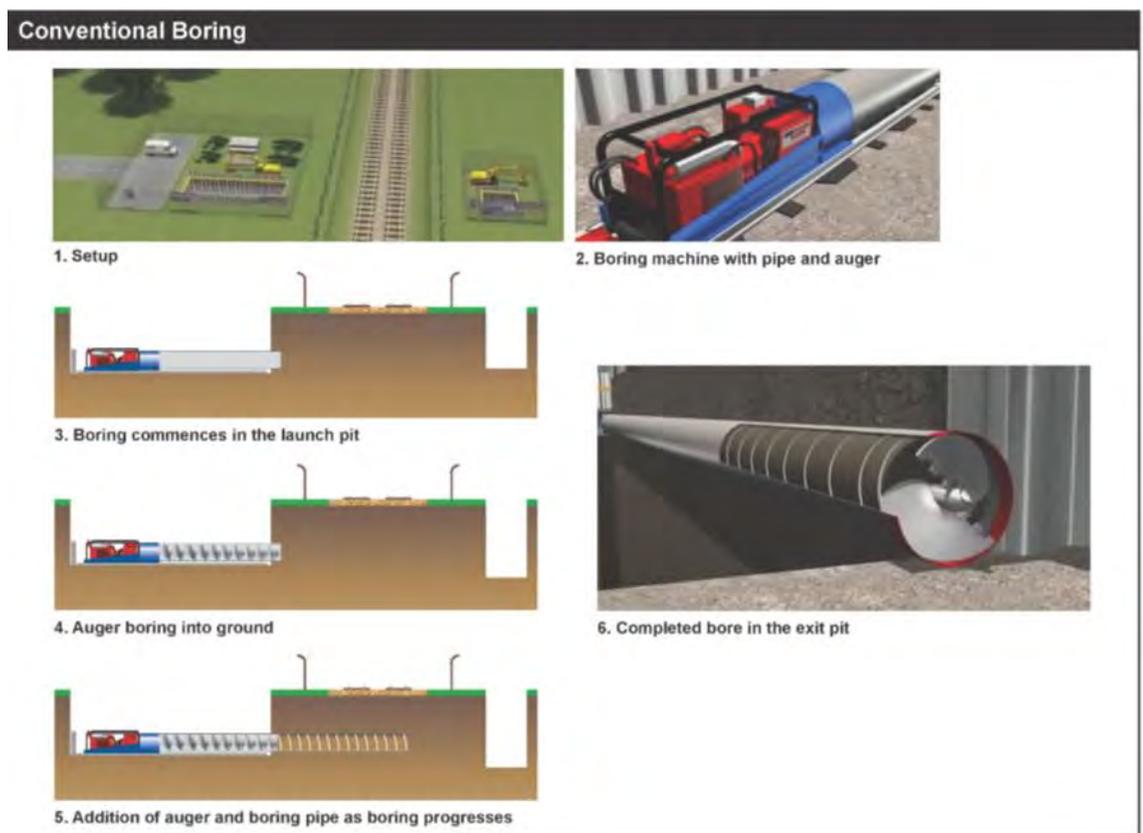
Figure 3-3 Horizontal boring construction method

The methodology for horizontal boring (referred to as thrust boring or micro-tunnelling) involves excavation of a horizontal bore hole for installation of a pipeline beneath sensitive surface features, roads and underground services. Pits are excavated with an approximate area of minimum four metres wide by eight metres long on both sides of the sensitive feature to the depth of the adjacent trench and graded to match the proposed slope of the pipeline. A boring machine operates within this bell hole to tunnel under the relevant constraint. The boring machine is located within the entry pit, which uses a hydraulic ram to jack the pipe section, behind a cutting head, in a straight line through the ground to the receiving pit. A typical set up for a thrust bore crossing is shown in Figure 3-3. Further details of shallow horizontal boring construction methodology, sequence and activities are outlined in EES Chapter 4 Project Description.

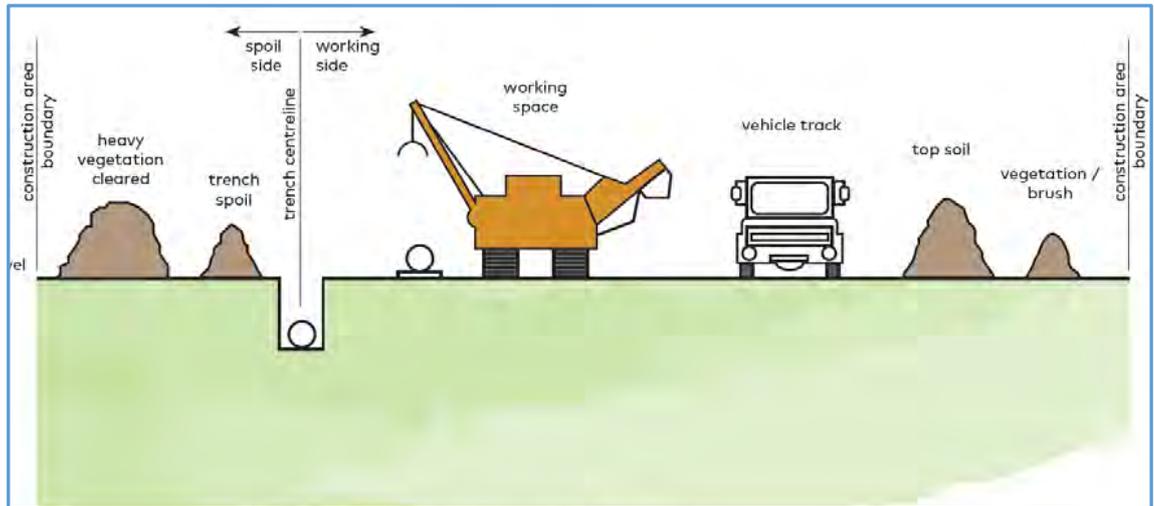
Figure 3-4 Typical trenching activity within construction corridor

Specialised trenching machines and excavators will be used to excavate the trench to a depth of approximately 2 metres and approximate width of 1 metre. Spoil generated during trench excavation will be stockpiled separate from vegetation and topsoil stockpiled earlier in the construction program. Rock breaking processes such as the use of rock saws/hammers and/or blasting is expected to be required to excavate the trench in areas of rock. Typical trenching activity within the construction corridor is shown in Figure 3-4. Further details of open trenching construction methodology, sequence and activities are outlined in EES Chapter 4 Project Description.

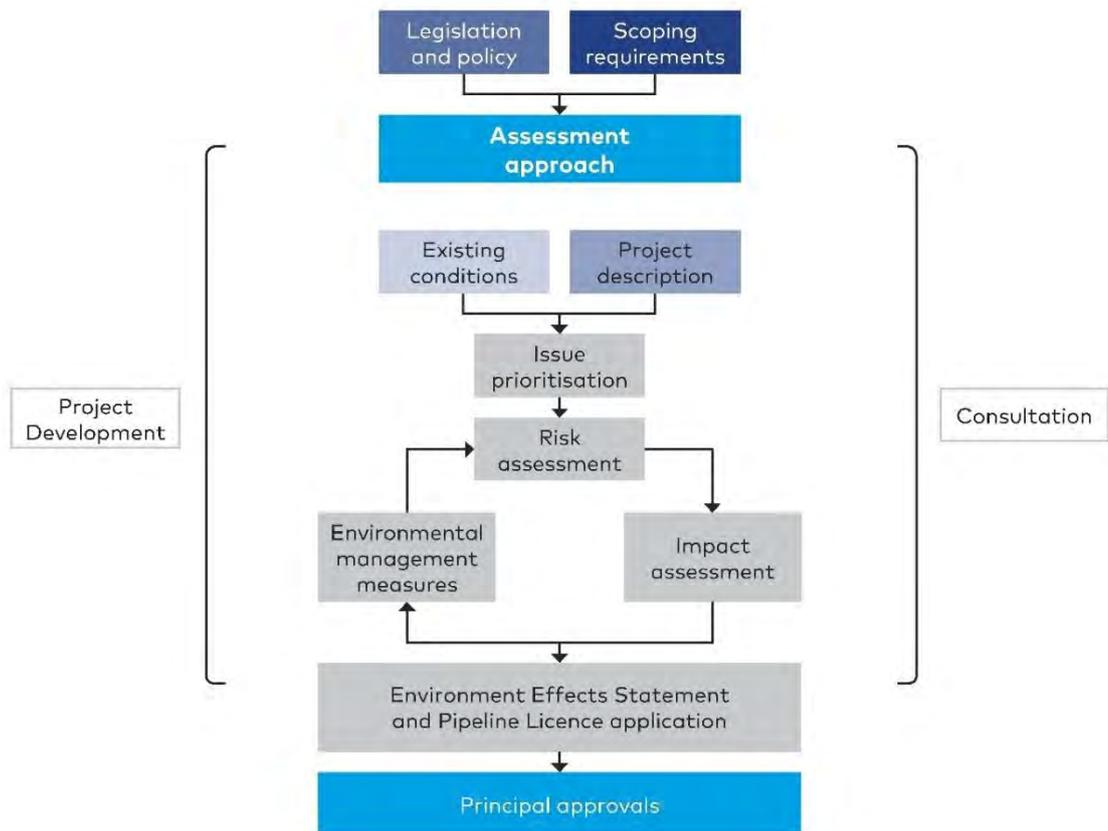
Figure 5-1 Overview of assessment method

This section describes the method that was used to assess the potential impacts of the Project. A risk based approach was applied to prioritise the key issues for assessment and inform measures to avoid, minimise and offset potential effects. Figure 5-1 shows an overview of the assessment method.

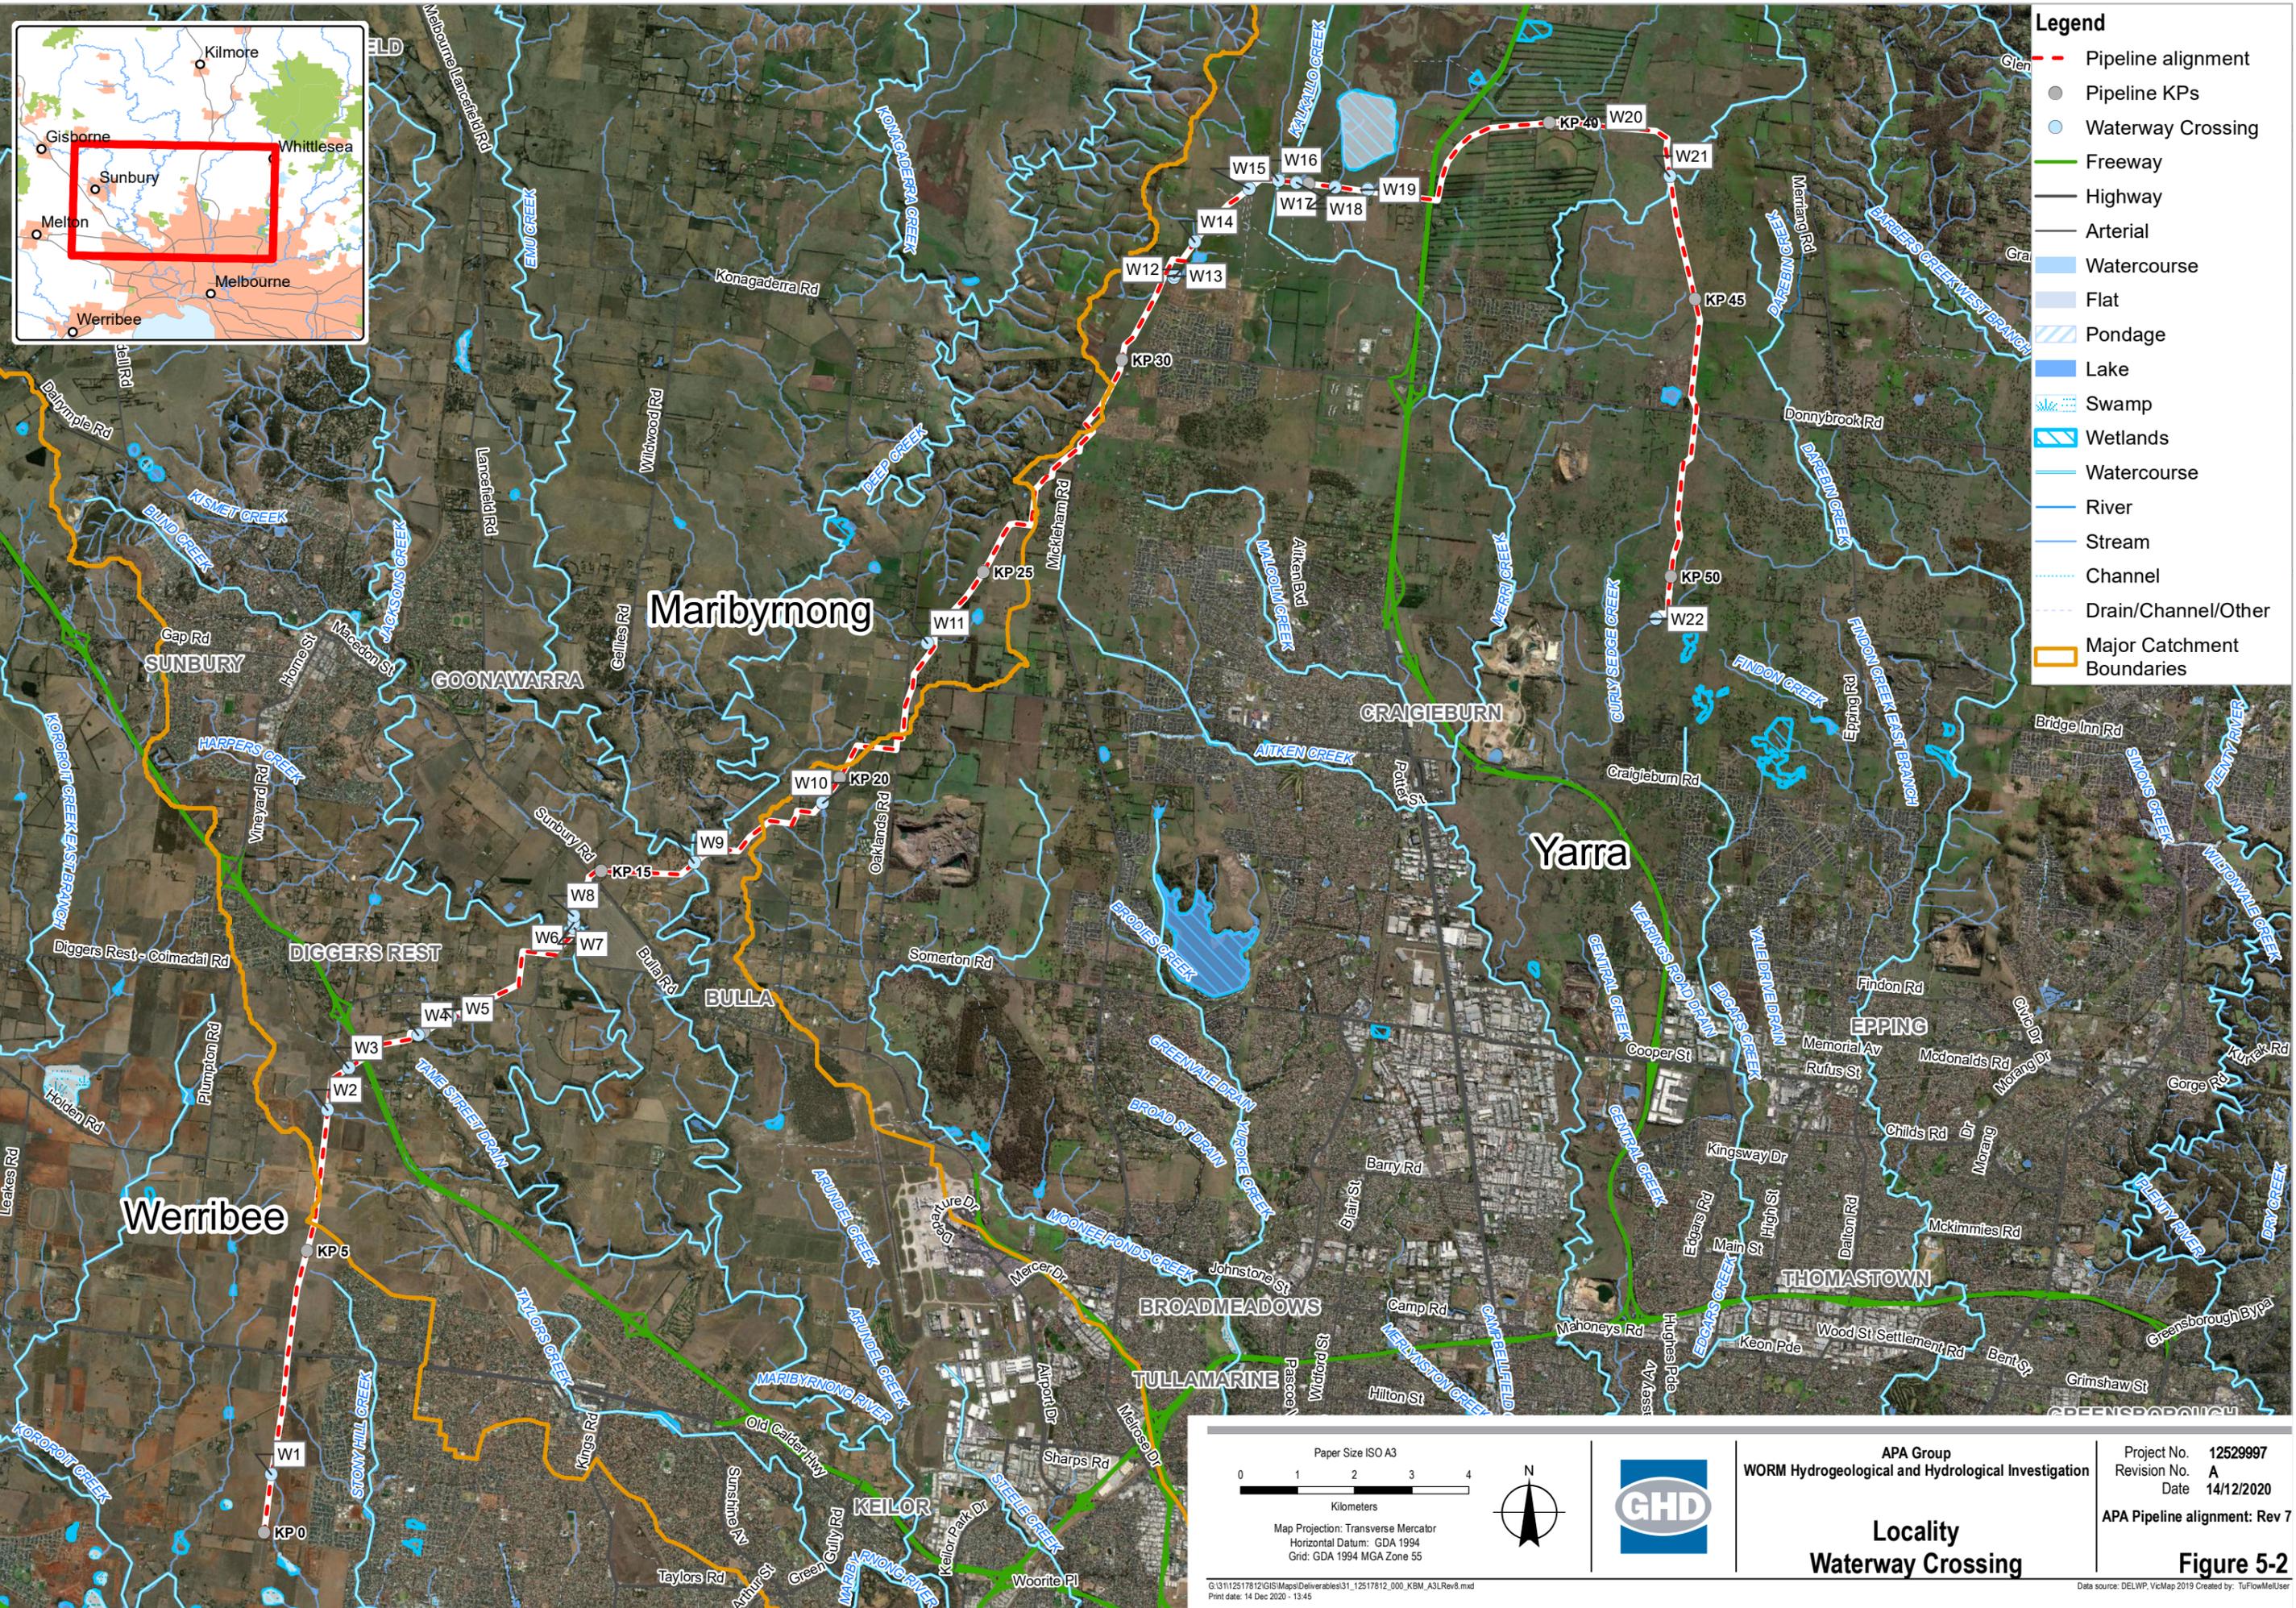
**Locality  
Waterway Crossing**

- Legend**
- - - Pipeline alignment
  - Pipeline KPs
  - Waterway Crossing
  - Freeway
  - Highway
  - Arterial
  - Watercourse
  - Flat
  - ▨ Pondage
  - Lake
  - ▨ Swamp
  - ▨ Wetlands
  - Watercourse
  - River
  - Stream
  - Channel
  - Drain/Channel/Other
  - Major Catchment Boundaries

No watercourses are crossed by the Project in the Werribee catchment. In addition to the above waterways, the pipeline alignment is proposed to cross another 16 minor watercourses and surface drains. An overview of the Project area showing the proposed pipeline alignment and the waterway crossings are presented in Figure 5-2.

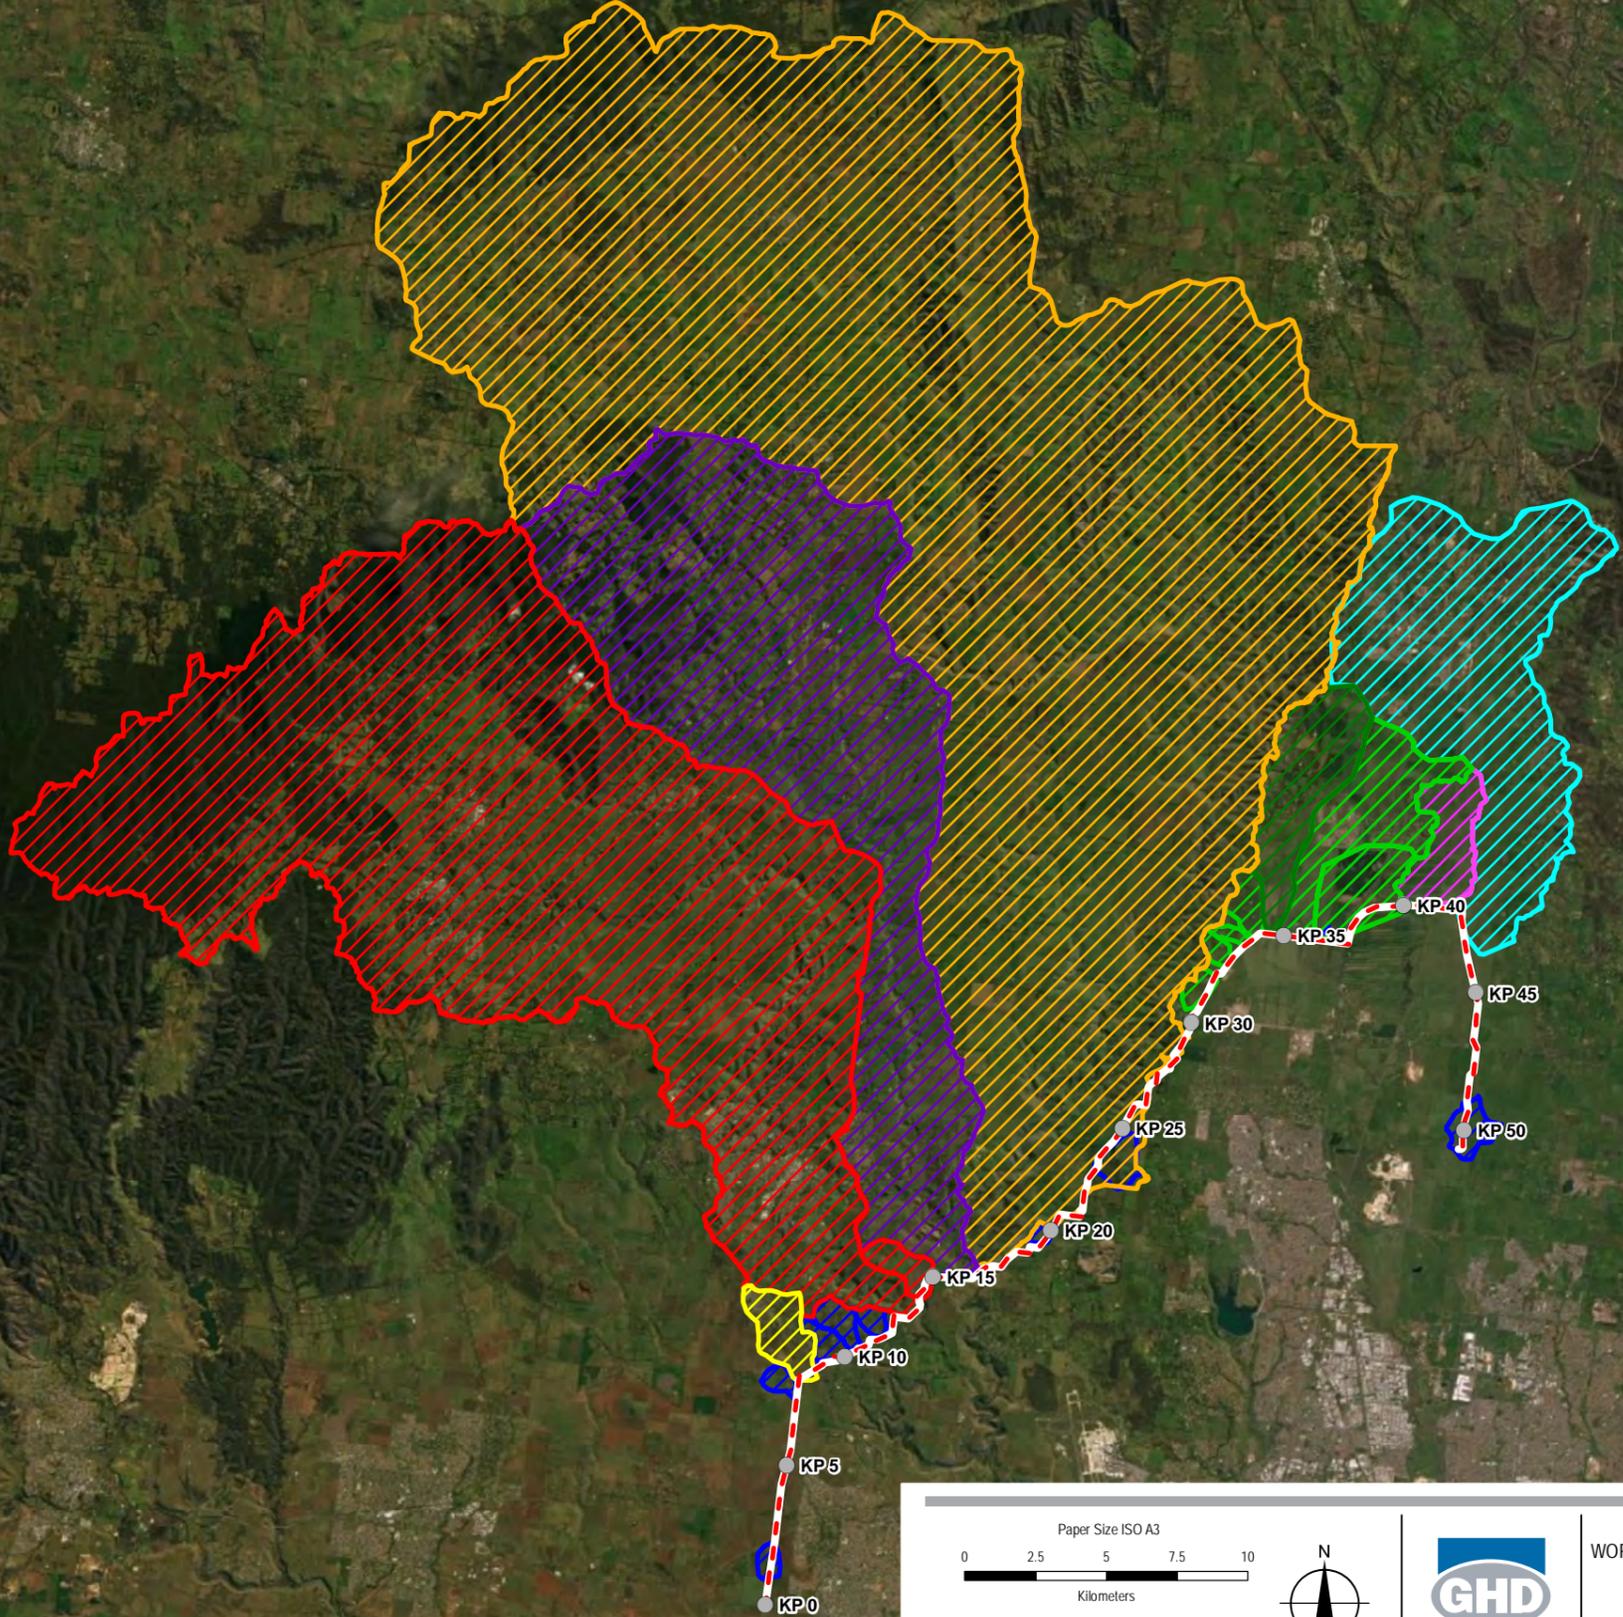
- Legend**
- - Pipeline alignment
  - Pipeline KPs
  - Minor Catchments
  - Tame Street Drain Catchment
  - Jacksons Creek Catchment
  - Emu Creek Catchment
  - Deep Creek Catchment
  - Kalkallo Creek Catchment
  - Kalkallo Creek Retarding Basin Catchment
  - Trib. Merri Creek Catchment
  - Merri Creek Catchment

<p>Paper Size ISO A3</p> <p>Kilometers</p> <p>Map Projection: Transverse Mercator Horizontal Datum: GDA 1994 Grid: GDA 1994 MGA Zone 55</p>			<p>APA Group WORM Hydrogeological and Hydrological Investigation</p> <p><b>Overview</b> Delineated Catchments</p>	<p>Project No. 12529997 Revision No. A Date 14/12/2020 APA Pipeline alignment: Rev 7</p>
---	--	--	---	--

The catchments have been delineated from the available terrain data (LiDAR, Vic topographic data). The delineated catchments are presented in Figure 5-3.

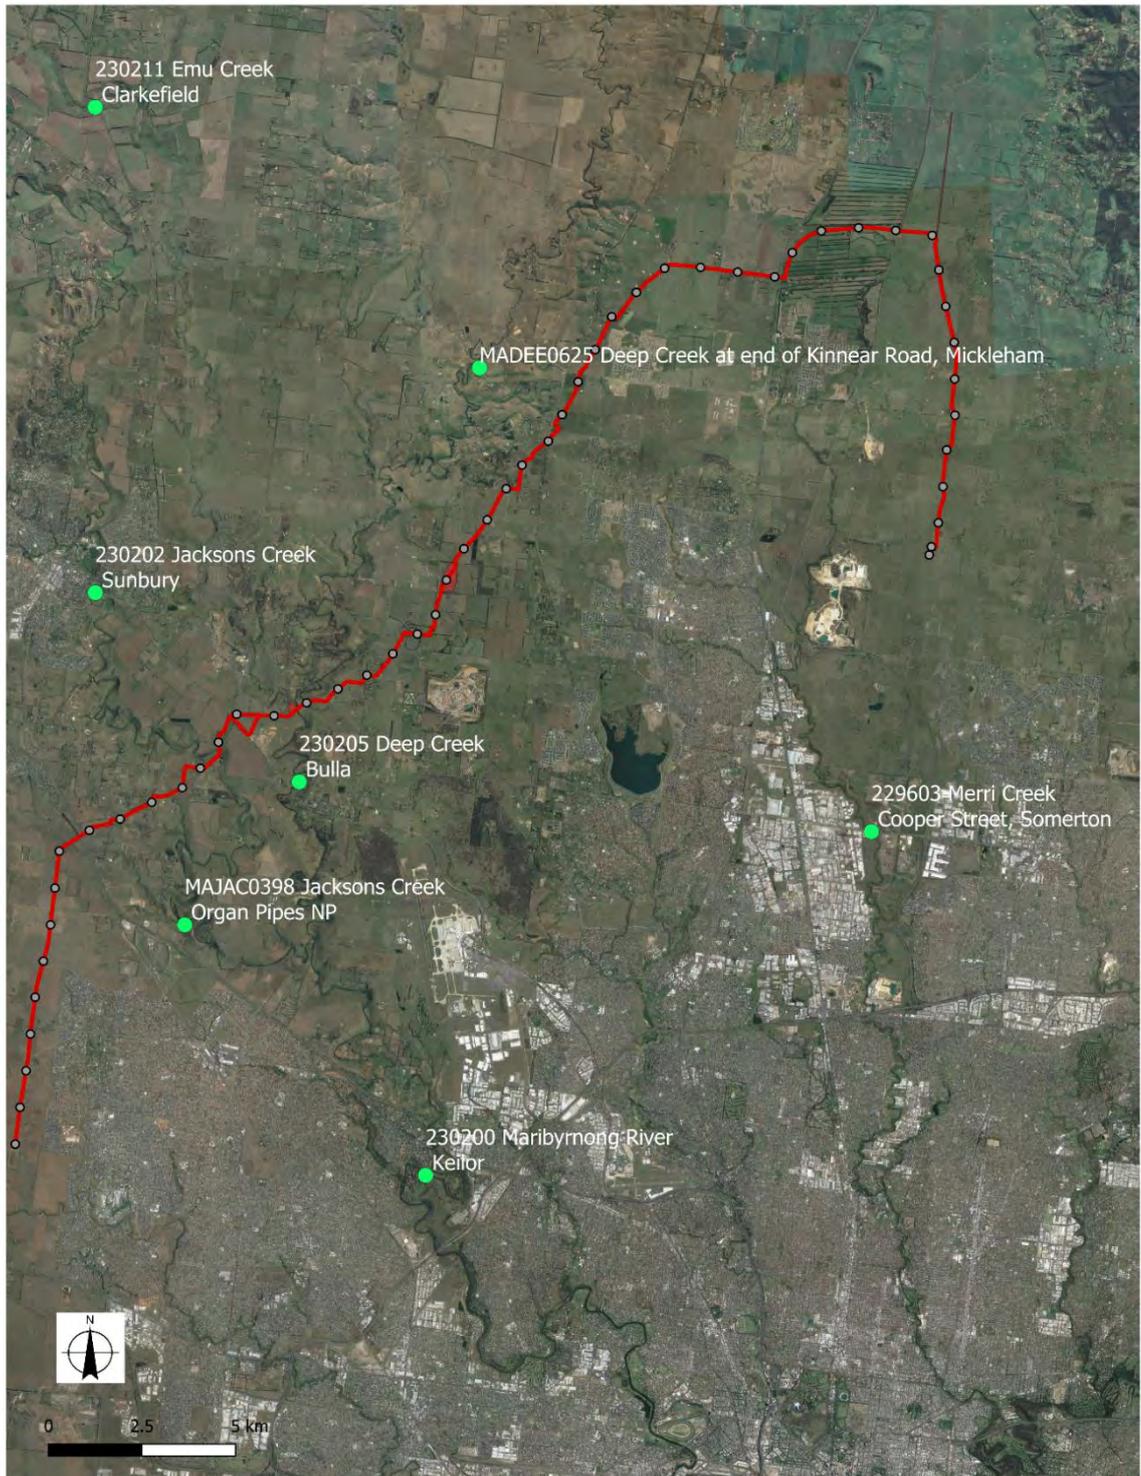
Figure 5-4 Gauge locations in relation to the Project alignment

Under the *Water Act 1989* the State Environment Protection Policy (Waters) guides environmental management of waterways. Guideline water quality parameters were assessed against available water quality monitoring data from gauge sites. The background conditions of the Jacksons, Deep and Merri Creek were assessed by comparing water quality monitoring data against the relevant guidelines. The location of these gauges in relation to the Project alignment is presented in Figure 5-4.

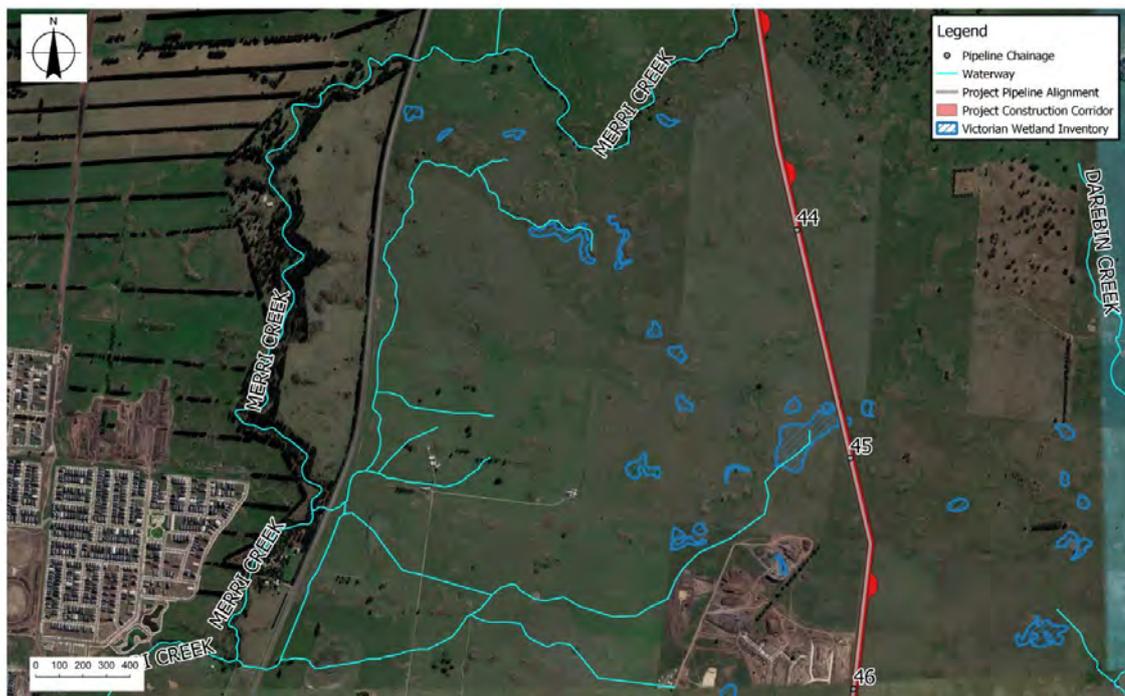
Figure 6-1 Small Seasonal wetlands between KP44 and KP45 mapped in the Victorian Wetland Inventory (2017)

Wetland data sets sourced from the Department of Environment and Primary Industries Directory of Important Wetlands in Australia (DIWA), Australian Ramsar Wetlands and DELWP Victorian Wetland Inventory (2017) were interrogated to identify the location of any wetlands along the alignment. The wetlands identified are listed and described in more detail in Section 6.13 of the EES Technical Report C Groundwater. Alluvium (2019) reported three small wetlands between KP44 and KP45, two of which are partially traversed by the pipeline alignment, as shown in Figure 6-1.

Based on the Groundwater assessment, it is indicated that the interpreted groundwater level is likely to be deeper than 2 metres and dewatering at this location would not be expected as long as trenching is undertaken during a dry period. Note that the interpreted groundwater depth is based on regional data where the mapping is likely to be coarse and may not provide an adequate representation of the groundwater levels in this area. It is considered that further targeted site investigations could confirm the surface water and groundwater interfaces and dependencies in and around the identified seasonal wetlands.

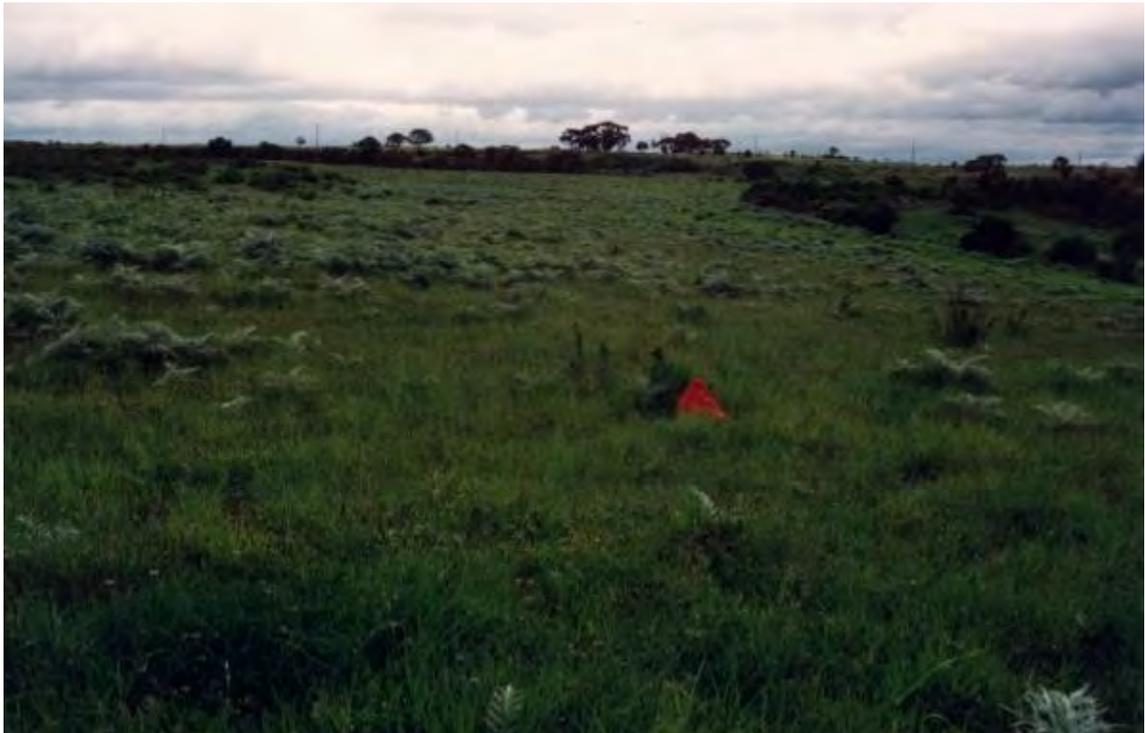
Figure 6-2 Example of Gilgai at Craigieburn East within the Merri Creek Catchment (Merri Creek Management Committee, 2008)

Gilgai formation describes terrain consisting of mounds and depressions formed over time by expansion and contraction of the clay soil layers during alternating dry and wet weather periods. During hot dry weather, the clay soil contracts forming deep cracks along the surface. Gilgai tend to respond to rainfall events that cause the swelling of the clay material resulting in the formation of natural mounds and depressions. During and following a wet period, gilgai depressions may be filled with water forming shallow wetlands. These shallow wetlands are typically difficult to detect in dry seasons or conversely when vegetation is dense as they are relatively small and ephemeral. Figure 6-2 shows an example of gilgai terrain identified within the Merri Creek catchment in Craigieburn East (Merri Creek Management Committee, 2008) outside of the Project area.

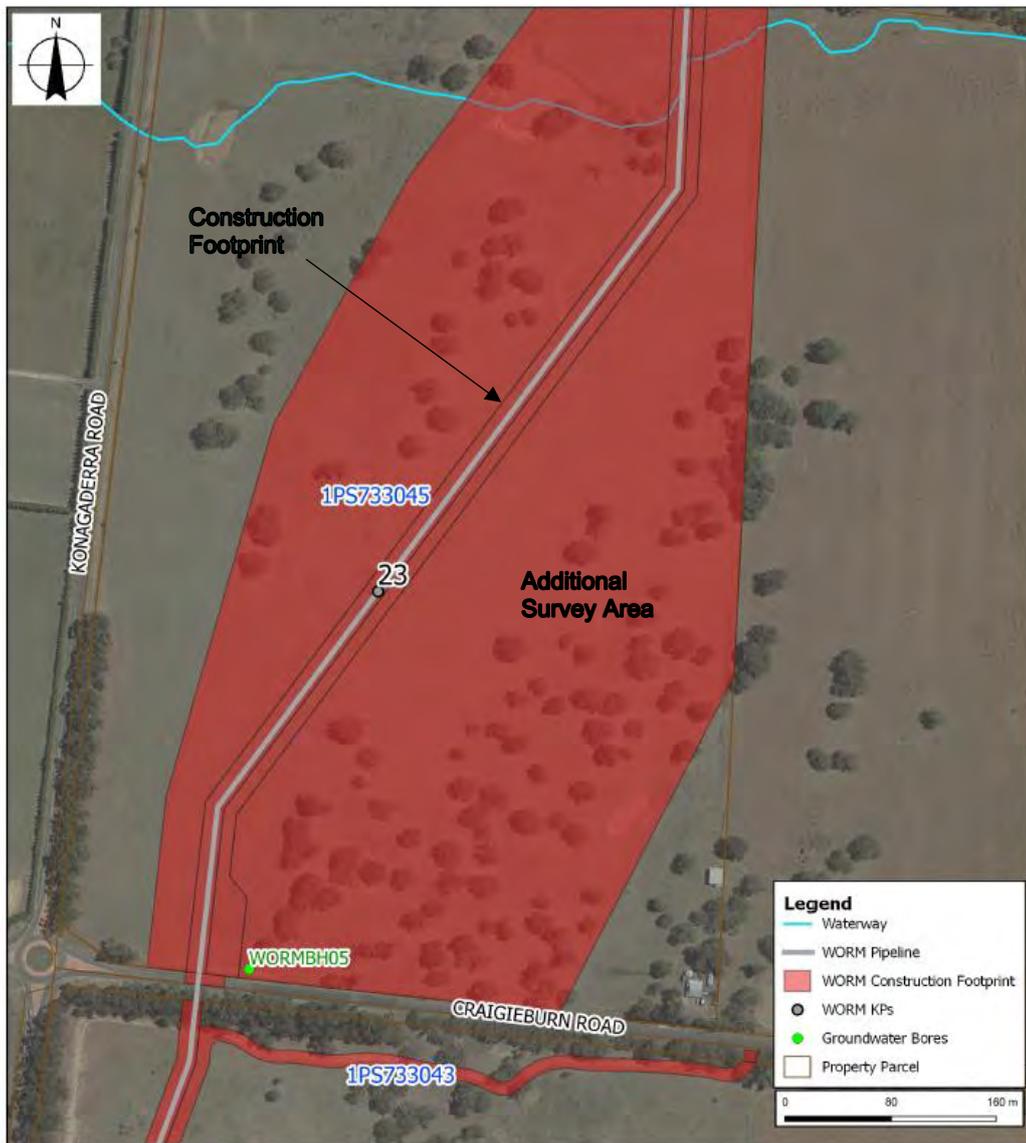
Figure 6-3 Private property north-east of the Craigieburn Road/Oaklands Road/Konagaderra Road intersection

The two properties are identified as agricultural land with relatively flat terrain. A minor gully tributary to Deep Creek traverses the property to the north as shown in Figure 6-3 and a number of farm dams within the two properties. The ground condition is expected to comprise of Newer Volcanics Basaltic soils with possible shallow basalt bedrock, as described in Table 6-3 of the EES Technical Report D: *Ground movement and land stability*. This area of the project lies within the Victorian Volcanic Plain (VVP) region and has been mapped by GHD specialist as Plains Grassy Woodland, as shown in Figure 7.13 of the EES Technical Report A: *Biodiversity and Habitats*. In addition, the two areas have also been mapped as Grassy Eucalypt Woodland of the Victorian Volcanic Plain (GEWVVP) which is listed as a threatened ecological community under the EPBC Act. This is discussed in more detail in EES Technical Report A: *Biodiversity and Habitats*.

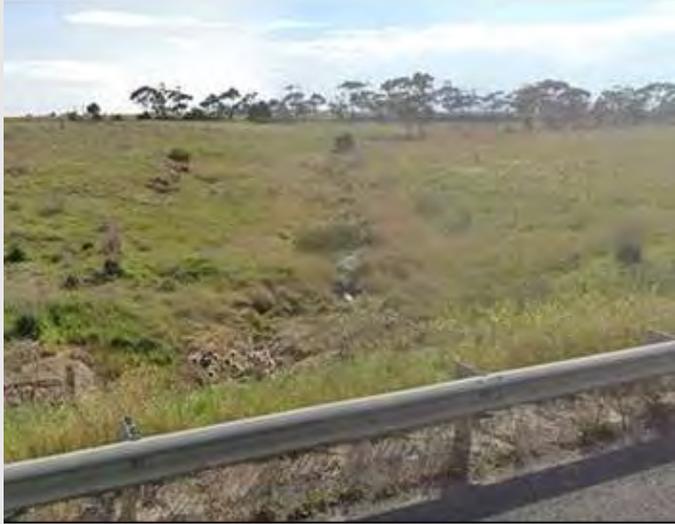
<p data-bbox="316 1301 727 1335">Source: Site photo taken (GHD, 2020)</p>	<p data-bbox="1034 770 1394 965">Tame Street Drain looking upstream from the Calder Fwy – approximately 600 m downstream of the pipeline crossing. Looking North West.</p>

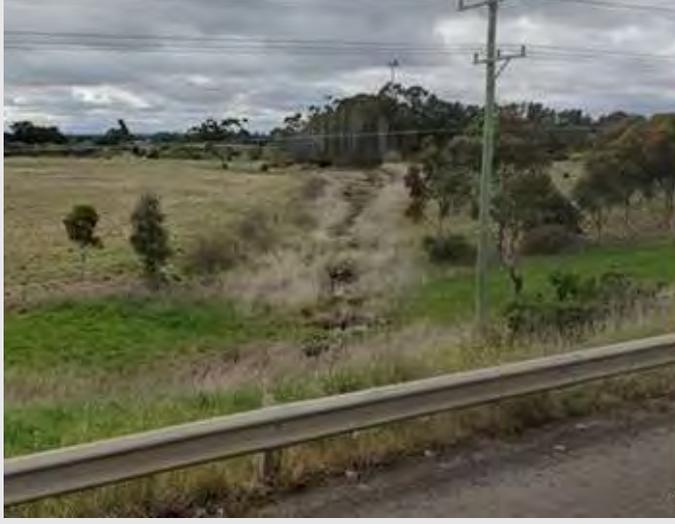
<p data-bbox="316 1877 727 1910">Source: Site photo taken (GHD, 2020)</p>	<p data-bbox="1034 1346 1347 1541">Tame Street Drain looking downstream from the Calder Fwy – approximately 600 m downstream of the pipeline crossing. Looking South East.</p>

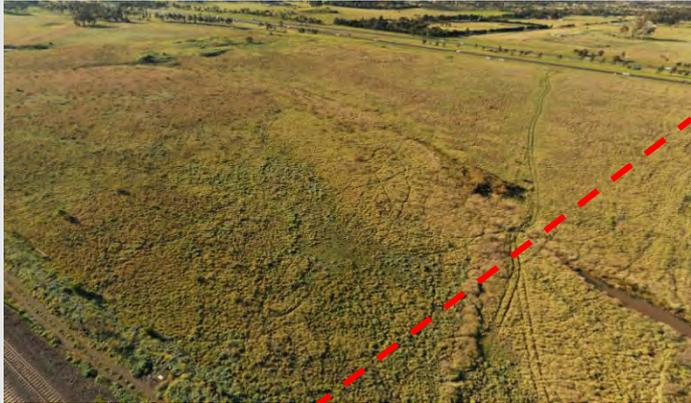
<p data-bbox="316 607 871 640">Source: Panosphere Screen Capture (AUAV, 2020)</p>	<p data-bbox="1031 203 1347 371">Panosphere – Drone aerial imagery looking north east. Upstream of crossing. Red dashed line = Indicative pipeline alignment.</p>

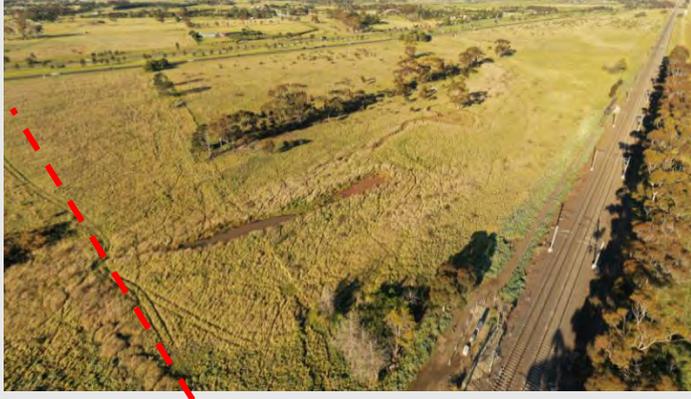
<p data-bbox="316 1048 871 1081">Source: Panosphere Screen Capture (AUAV, 2020)</p>	<p data-bbox="1031 656 1347 824">Panosphere – Drone aerial imagery looking east. Downstream of crossing. Red dashed line = Indicative pipeline alignment.</p>

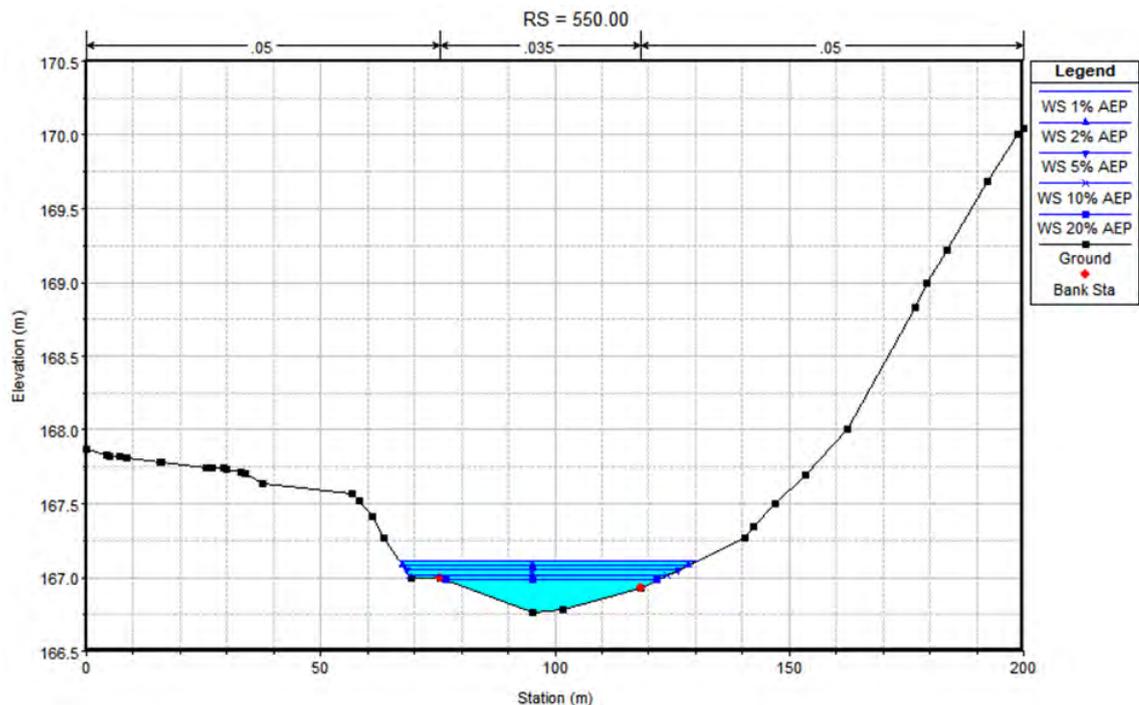
Figure 6-5 Tame Street Drain flood levels at CH 550.00 (5, 10, 20, 50 and 100 year ARI)

- The main channel has a less than 1 in 5 year ARI capacity
- The estimated 1 in 100 year ARI flood level is approximately 167.15 metres AHD (m AHD), and the flood plain is engaged to a width of approximately 65 m

The HEC-RAS results were interpreted at a representative cross section within the HEC-RAS model nearest to the location of the Project crossing as indicated in Figure 6-5 below.
