technical report B  
**surface  
water.**

Environment Effects Statement | May 2021

**western outer  
ring main**

APA VTS (Operations) Pty Ltd  
Western Outer Ring Main Environment Effects Statement  
Surface Water Report

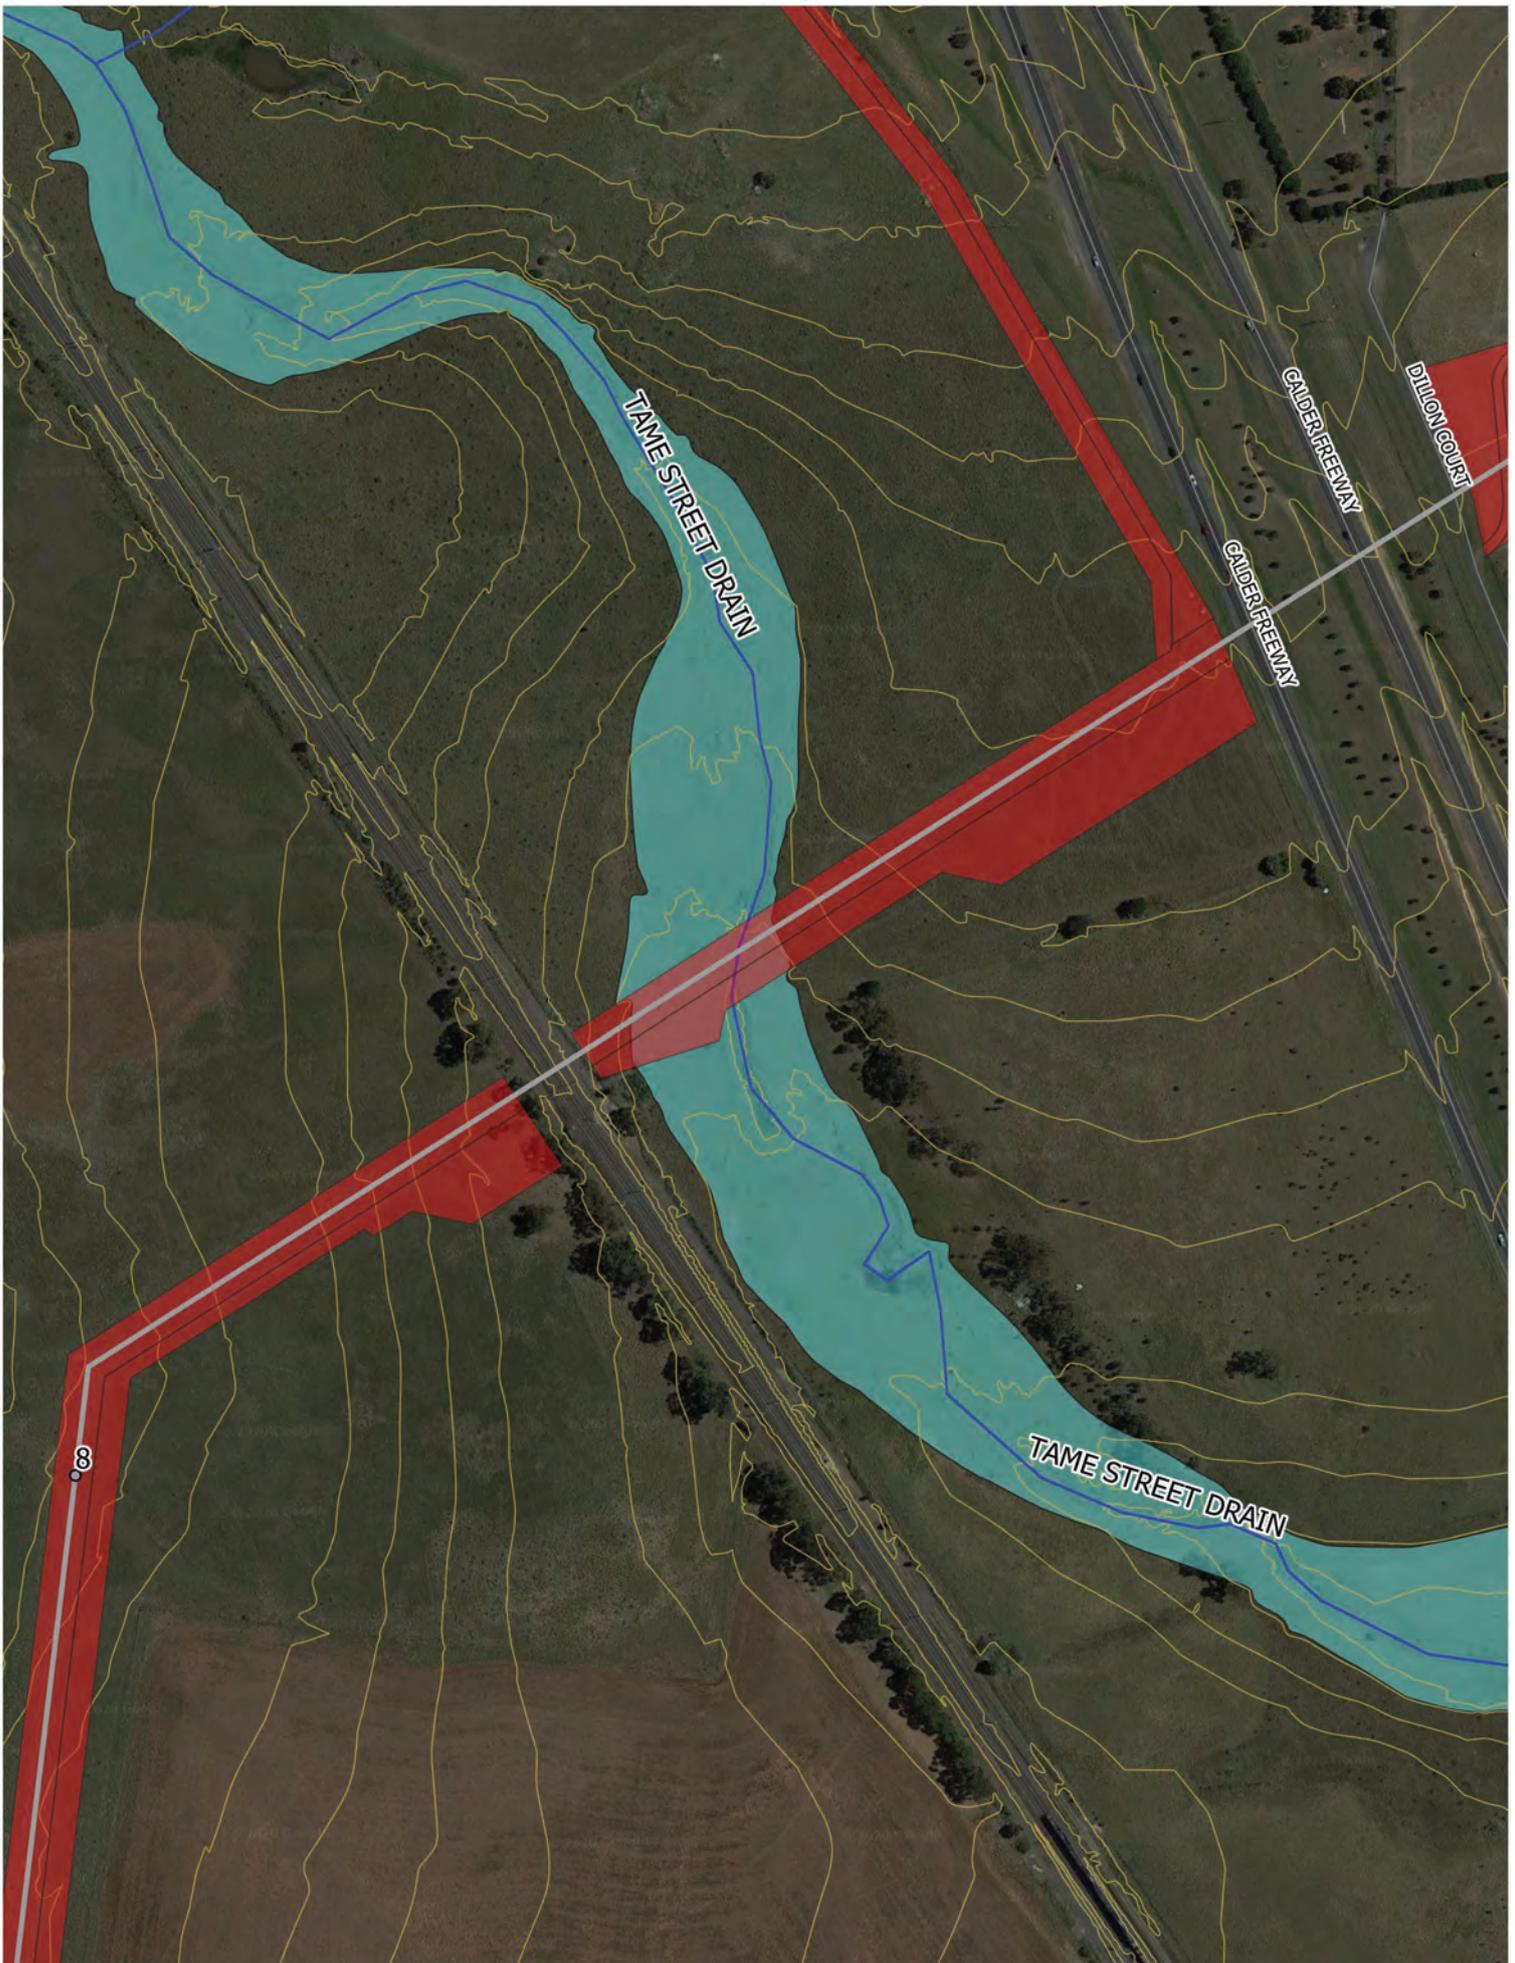
Figure 6-6

LEGEND	
	Waterway
	1m Contours
	100yr ARI Flood Extent
	WORM Construction Footprint
	WORM KPs
	WORM Pipeline

Flood mapping outputs were provided in the MWC data as presented in Figure 6-6.

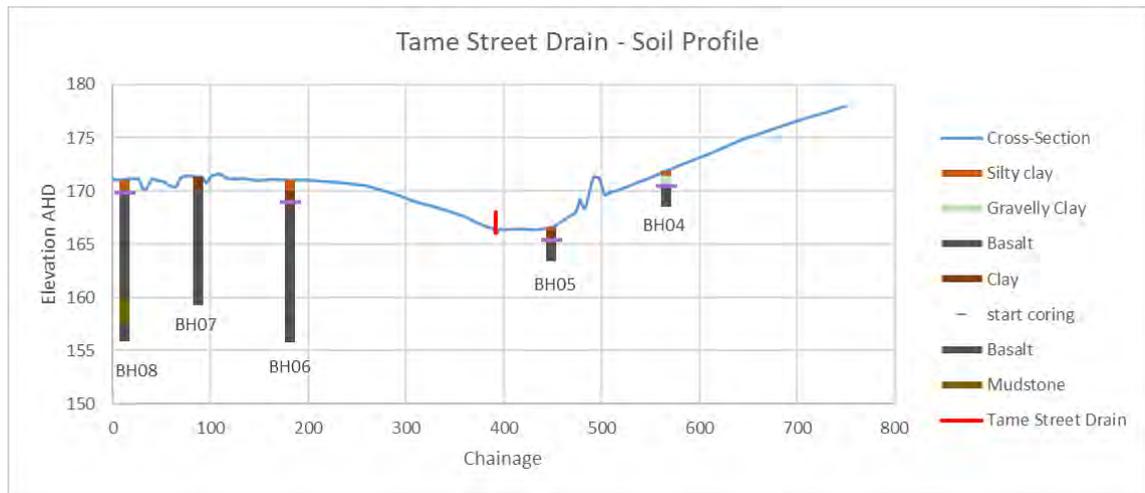
Figure 6-7 Tame Street Drain schematic soil profile cross-section

Geotechnical bore logs were provided by Construction Sciences at 5 locations near the Tame Street Drain channel and floodplain, as shown in Figure 6-7.

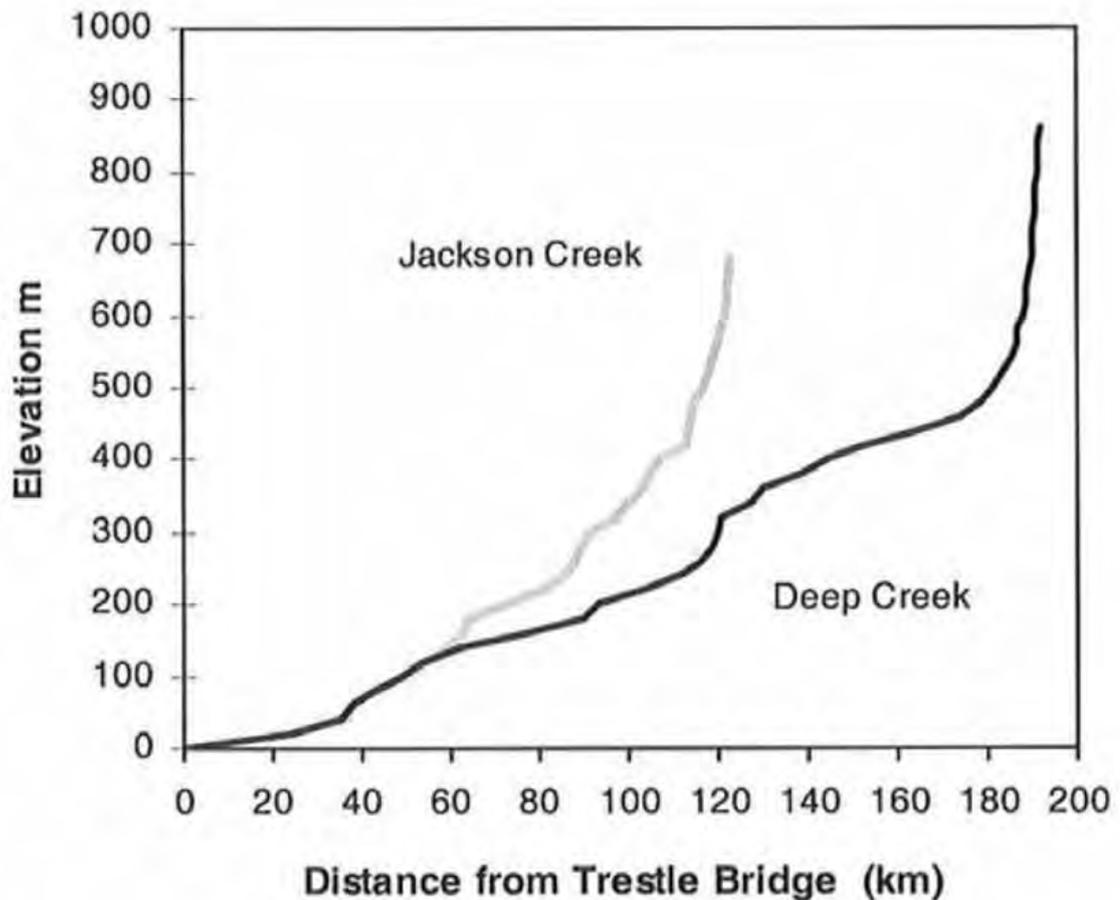
Figure 6-8 Jacksons Creek and Deep Creek Bed Profiles (Gippel & Walsh, 2000)

The Maribyrnong River commences at Bulla where Jacksons Creek and Deep Creek combine, over 10 km downstream of the pipeline crossing. Jacksons Creek was formed on basaltic terrain in the upper plains of the Maribyrnong catchment. In response to volcanic activity and regional uplifting, the waterways in the catchment are typically incised into the basalt resulting in deep valleys and gorges. The stream gradients are controlled by the lithology, and there tends to be steeper gradients associated with basalt. It is noted that the gradient of Jacksons Creek is significantly steeper than Deep Creek projecting from the stream confluence, as indicated in Figure 6-8 below.

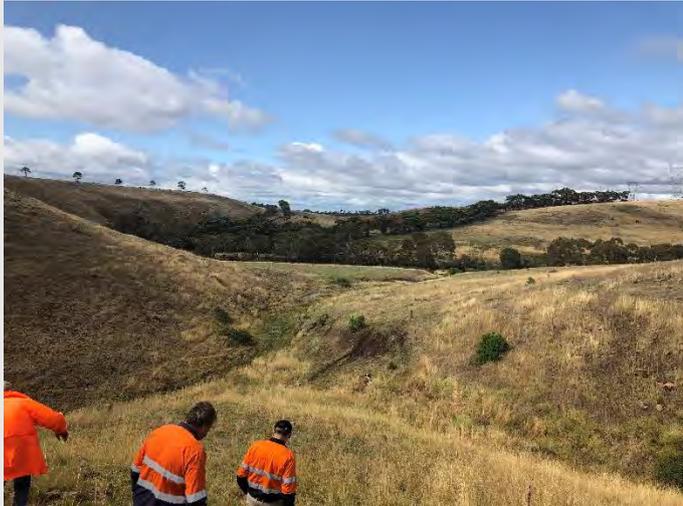
<p data-bbox="316 712 727 745"><i>Source: Site photo taken (GHD, 2020)</i></p>	<p data-bbox="1054 203 1390 360">Jacksons Creek in the background with tributary connection in the foreground. View is looking south.</p>

Jacksons Creek was initially inspected near the location of the pipeline crossing on 23 January 2020 the day immediately following heavy rainfall in the catchment. Complementing the site inspection photos, AUAV captured drone aerial images at each of the main waterway crossing. The photos presented below indicate the pipeline alignment (white stakes).

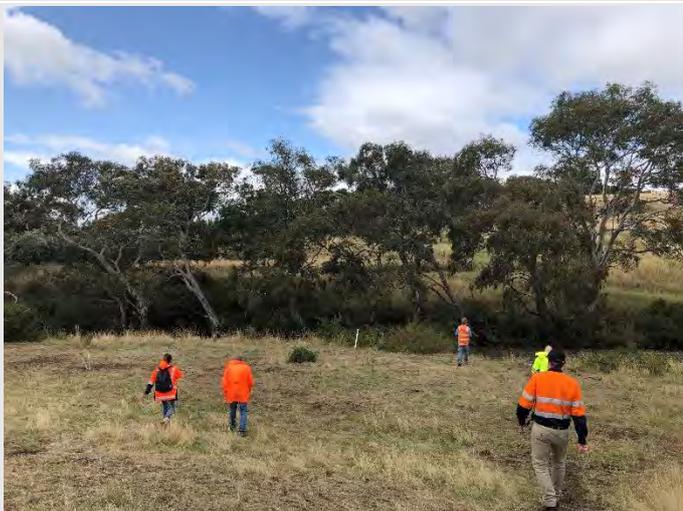
<p data-bbox="316 1265 727 1301"><i>Source: Site photo taken (GHD, 2020)</i></p>	<p data-bbox="1054 752 1362 882">Jacksons Creek crossing and eastern floodplain in the foreground. View is looking south.</p>

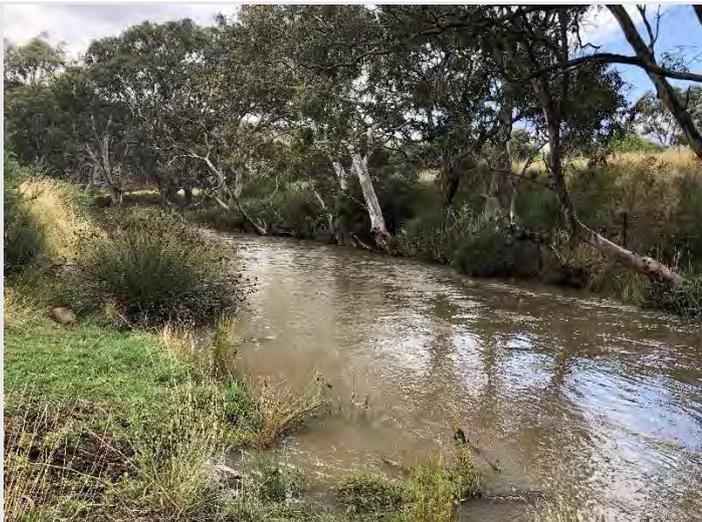
<p data-bbox="316 1832 727 1865"><i>Source: Site photo taken (GHD, 2020)</i></p>	<p data-bbox="1054 1308 1394 1438">Jacksons Creek looking immediately downstream of crossing location. View is looking east.</p>

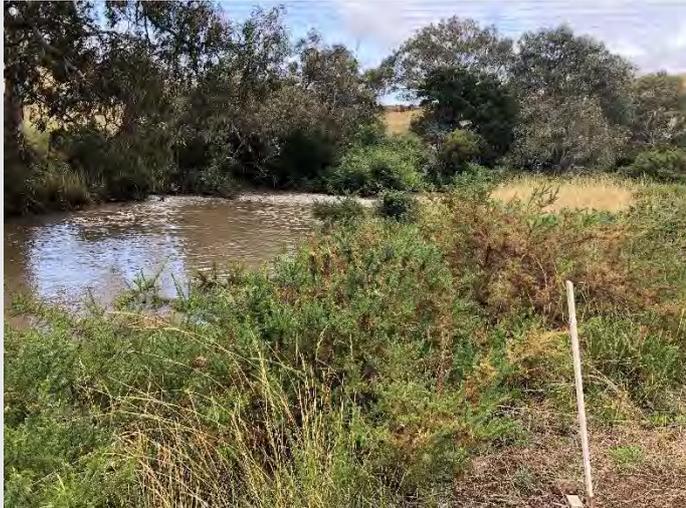
<p data-bbox="316 712 727 745"><i>Source: Site photo taken (GHD, 2020)</i></p>	<p data-bbox="1054 197 1362 327">Jacksons Creek looking immediately upstream of crossing location. View is looking west.</p>

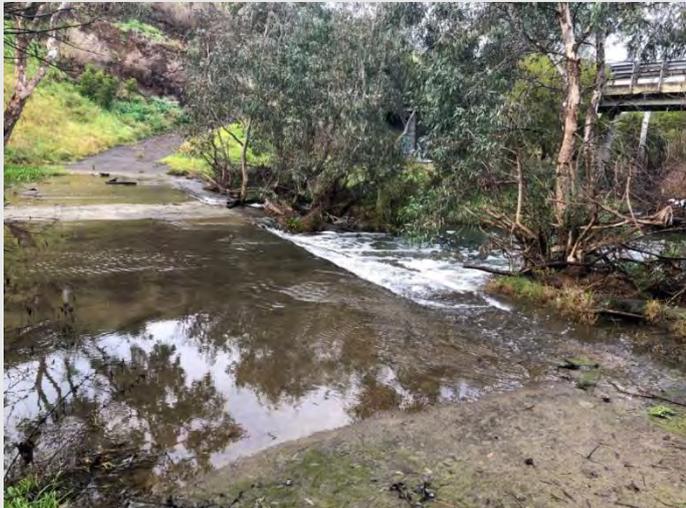
<p data-bbox="316 1265 727 1299"><i>Source: Site photo taken (GHD, 2020)</i></p>	<p data-bbox="1054 750 1390 1010">Ford crossing over basalt rock outcrop observed downstream of the crossing location, directly upstream of the Bulla-Diggers Road crossing (shown in Figure 6-9 as Key Feature 6). View is looking east.</p>

A number of key features were identified during the subsequent site inspection on 6 July 2020 in the vicinity of the crossing location, as outlined in Table 6-4. A key hydraulic control was observed approximately 350 m downstream of the crossing location, directly upstream of the Bulla-Diggers Road crossing. The location of this feature is shown in Figure 6-9 as Key Feature 6 and indicated in the longitudinal profile in Figure 6-10. The ford crossing is expected to provide some level of backwater control to the site of interest at the pipeline crossing.

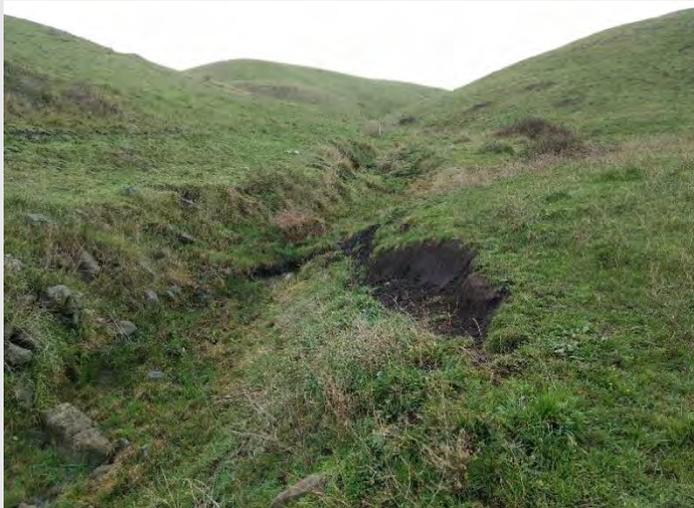
<p data-bbox="316 1825 727 1859"><i>Source: Site photo taken (GHD, 2020)</i></p>	<p data-bbox="1054 1303 1390 1473">Minor Tributary discharging to Jacksons Creek at crossing location looking North. (shown in Figure 6-9 as Key Feature 4)</p>

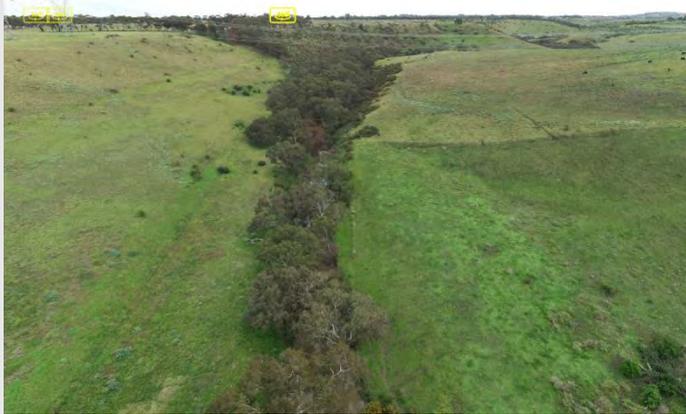
<p data-bbox="316 633 861 667">Source: Panosphere screen capture (AUAV, 2020)</p>	<p data-bbox="1054 208 1385 264">Panosphere – Drone aerial imagery</p> <p data-bbox="1054 275 1316 331">Upstream of crossing looking West.</p>

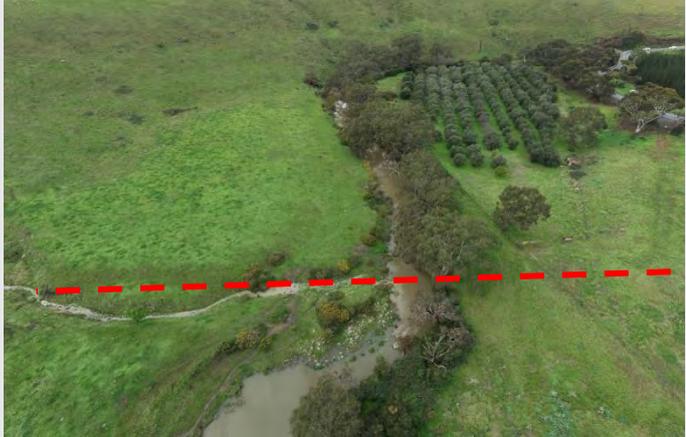
<p data-bbox="316 1126 861 1160">Source: Panosphere screen capture (AUAV, 2020)</p>	<p data-bbox="1054 678 1385 734">Panosphere – Drone aerial imagery</p> <p data-bbox="1054 745 1348 835">Jacksons Creek looking downstream at crossing location looking East.</p> <p data-bbox="1054 846 1276 936">Red dashed line = Indicative pipeline alignment.</p>

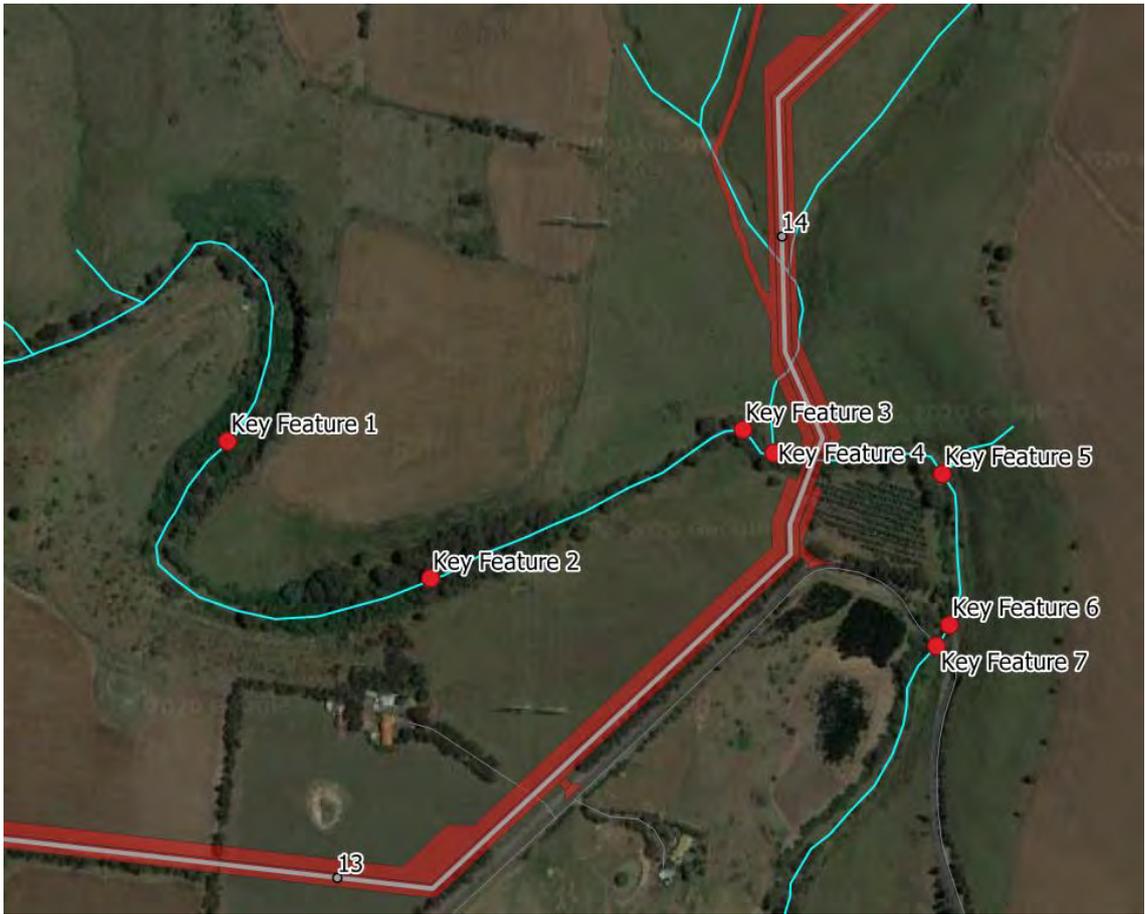
Figure 6-9 Plan view of Jacksons Creek waterway crossing with Key Features.

Table 6-4 Key features along the waterway in the vicinity of the crossing

Key feature No.	Description
1	200 metre riffle along stream bed
2	300 metre riffle along stream bed
3	Meander with pool in Jacksons Creek
4	Discharging tributary
5	Discharging tributary
6	Ford crossing over basalt rock outcrop (Hydraulic Control)
7	Bulla-Diggers Road crossing and piers

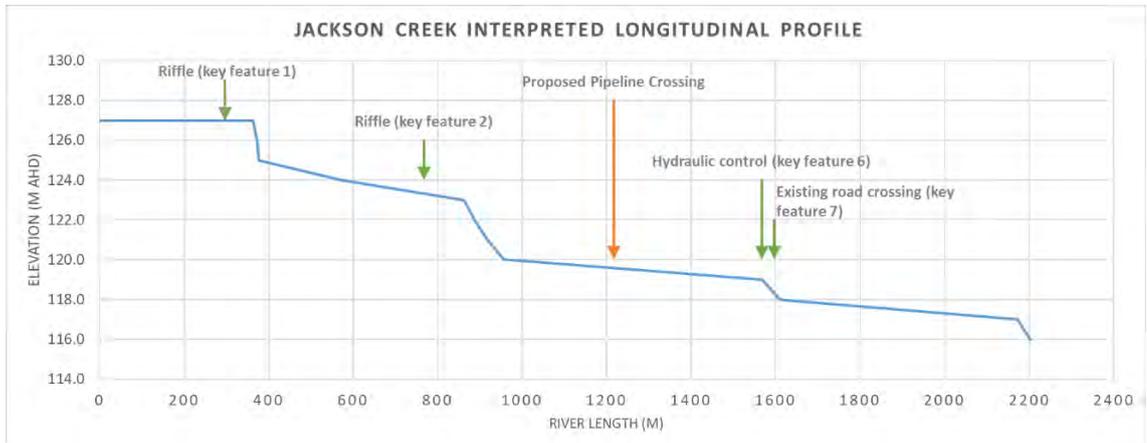
Figure 6-10 Jacksons Creek schematic profile indicating location of pipeline crossing and observed hydraulic control feature

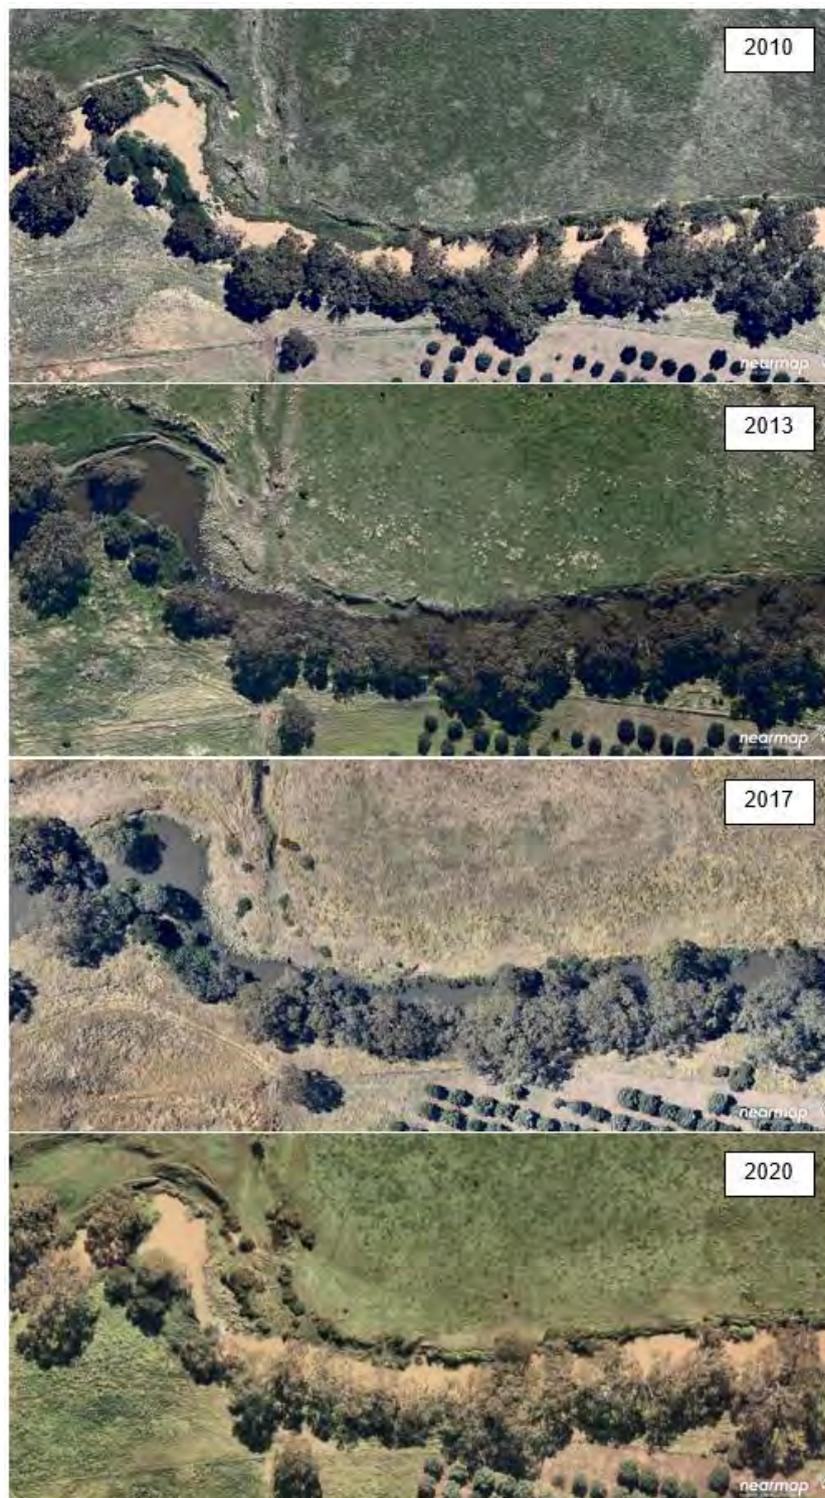
Near map images were obtained for Jacksons Creek over a 10 year period, between 2010 and 2020, as shown in Figure 6-11. The time series images below concentrate mainly on the section of Jacksons Creek where the pipeline alignment crosses the waterway.

Figure 6-11 Nearmap images of Jacksons Creek at the crossing location over a 10-year period

- Within the upstream reach there is sharp meander bend in the creek and some minor erosion of the stream banks was evident. Evident in the Nearmap aerial images (as shown in Figure 37), there is a pool located within the sharp meander which is characterised by deep depths and reduced velocities. A grade rock structure providing protection to the stream bed was observed immediately upstream of the pipeline crossing.

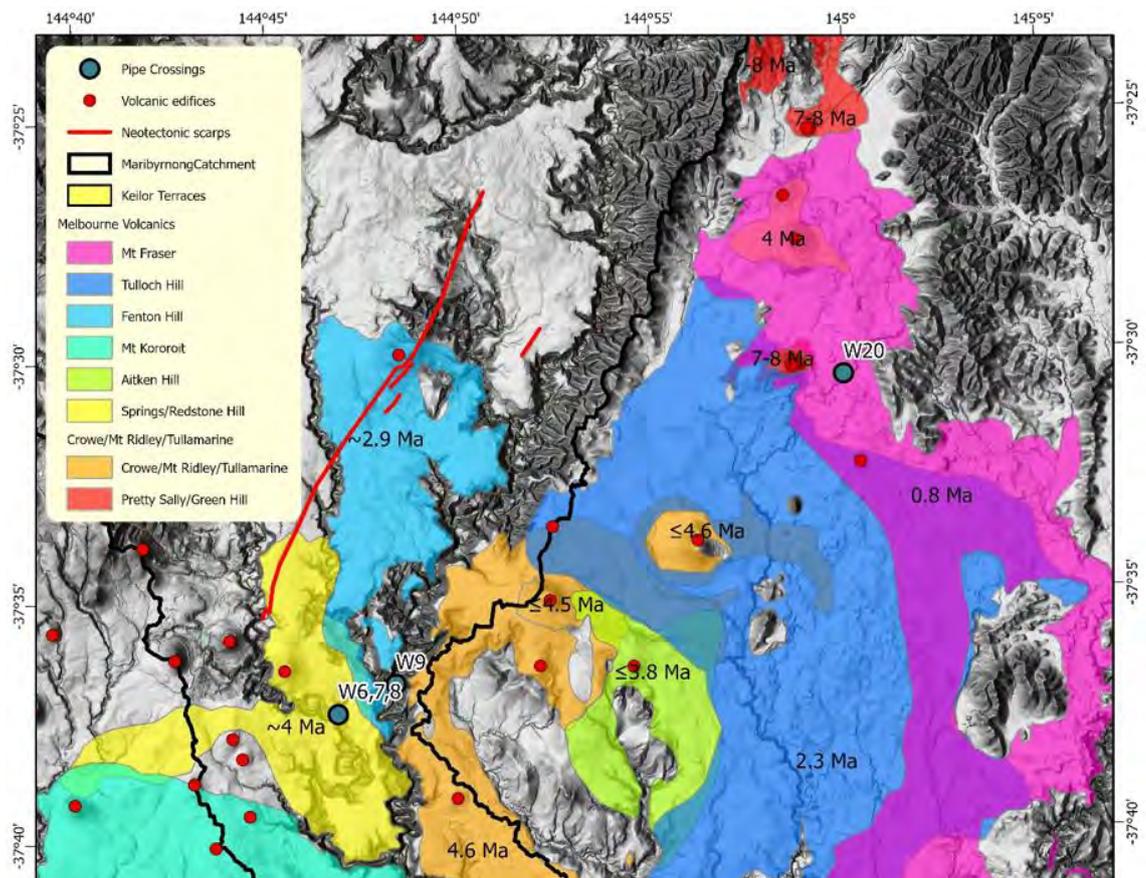
Heath et al. (2020)'s map suggests that Jacksons Creek at W6,7,8 is probably incised into c. 4Ma basalts of the Springs Hill / Redstone Hill Flow, as shown in Figure 6-12.

Figure 6-12 Map of Melbourne lava flows by age (based on Heath et al, 2020)

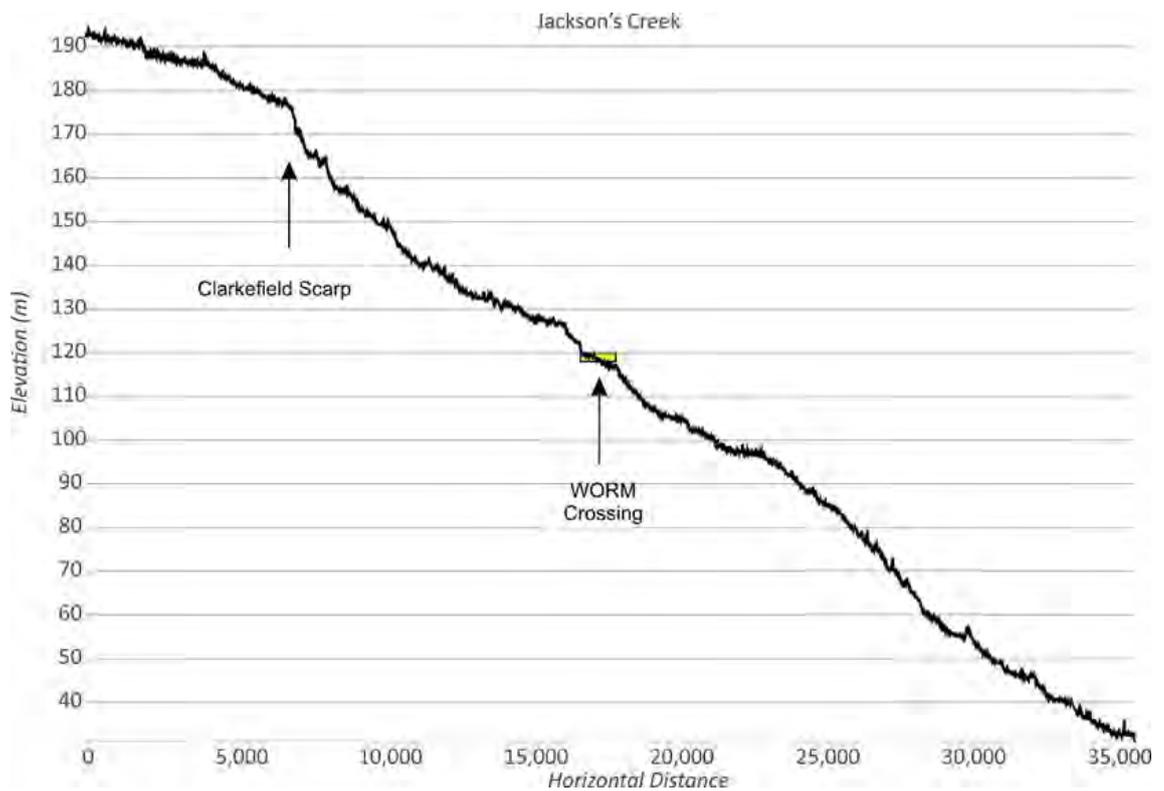
On a catchment scale, the gradient of Jacksons Creek is fairly consistent, apart from a marked convex profile anomaly as the creek crosses the neotectonic Clarkefield scarp (Figure 6-13). It is not clear whether this indicates differential lithological control, or whether it is the product of neotectonic derangement. Shorter wavelength gradient anomalies appear to reflect the upstream and downstream sides of meander bends, with generally steeper gradients on the downstream side. The pipeline crossing is in a slightly lower gradient section indicating it is likely to be erosional at the downstream end of the reach and depositional at the upstream end.

Figure 6-13 Jacksons Creek Stream Bed Profile

Jacksons Creek has incised through alluvial terraces to a base level that is possibly presently controlled by the ford crossing located about 300 m downstream of the alignment. As noted above the profile is convex towards the downstream end of the alignment reach (essentially at the ford crossing) and therefore is likely to be higher erosion potential downstream, and more likely to be depositional upstream. The ford crossing is located on a natural basalt outcrop control. Any erosion head located downstream migrating upstream will be halted by the basalt outcrop. The river currently abrades hard rock in some locations within the upstream alignment reach, including a series of rock outcrop drops within the alignment gully and at the outside meander bend immediately upstream of the of the pipeline alignment.

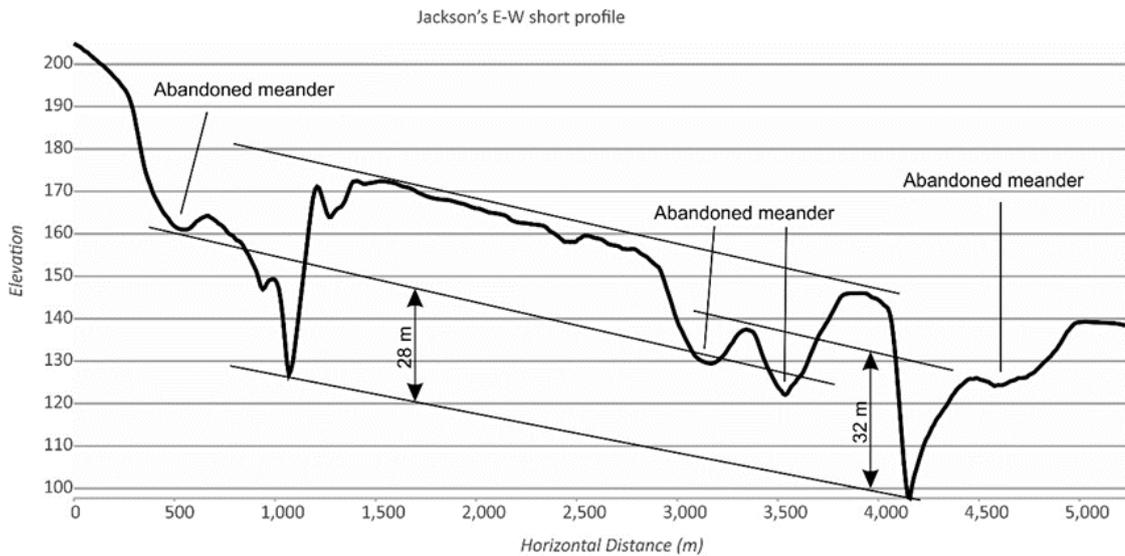
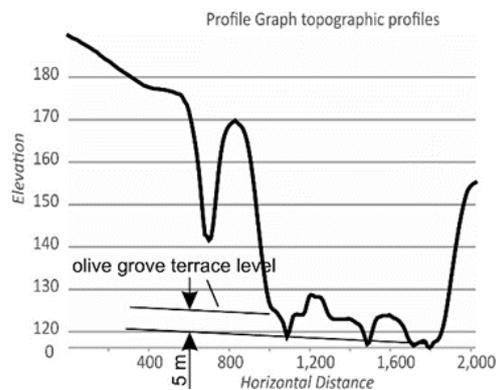
A sequence of abandoned meanders are occasionally found at 25-35 m above the main channel and roughly similar elevation below the main lava shield (Figure 6-14). One of these is located 1 km upstream of the pipeline crossing.

Figure 6-14 Profiles at Jacksons Creek showing levels of major terraces and abandoned meanders

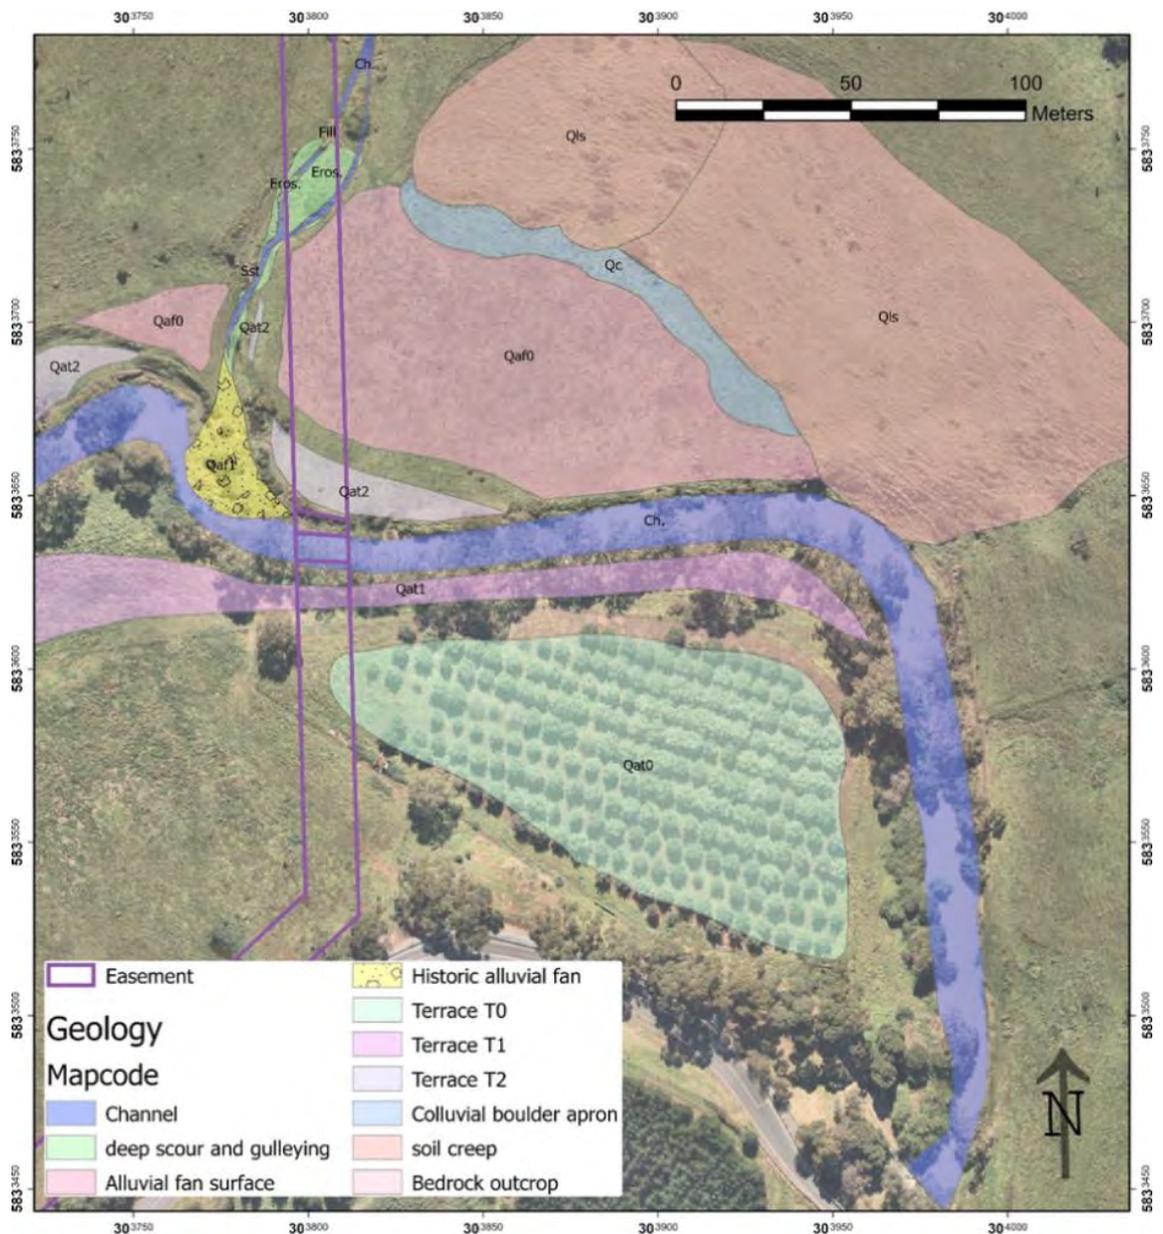
A geomorphological map is provided of Jacksons Creek near the crossing location in Figure 6-15.

Figure 6-15 Geomorphological map of Jacksons Creek near crossing location

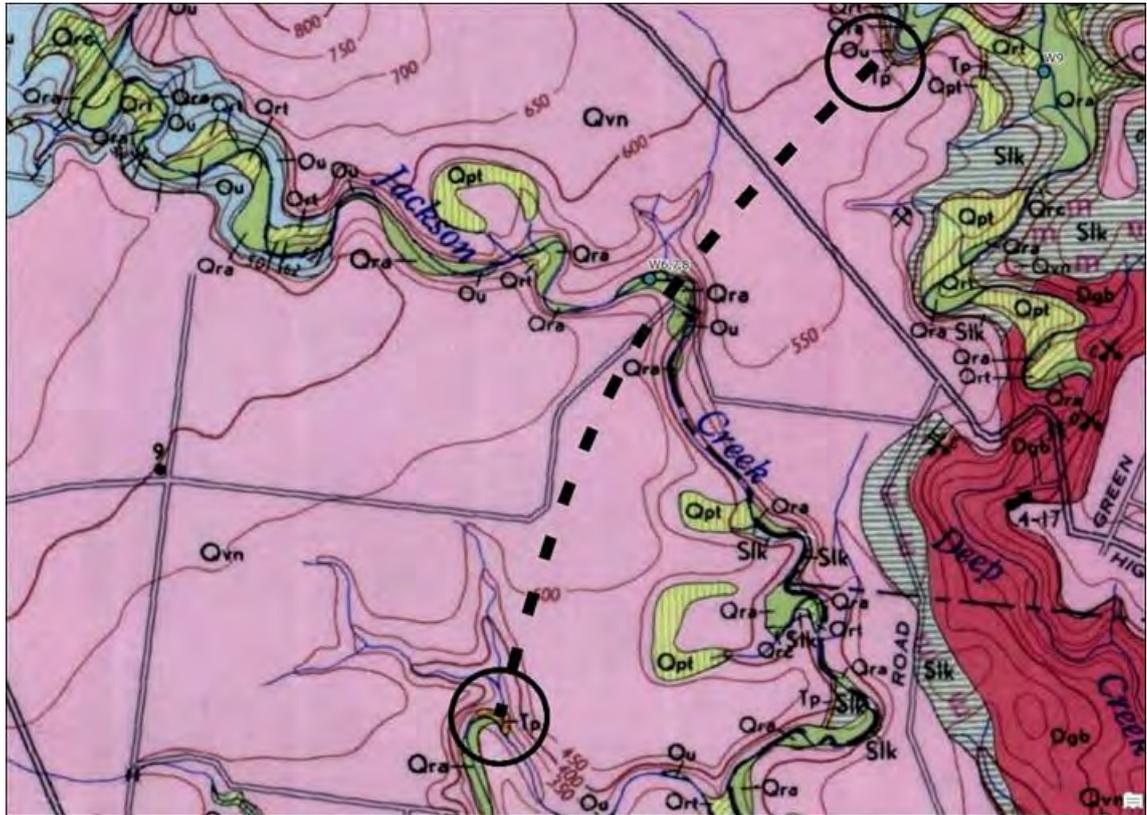
Figure 6-16 Sunbury Geological map of Brighton Group Gravels

It is possible the alluvium at depth may represent a paleochannel of the modern Jacksons Creek, from which it has been deflected by the gully fan. More likely the presence of basalt at stream level at the ford suggests that the gravel intersected in the borehole may be Mio-Pliocene in age and this alluvium might be interpreted as the Mio-Pliocene fluvial sediments of the Brighton Group. This is consistent with the Sunbury geological map indicated in Figure 6-16, which shows basalt to river level in this area, probably infilling a paleochannel eroded into Ordovician and Silurian sedimentary rocks. There are possible implications if the Brighton Group sediments form the substrate of the channel or underlie the terraces along the alignment and these will be expected to be more vulnerable to scour once disturbed.

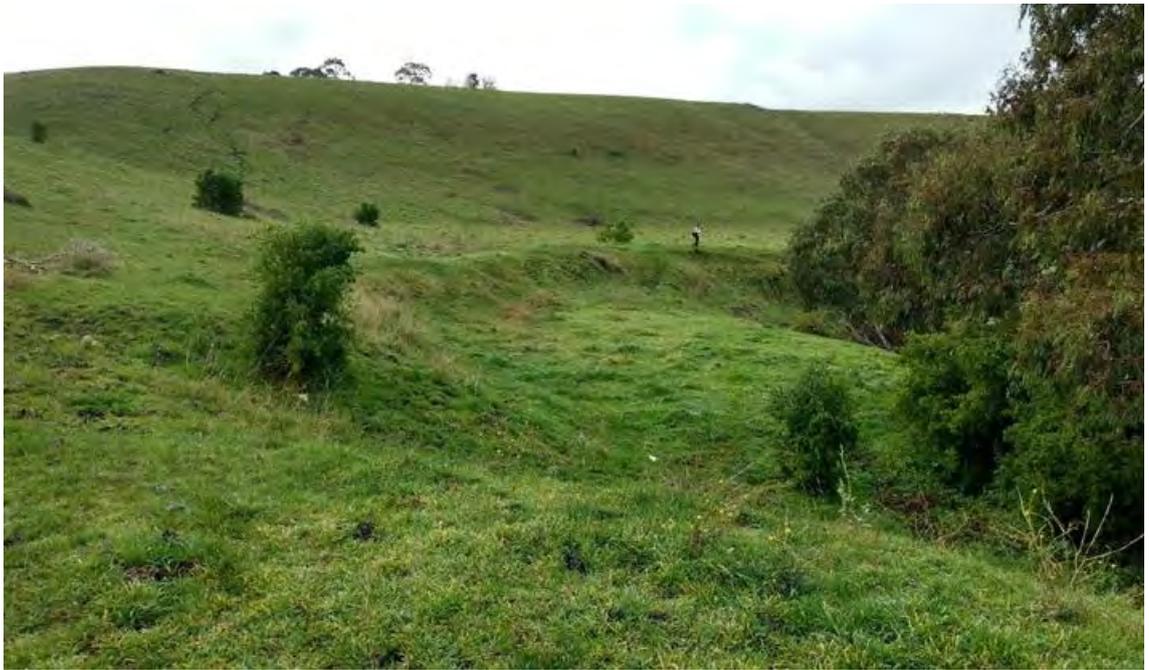
- On the north side of the stream, as shown in Figure 6-17, the main expanse of terrace slopes up toward the mouth of the alignment gully and is probably developed on an alluvial fan that has built out of the gully
- A lower terrace is eroded up to 2 m into the margins across much of the site and tapers out approximately where the alignment crosses the stream and is inset into Qaf0. This terrace will be engaged during moderate flow events, and appears to represent the short-wavelength meandering on the upstream side of the alignment gully.
- A small boulder fan has built out into Jacksons Creek at the mouth of the alignment gully. Finer sediments may have been removed over time leaving protruding ~400 mm rocks that give the appearance of a placed armoured bank

Figure 6-17 Terrace on north side of the waterway

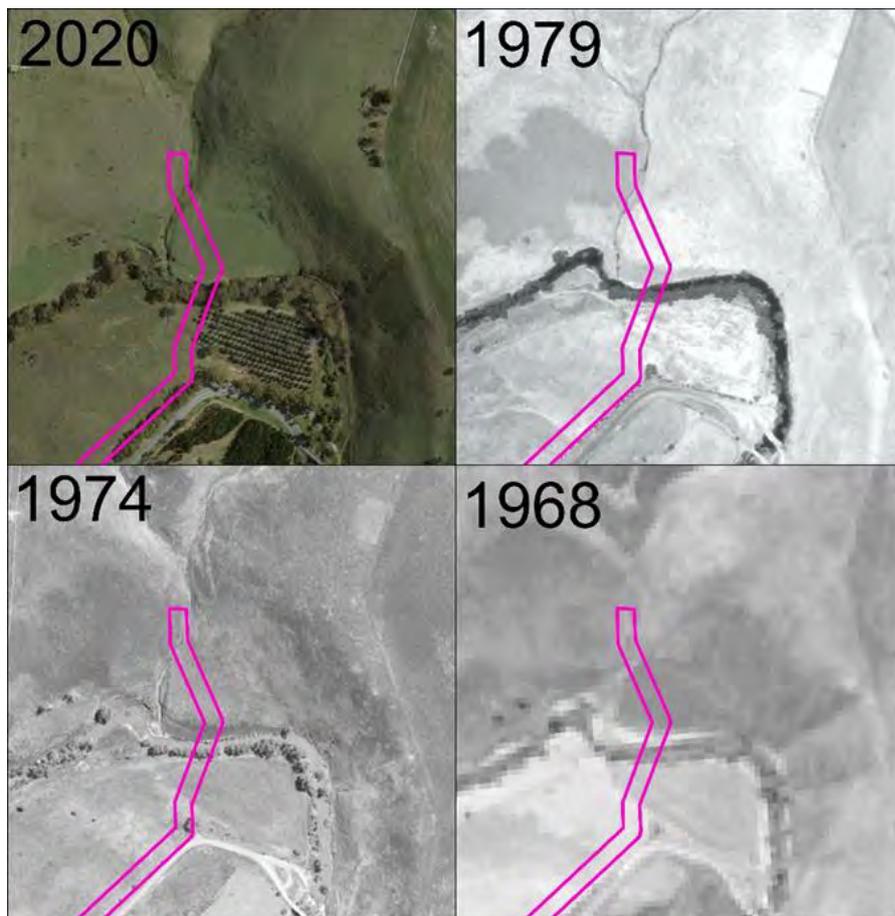
Comparison of aerial photographs suggests that the alignment has not changed and the 'boulder fan' has been present since at least 1974, as indicated in Figure 6-18.

Figure 6-18 Historical Aerial Photos

The left stream bank on the immediate upstream side of the alignment gulley and boulder fan shows exposed sediments and a steep bank. Although this seems like severe erosion, the position of the bank has also changed little in 40 years based on comparison of aerial photographs.

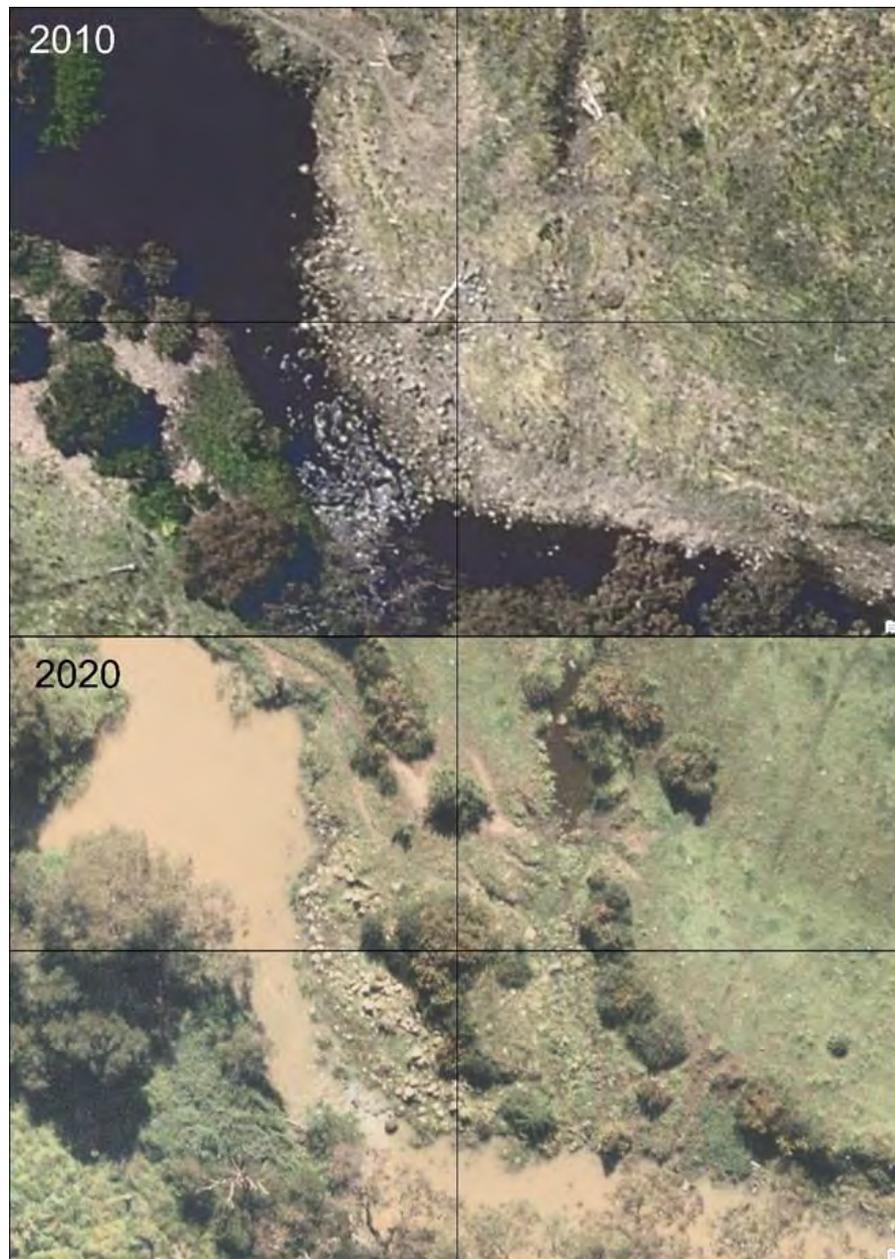
The upstream reach appears to be relatively passive flow due to the hydraulic control of the boulder fan, which has narrowed the stream and formed the rock riffle where there is the increase in flow velocity as shown in Figure 6-19.

Figure 6-19 Historical Aerial Photos highlighting Boulder Fan

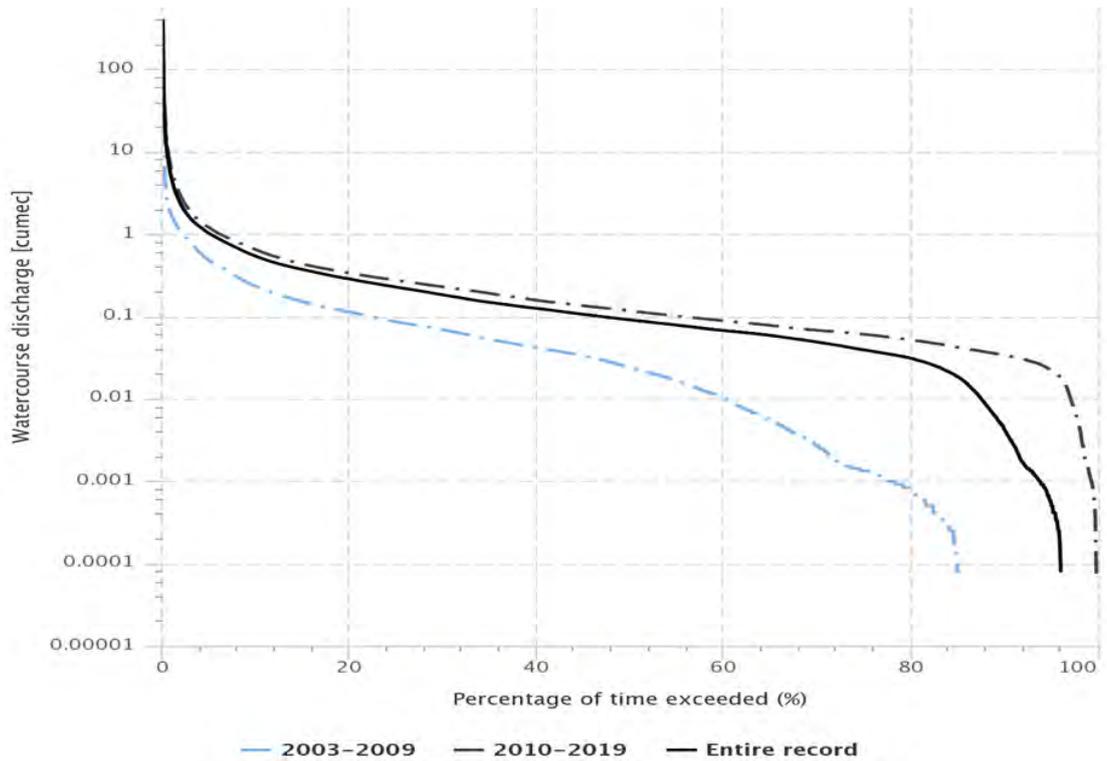
From Figure 6-20 and Figure 6-21 below, the mean annual flow is 0.1 m<sup>3</sup>/sec, and the mean summer-autumn flow is 0.06 m<sup>3</sup>/sec.

Figure 6-20 Jacksons Creek - Flow Duration Curve

Streamflow data on Jacksons Creek was obtained at Sunbury gauging station. This is located 12 km upstream of the site of the crossing. The period of record at this gauge station is from November 2003 to June 2019.

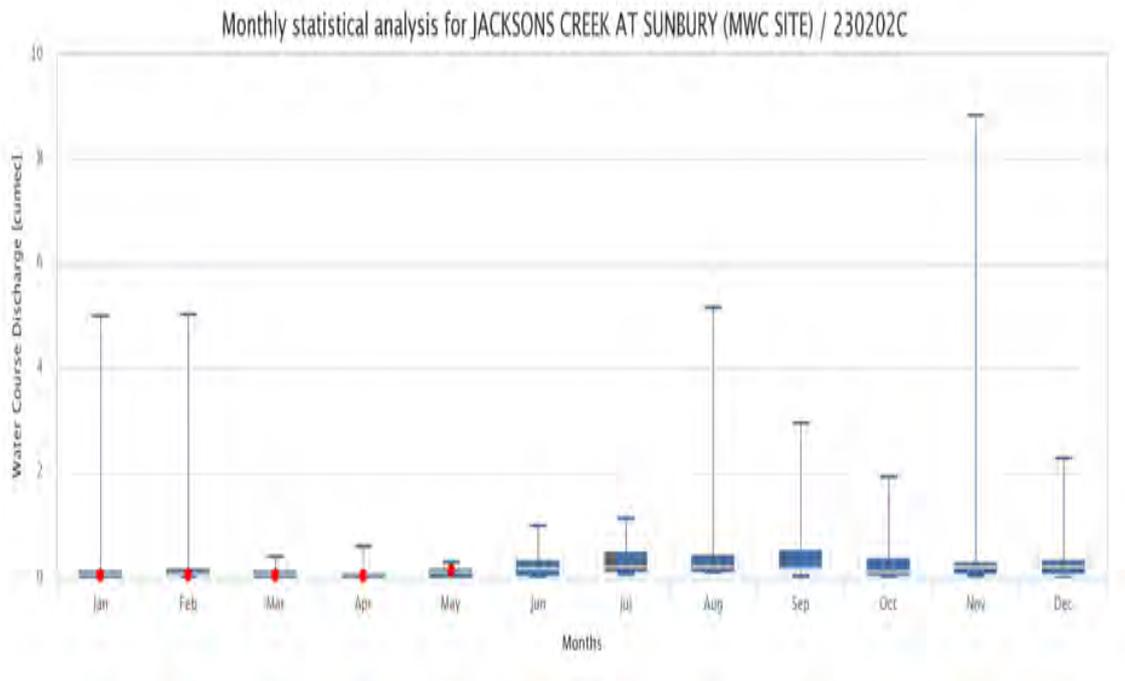
Figure 6-21 Jacksons Creek gauge station - Monthly data.
