technical report B  
**surface  
water.**

Environment Effects Statement | May 2021

**western outer  
ring main**

APA VTS (Operations) Pty Ltd  
Western Outer Ring Main Environment Effects Statement  
Surface Water Report

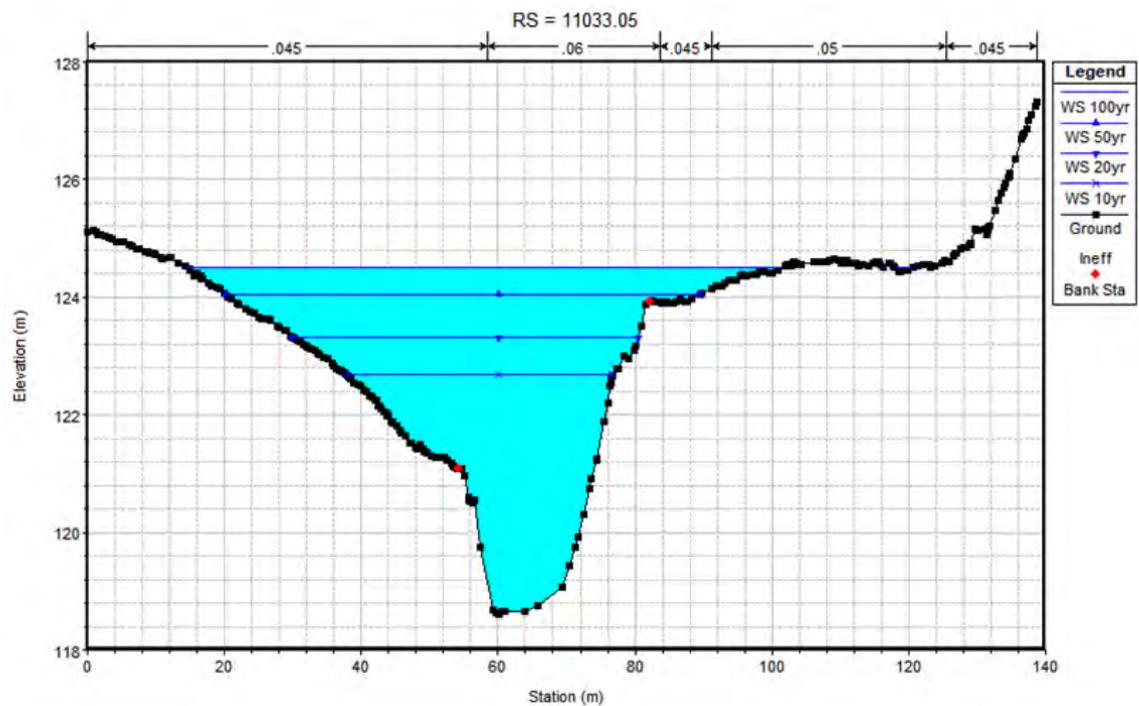
The design flows were modelled in HEC-RAS and results interpreted at a representative cross section within the HEC-RAS model nearest to the location of the Project crossing as indicated in Figure 6-22 below.

Figure 6-22 Jacksons Creek flood levels at CH 11033.05 (10, 20, 50 and 100 year ARI)

- The main channel has a less than 1 in 10 year ARI capacity
- The estimated 1 in 100 year flood level is approximately 124.5 m AHD, and starts to spill into the floodplain terrace

Design flows and subsequent flood levels and extents for the 1% to 10% AEP events were adopted from the previous flood-mapping project using HEC-RAS. The channel velocities for the range of design flows exceed 2 m/s, and the stream powers exceed 300 N m<sup>2</sup>. These velocities and stream powers indicate a relatively high potential for stream bed and bank erosion. Given the steep gradient of the channel within this reach and steepening of the gradient moving further upstream from the Maribyrnong confluence, there is a higher erosion potential for Jacksons Creek compared to Deep Creek. Flow, Velocity and Stream Power profiles along the modelled reaches are displayed in Appendix E which capture hydraulic changes along the reach.

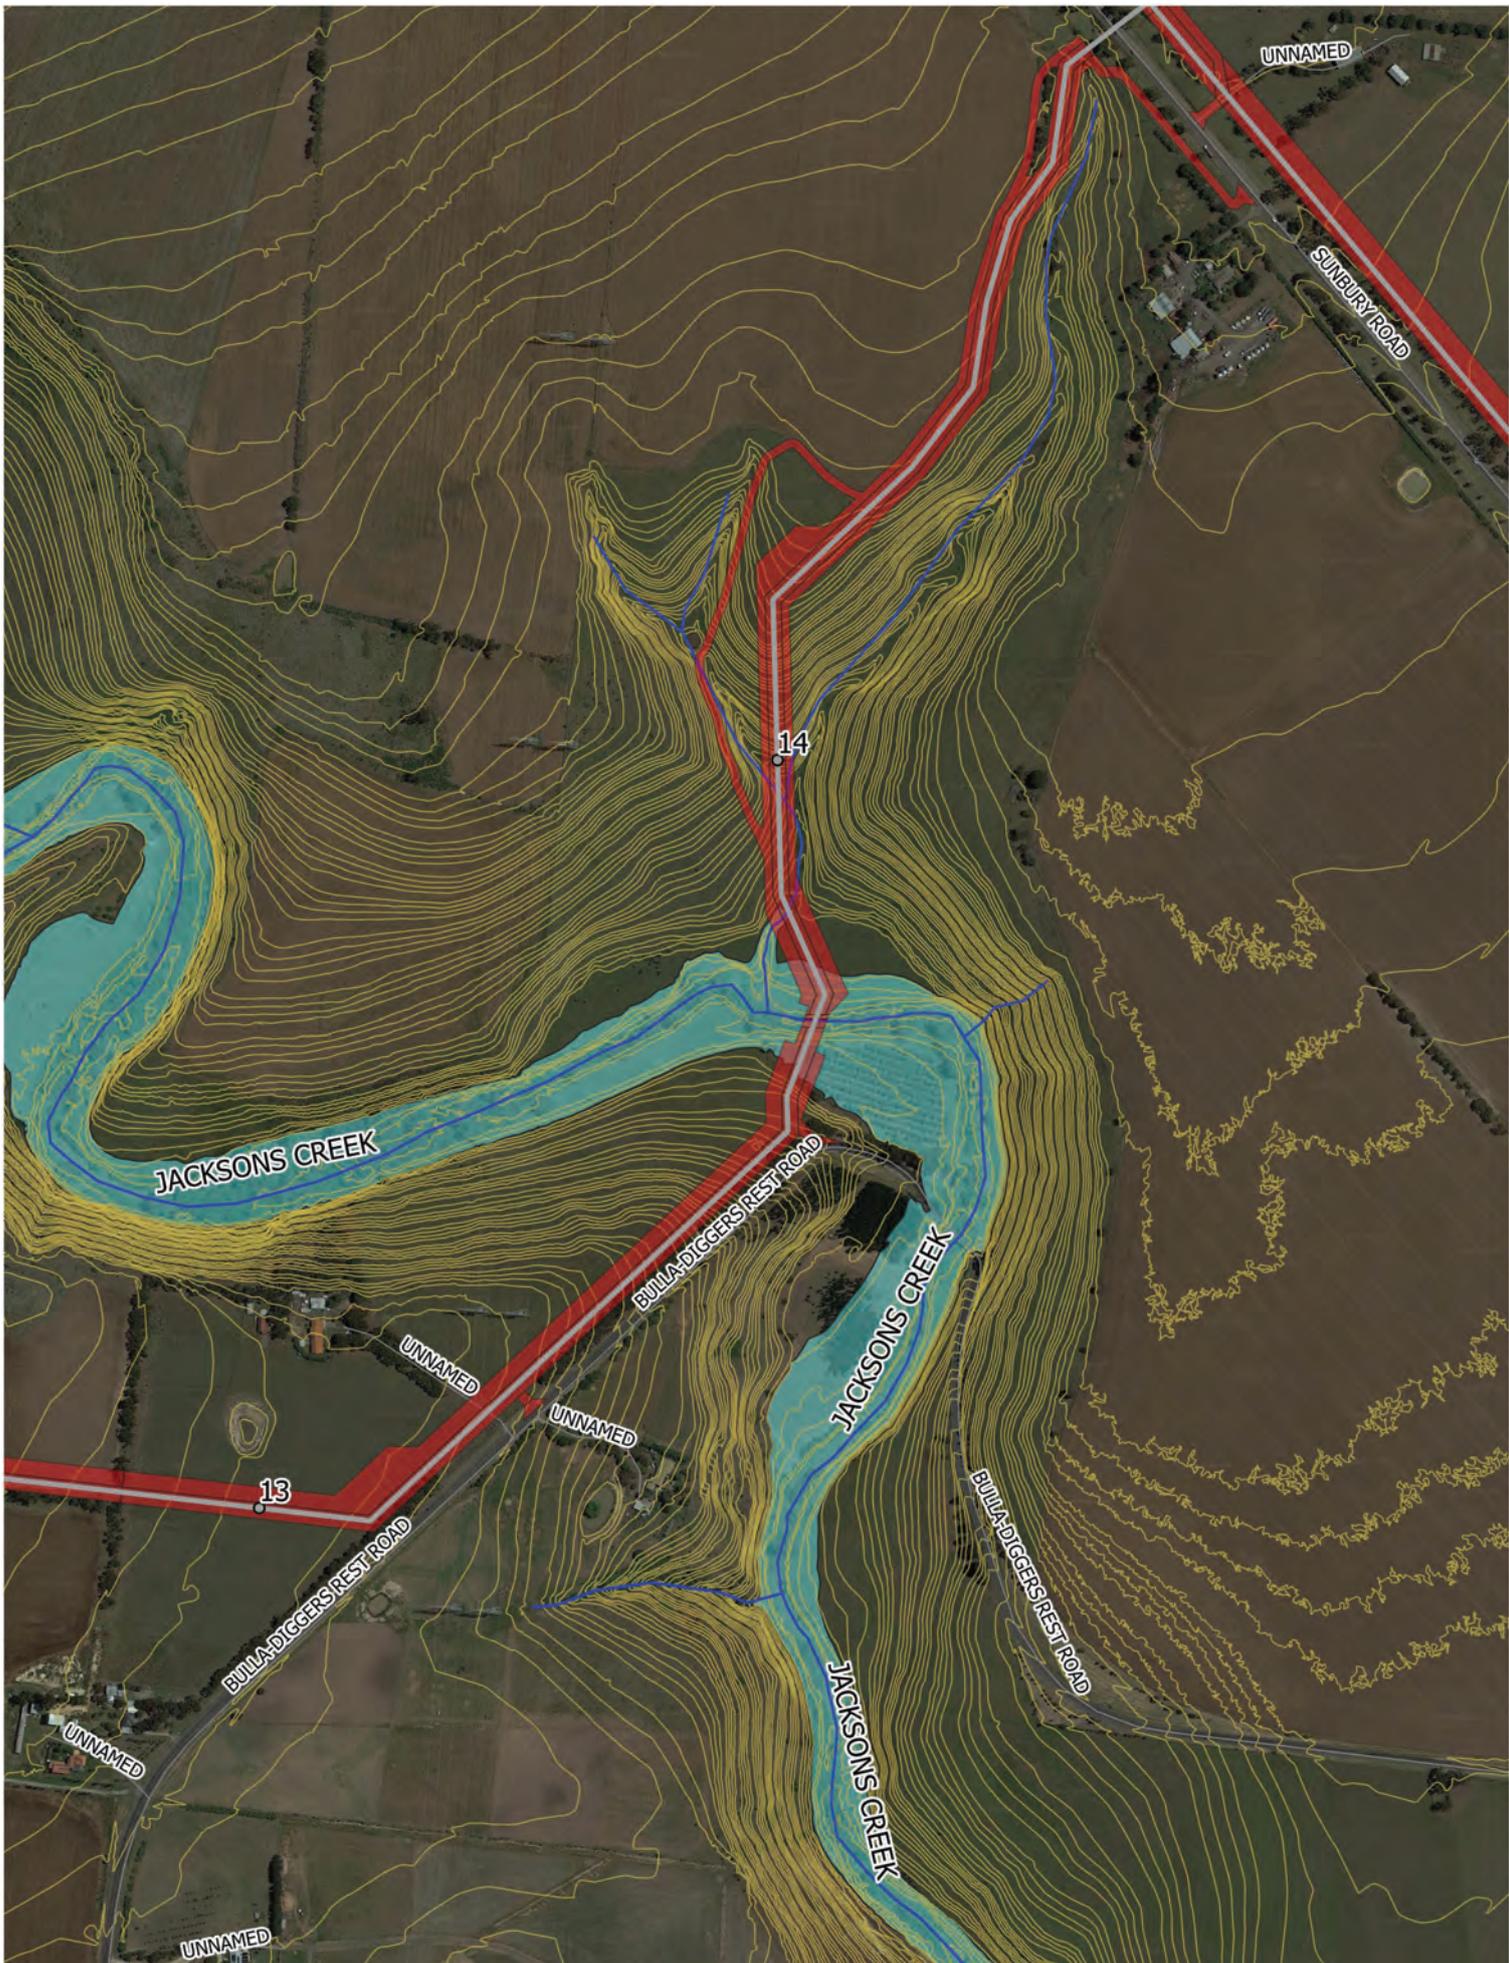
Flood mapping outputs were provided in the MWC data as presented in Figure 6-23 below.

**Jacksons Creek - Crossing 7  
100yr ARI Flood Extent Figure 6-23**

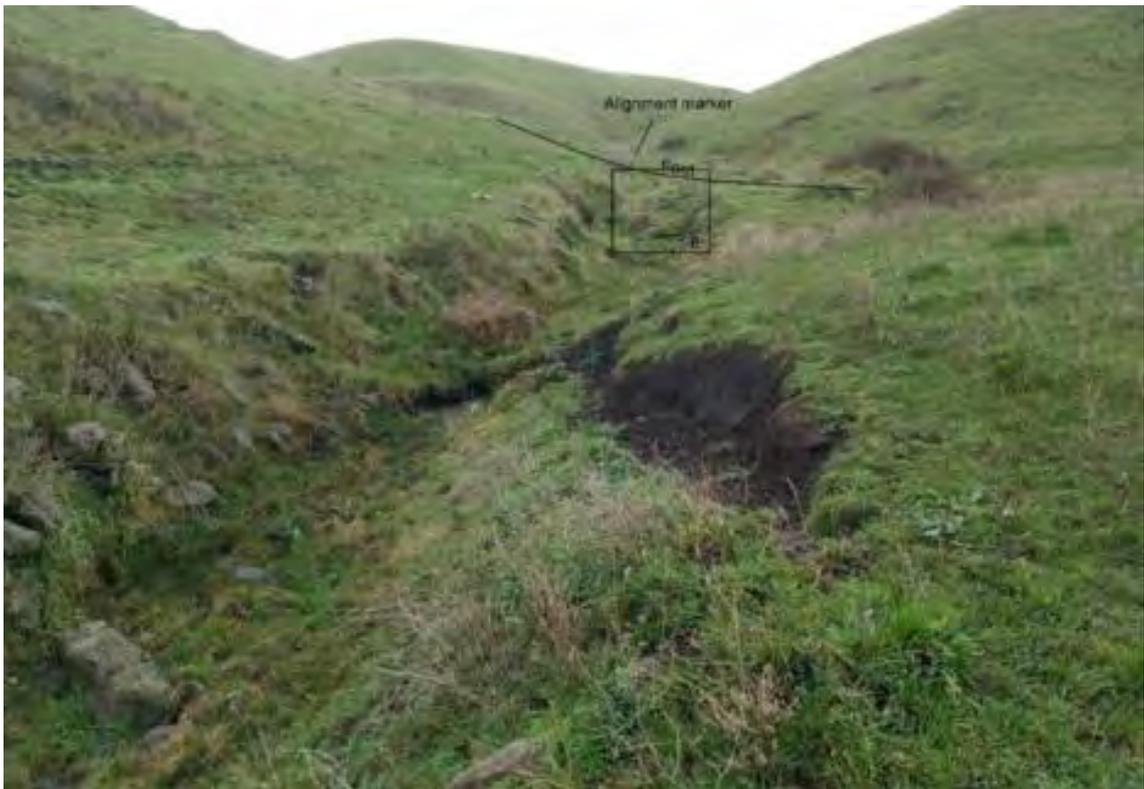
The gully is crossed by a ford formed from boulders and soil, noticed during the site inspection as shown in Figure 6-24. Some erosion is evident on the downstream side of the ford, with deep potholes and large exposed boulders. This may be part of the original gully fan evident in Jacksons Creek, or be sourced from higher up the gully or from the ford itself. There is an ongoing risk of continued head ward erosion of the gully that will need to be considered.

Figure 6-24 Unnamed tributary waterway crossing on steep terrain

The assessment of Jacksons Creek includes waterway crossing 8 the unnamed tributary which discharges into Jacksons Creek at the Project crossing. The initial assessment of the gully tributary highlighted a high erosional risk due to a high stream velocity ( $> 3 \text{ m/s}$  which exceeds the threshold of  $2.0 \text{ m/s}$ ). The terrain of the tributary catchment is relatively steep as it runs south of Sunbury Road and intersects the pipeline with a river grade of 1 in 10 at the pipeline crossing.

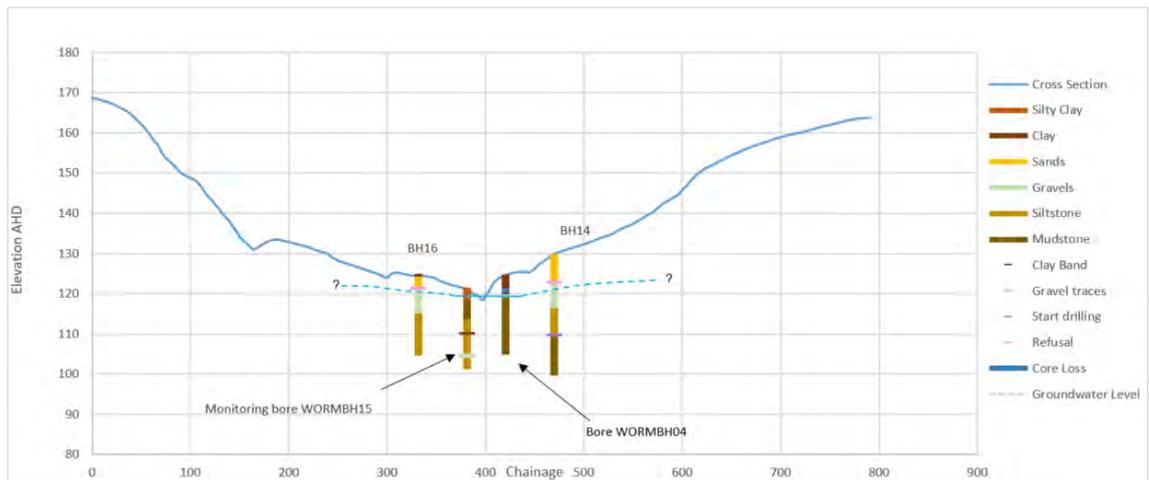
Geotechnical bore logs were obtained by Construction Sciences at 3 locations near the Jacksons Creek channel and floodplain. The bore logs based on their coordinate locations have been interpreted on a schematic cross section interpreted from LiDAR which can be seen in Figure 6-25 below. The bore logs have been projected from the natural surface levels to their indicated depths.

Figure 6-25 Jacksons Creek schematic soil profile cross-section

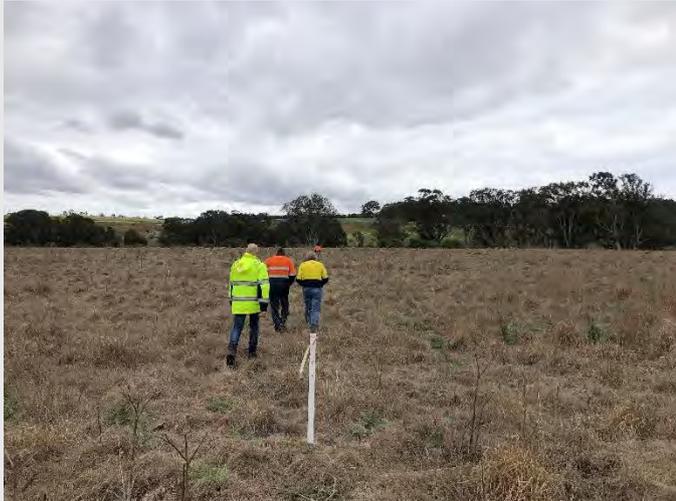
<p data-bbox="316 705 727 741"><i>Source: Site photo taken (GHD, 2020)</i></p>	<p data-bbox="1054 203 1385 360">Deep Creek in the background with the wide flood plain on the eastern side in the foreground. View is looking south west.</p>

Deep Creek was initially inspected near the location of the pipeline crossing on the 23<sup>rd</sup> of January 2020 the day immediately following heavy rainfall in the catchment. Complementing the site inspection photos, AUAV captured drone aerial images at each of the main waterway crossing. The photos presented below indicate the pipeline alignment (white stakes).

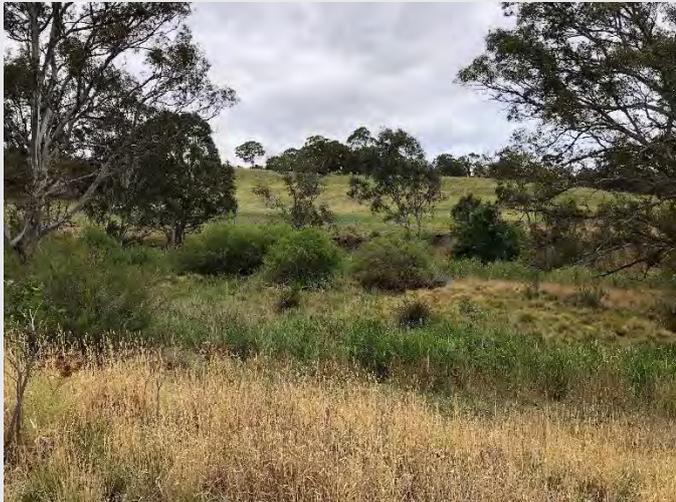
<p data-bbox="316 1254 727 1290"><i>Source: Site photo taken (GHD, 2020)</i></p>	<p data-bbox="1054 752 1385 875">Deep Creek crossing looking west with evidence of riparian vegetation and variable terrain</p>

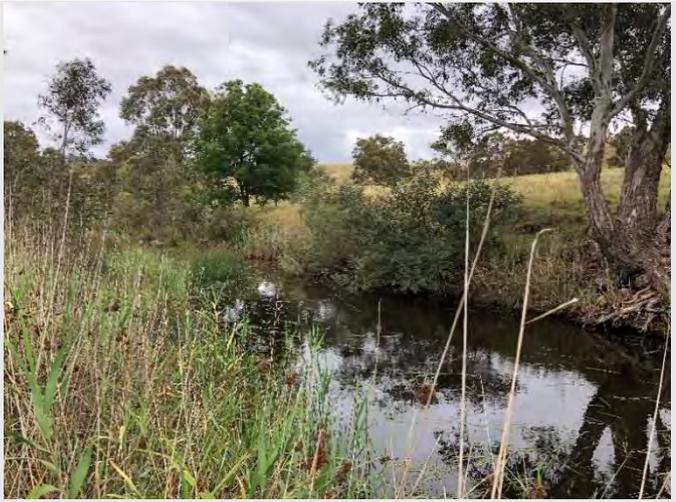
<p data-bbox="316 1803 727 1832"><i>Source: Site photo taken (GHD, 2020)</i></p>	<p data-bbox="1054 1301 1390 1391">Deep Creek looking south, immediately downstream of crossing location.</p>

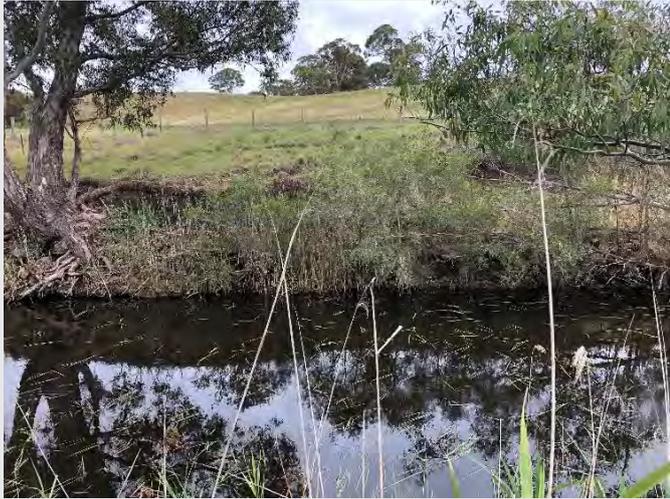
<p data-bbox="316 701 727 734"><i>Source: Site photo taken (GHD, 2020)</i></p>	<p data-bbox="1054 203 1358 327">Deep Creek at crossing location looking west, noting the relatively slow moving flow</p>

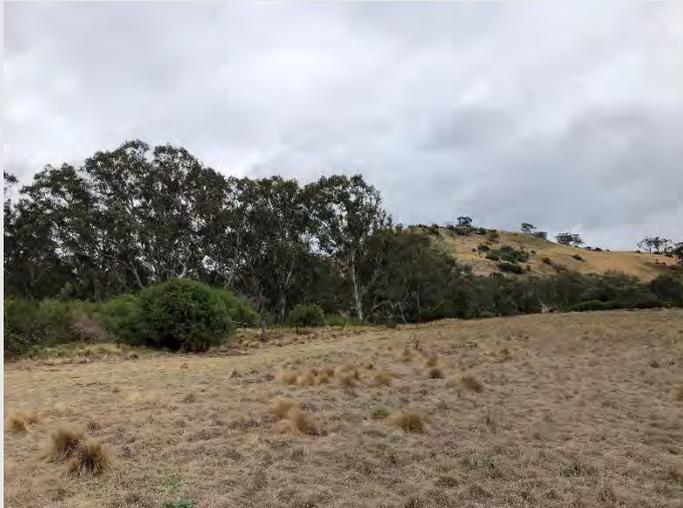
<p data-bbox="316 1254 727 1288"><i>Source: Site photo taken (GHD, 2020)</i></p>	<p data-bbox="1054 745 1385 902">Deep Creek looking upstream of crossing location including a view of the eastern flood plain looking north west.</p>

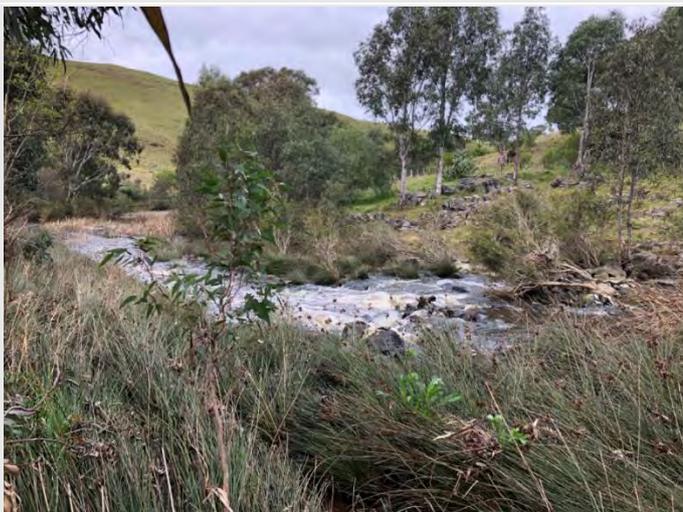
<p data-bbox="316 1807 727 1841"><i>Source: Site photo taken (GHD, 2020)</i></p>	<p data-bbox="1054 1299 1394 1487">Deep Creek looking downstream of rock outcrop control feature observed (shown in Figure 6-26 as Key Feature 5). View is looking south east.</p>

A number of key features were identified during the subsequent site inspection on 6 July in the vicinity of the crossing location, as outlined in Table 6-9. A key hydraulic control was observed approximately 280 m downstream of the crossing location. The location is marked on the plan view in Figure 6-26 as Key Feature 5 and indicated on the longitudinal profile in Figure 6-27. The rock outcrop feature is expected to increase the Manning’s roughness of the channel and provide some level of backwater control to the site of interest at the pipeline crossing.

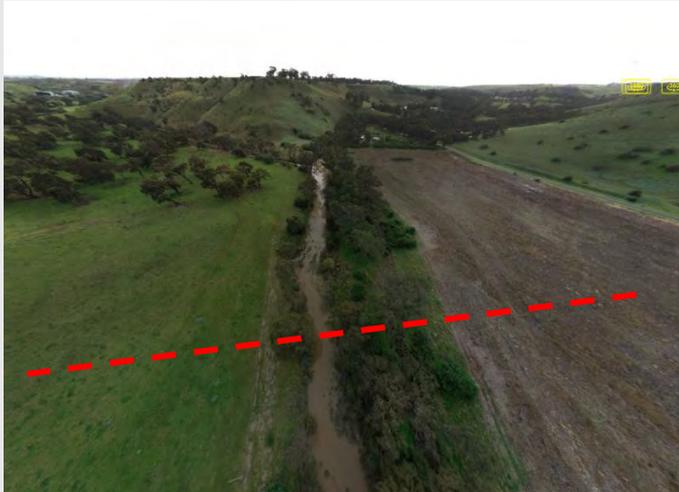
<p data-bbox="316 698 863 730">Source: Panosphere screen capture (AUAV, 2020)</p>	<p data-bbox="1054 201 1385 264">Panosphere – Drone aerial imagery</p> <p data-bbox="1054 271 1385 333">Upstream of crossing view is looking north.</p> <p data-bbox="1054 340 1278 434">Red dashed line = Indicative pipeline alignment.</p>

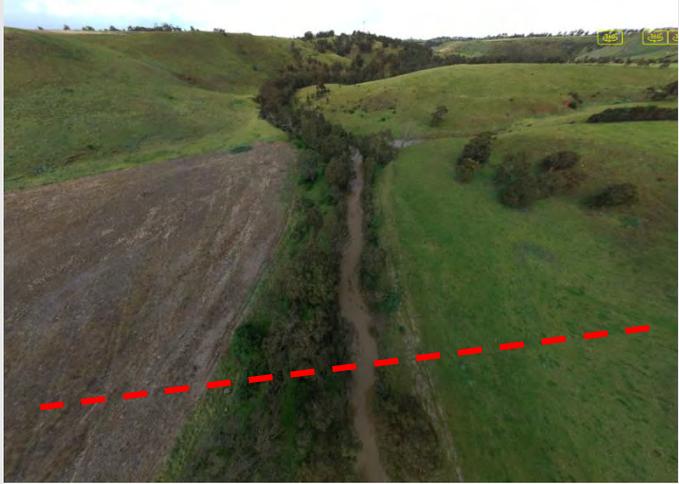
<p data-bbox="316 1232 863 1263">Source: Panosphere screen capture (AUAV, 2020)</p>	<p data-bbox="1054 743 1385 806">Panosphere – Drone aerial imagery</p> <p data-bbox="1054 813 1353 875">Downstream of crossing view is looking south.</p> <p data-bbox="1054 882 1278 976">Red dashed line = Indicative pipeline alignment.</p>

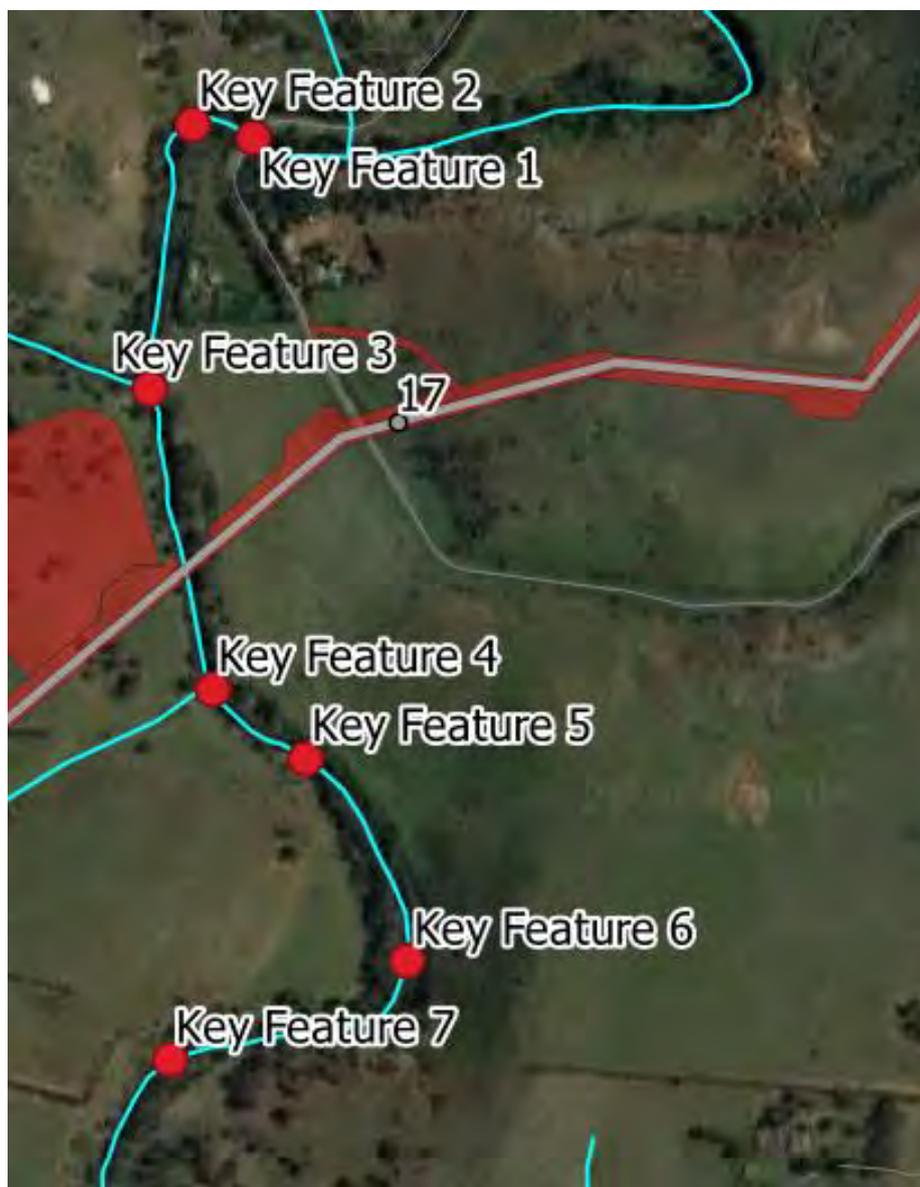
Key feature No.	Description
1	Wildwood Road crossing and piers
2	Meander in Deep Creek
3	Emu Creek Confluence
4	Discharging tributary
5	Hydraulic Rock Outcrop Control
6	Meander in Deep Creek
7	Meander in Deep Creek

Figure 6-26 Plan view of Deep Creek waterway crossing with Key Features.

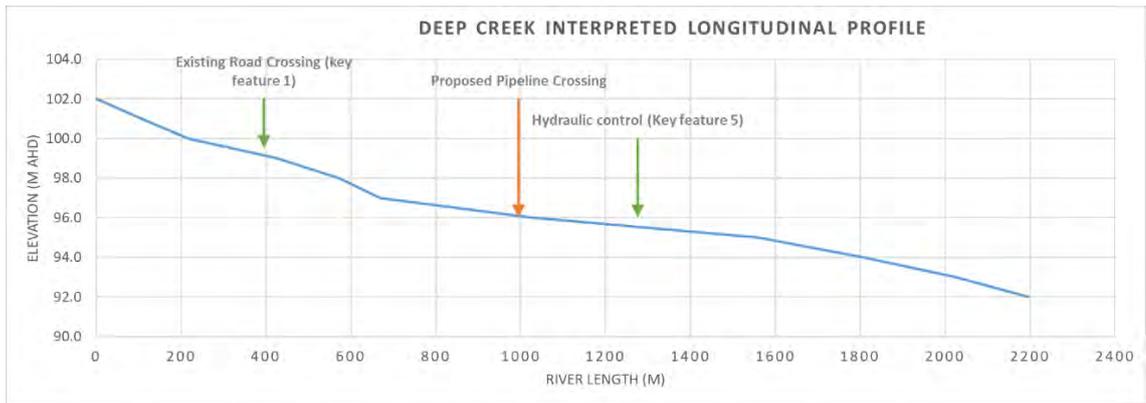
Figure 6-27 Deep Creek schematic profile indicating location of pipeline and hydraulic control feature

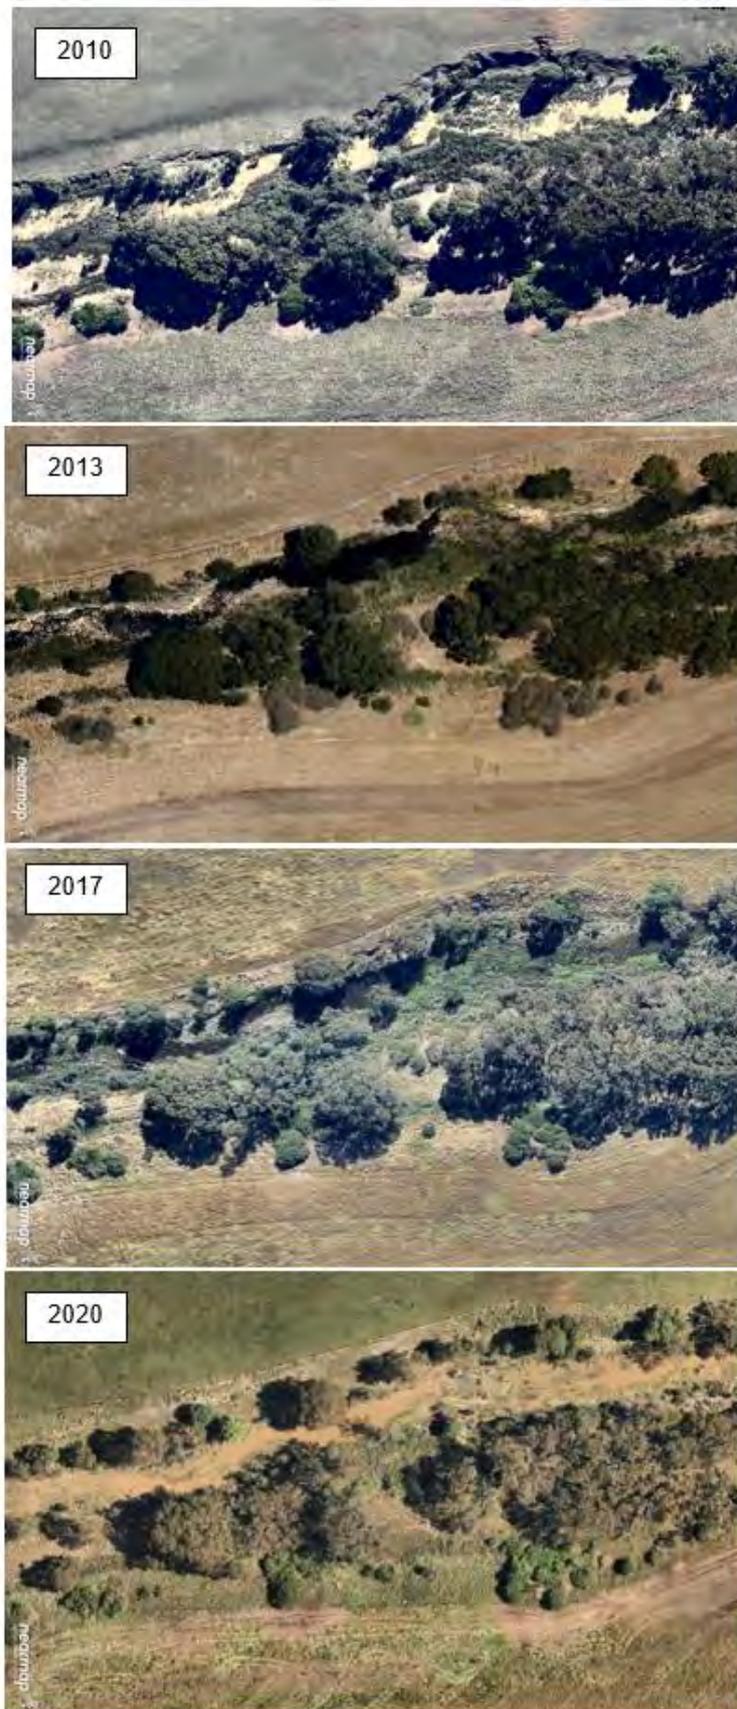
Near map images were obtained for Deep Creek over a 10 year period, between 2010 and 2020, as shown in Figure 6-28. The time series images below concentrate mainly on the section of Deep Creek where the pipeline alignment crosses the waterway.

Figure 6-28 Nearnmap images of Deep Creek at the crossing location over a 10-year period

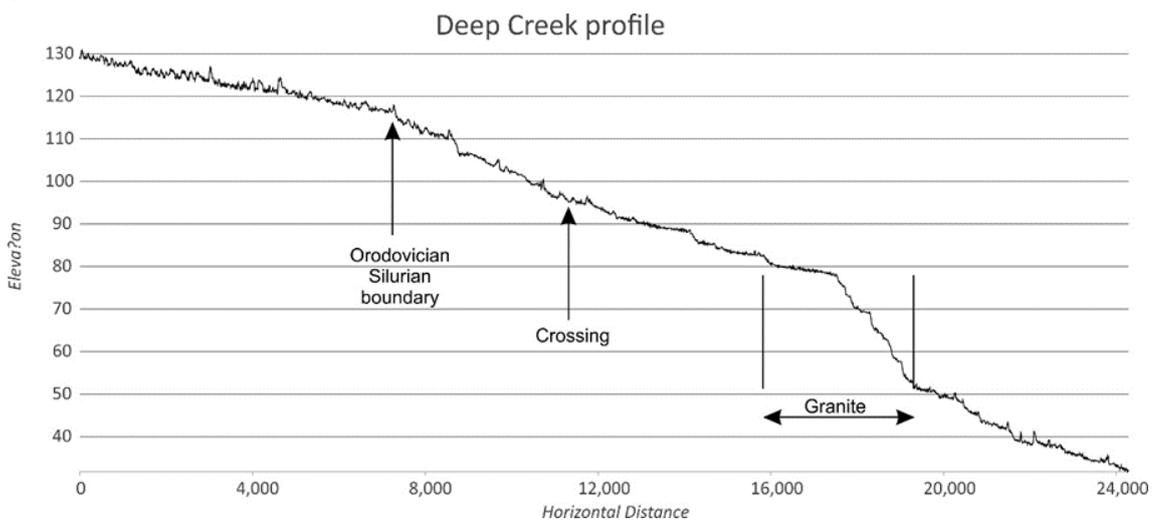
Stream gradient features in Deep Creek appear to reflect lithological control. Three gradient features are notable within a few km of the crossing, as shown in Figure 6-29. Upstream there is a broad convexity in the channel profile and the crest of that convexity corresponds to the boundary between Ordovician and Silurian rocks. It is likely that this is reflective of bulk erodibility, which is lower in the Ordovician rocks. The downstream feature is a much more prominent steepening of the gradient that closely corresponds to the upstream and downstream extent of granite outcrop.

Figure 6-29 Deep Creek Stream Bed Profile

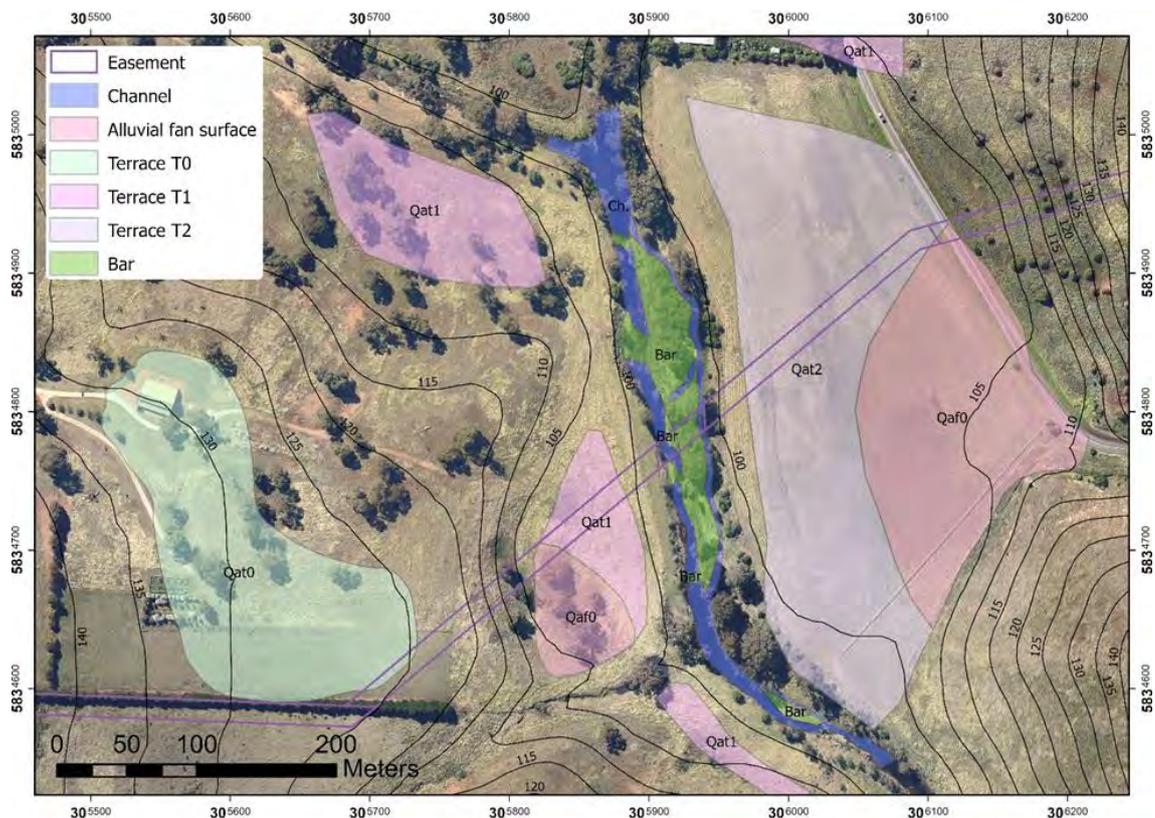
Figure 6-30 Geomorphological map of Deep Creek near crossing location

The Sunbury geological map indicates that the pipeline crosses Deep Creek in an area that is underlain by interbedded Silurian shales, greywackes and mudstones of the Keilor Group. Bedrock outcrops are visible at the southern end of the reach and in the right-bank cliffs at the north end of the reach. The Silurian bedrock is capped by basalts of the Newer Volcanics, and upstream from the mouth of Emu Creek these basalts infill a series of gravel-floored Mio-Pliocene paleochannels that align approximately parallel to the current Deep Creek.

A geomorphological map is provided of Deep Creek near the crossing location in Figure 6-30.

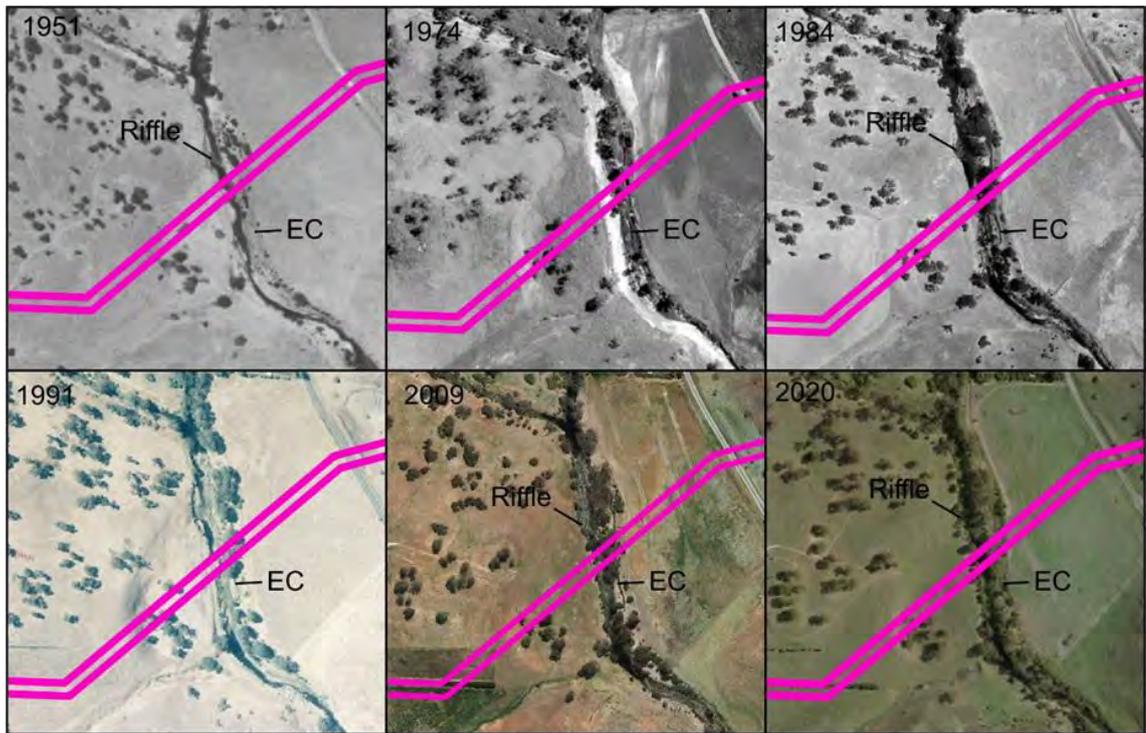
Figure 6-31 Historical Aerial Photo series

Although the reach is generally straight, it has a slightly meandering planform in detail. The reach is divided into riffles and pool segments, a characteristic of gravel bed rivers, with several channel widths separating each riffle. The riffles appear as shallow gravel bars located in crossovers between opposite facing meanders and seem to be stable. For instance, a riffle can be seen in the same position in photographs from 1951 through to 2020, and the alignment and lateral extent remains similar too, as indicated in Figure 6-31.

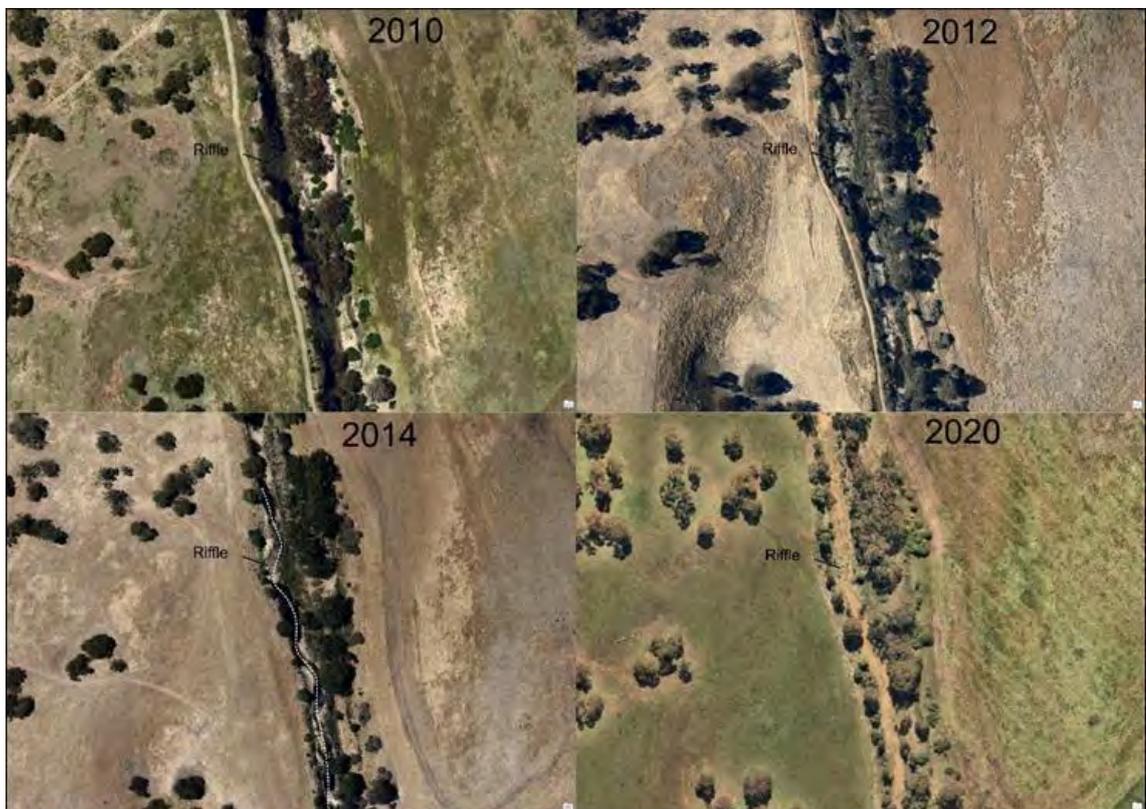
From Figure 6-32 below the river planform and lateral extent has not changed in recent years, nor has the riparian vegetation.

Figure 6-32 Recent Historical Aerial Photos

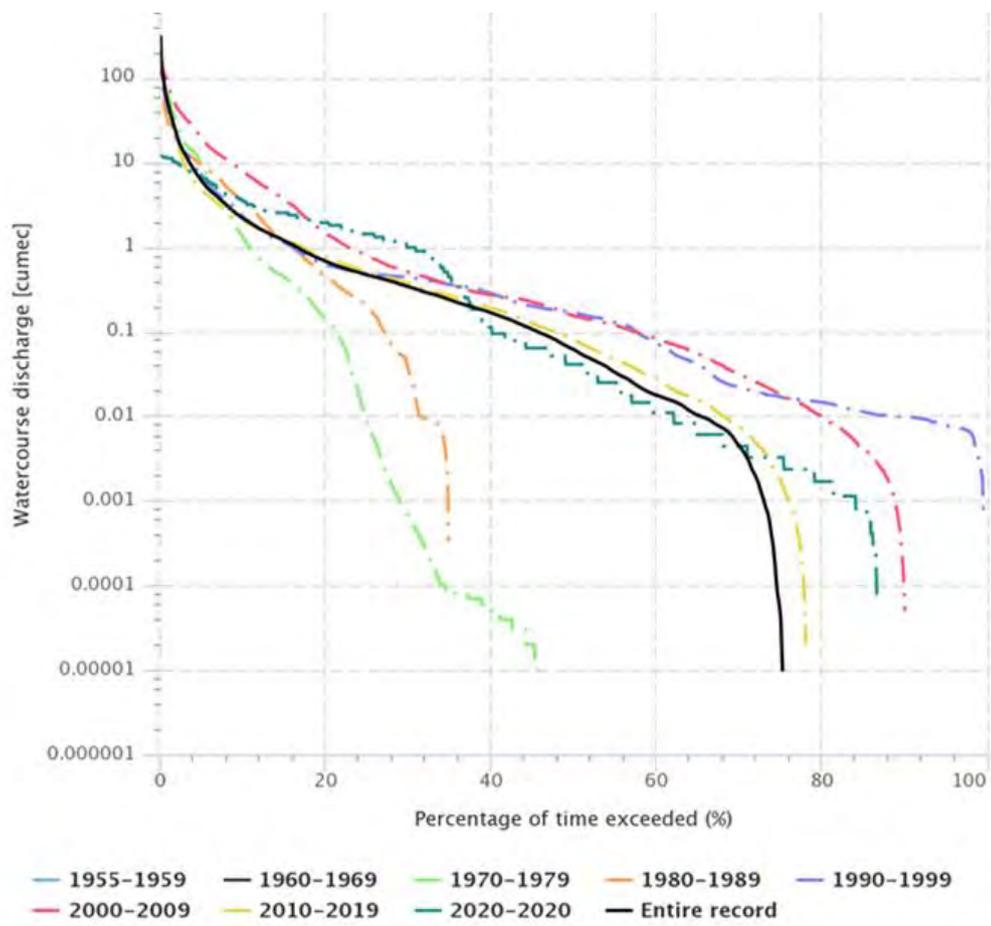
Figure 6-33 Deep Creek gauge station - Flow Duration Curve

From Figure 6-33 and Figure 6-34 below, the mean annual flow is 0.06 m<sup>3</sup>/sec, and the mean summer-autumn flow is 0.02 m<sup>3</sup>/sec.

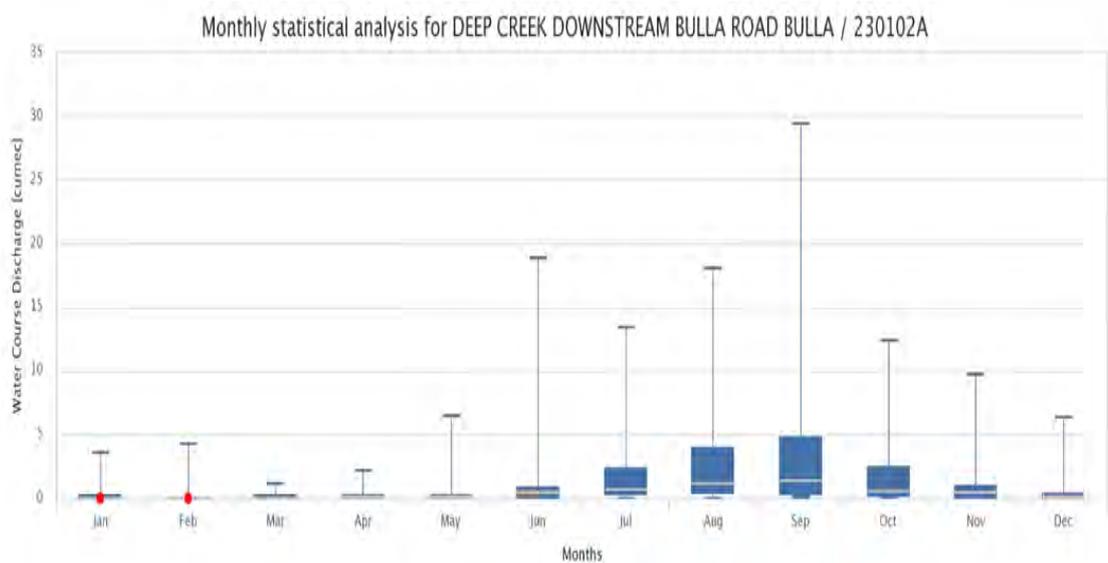
Figure 6-34 Deep Creek gauge station - Monthly data

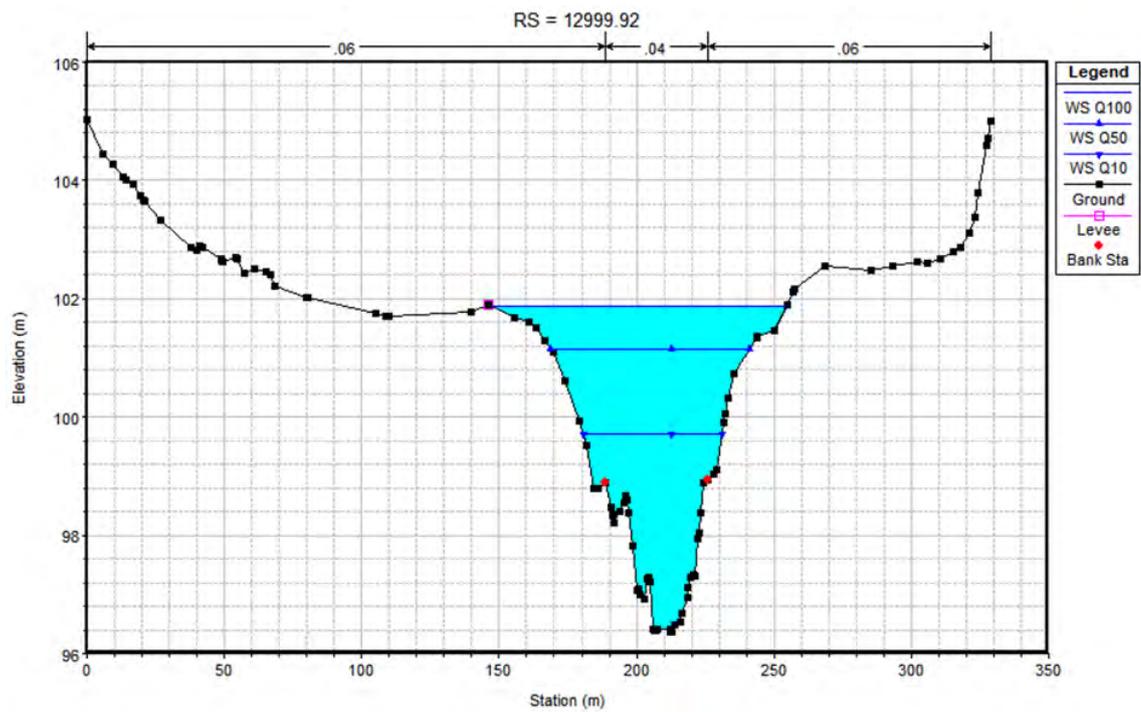
Figure 6-35 Deep Creek flood levels at CH 12,999.92 (10, 50 and 100 year ARI)

- The main channel has a less than 1 in 10 year ARI capacity
- The estimated 1 in 100 year flood level is approximately 101.9 m AHD, and has the potential to spill into the floodplain area at certain locations along the east bank

The design flows were modelled in HEC-RAS and results interpreted at a representative cross section within the HEC-RAS model nearest to the location of the Project crossing as indicated in Figure 6-35 below.

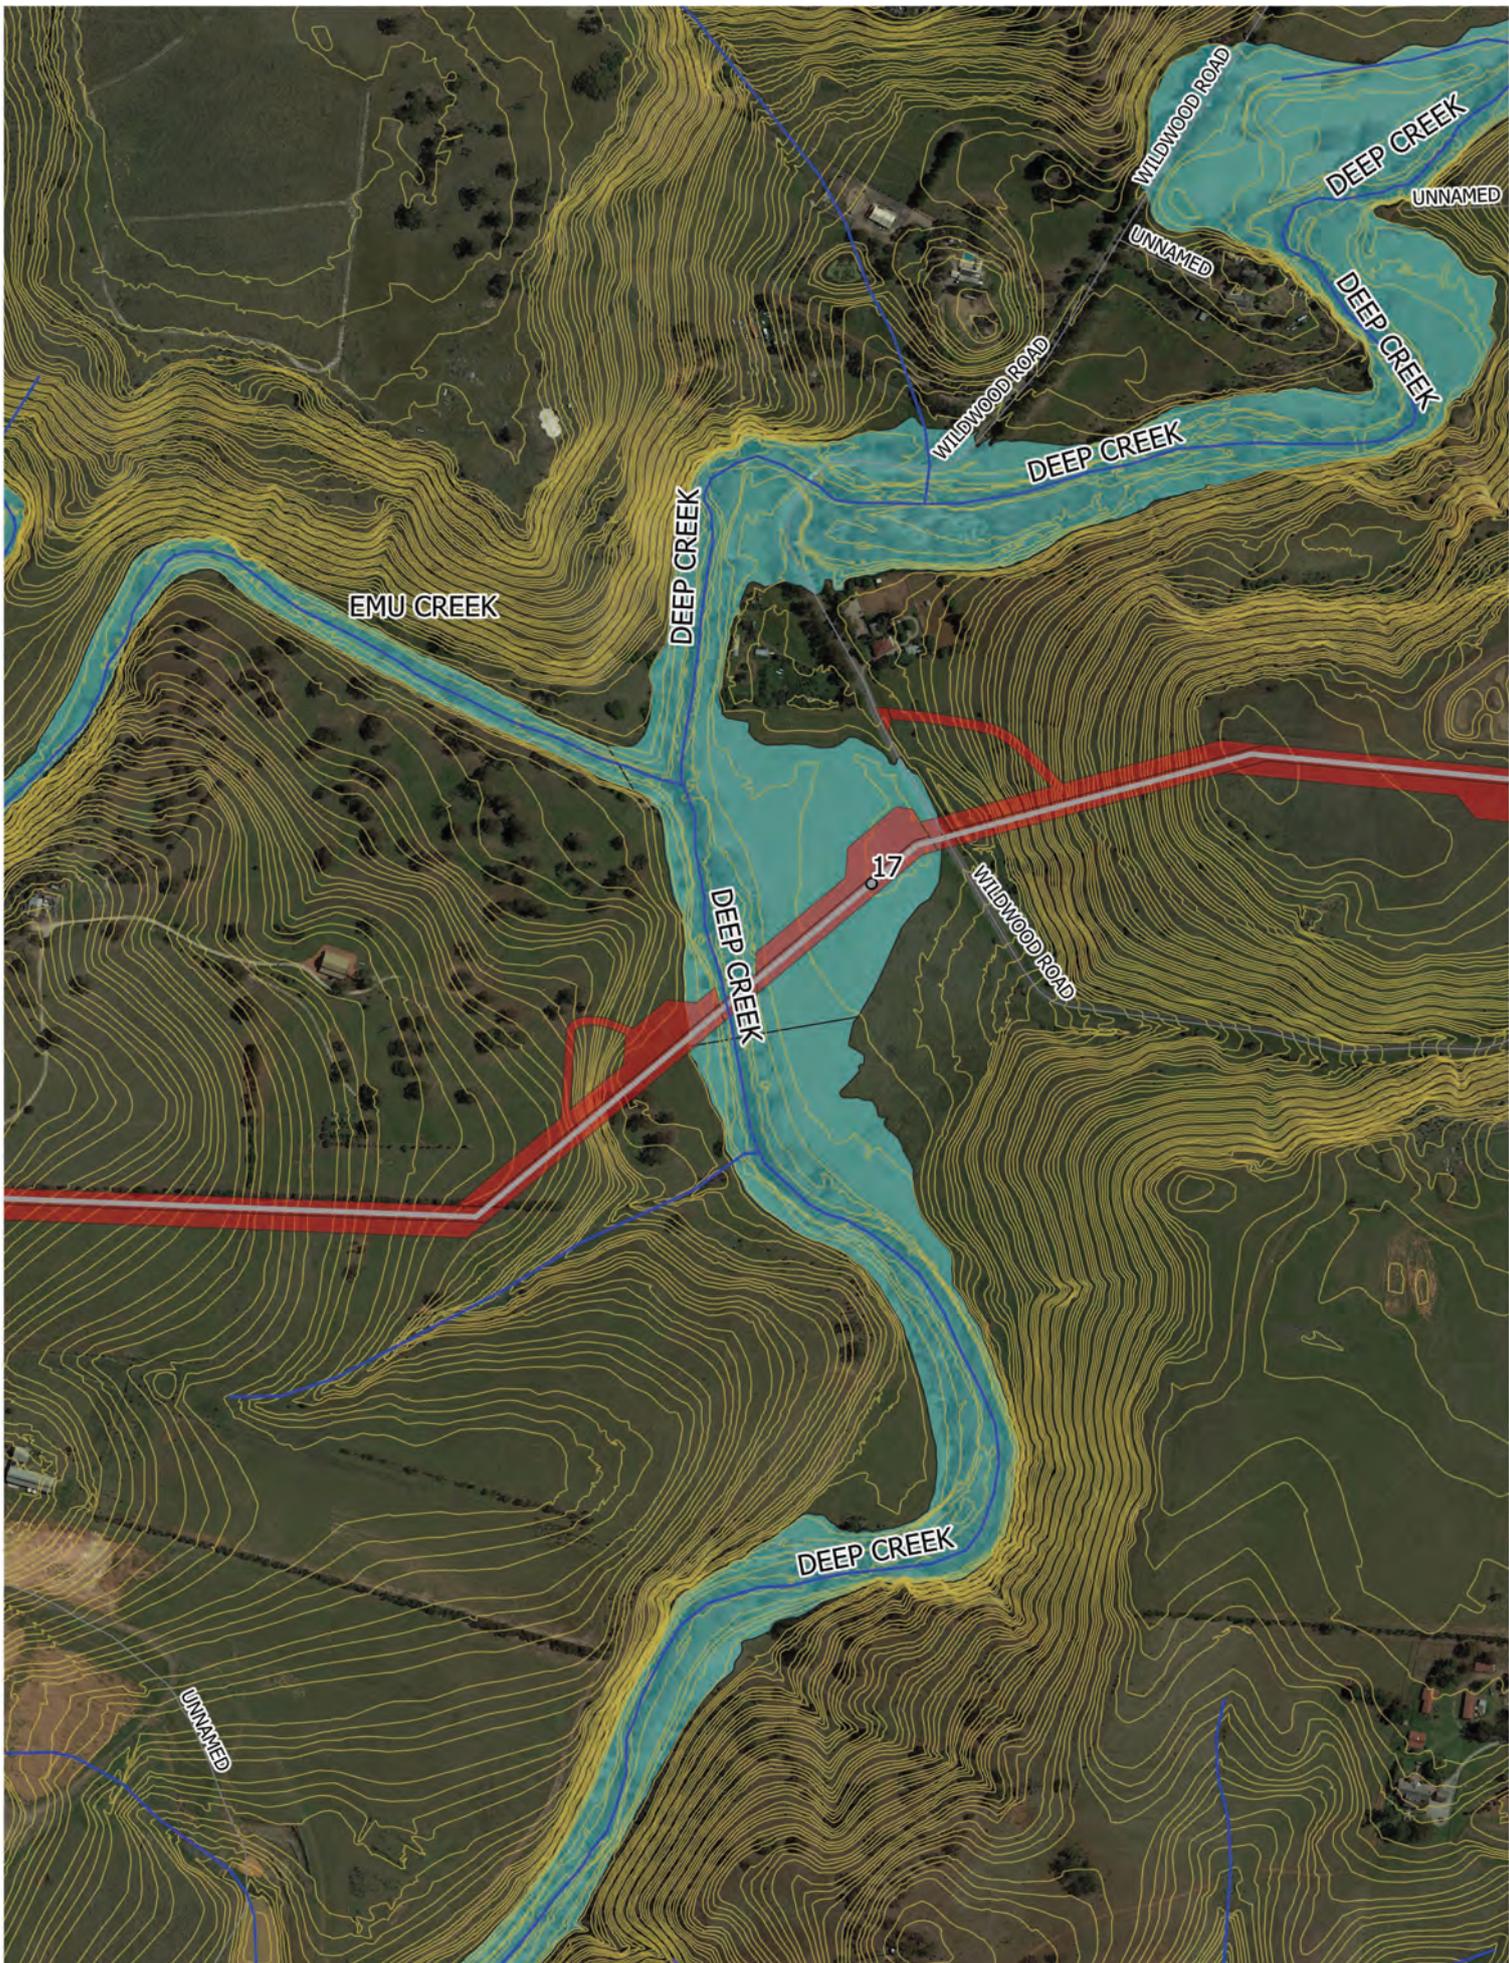
Flood mapping outputs were provided in the MWC data as presented in Figure 6-36 below.

- The estimated flood levels near the location of interest starts to extend across the floodplain terrace as shown in Figure 6-36
- Water quality in Deep Creek upstream and downstream is noncompliant with guideline values for a number of parameters, including electrical conductivity, nitrate, oxidised nitrogen, total nitrogen, total phosphorus, chromium, copper, lead, nickel and zinc

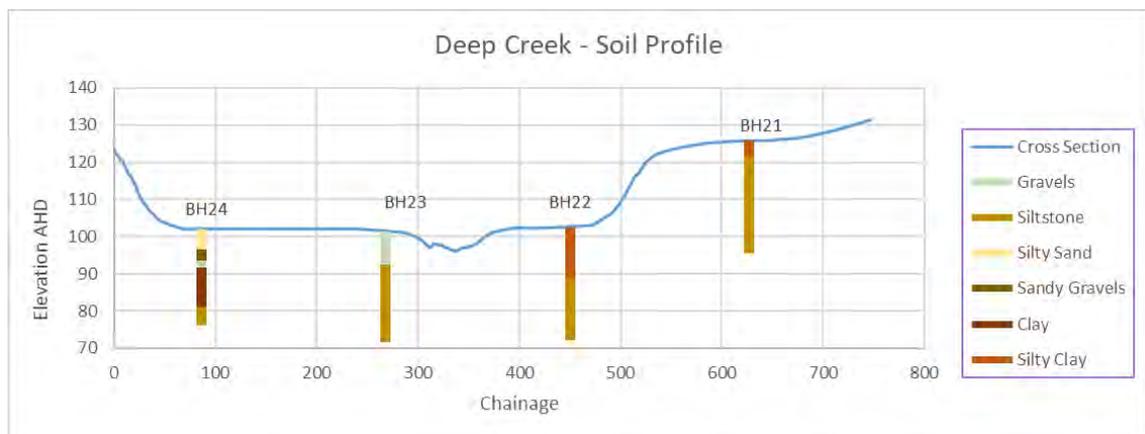
- The soil profile typically consists of various layers of sands, gravels and clays in the upper profiles (first 5-10 m)
- The lower profiles consist of siltstones for most of the bore holes and continues for the remainder of the bore hole until termination
- No basalt rock was encountered

Figure 6-37 Deep Creek schematic soil profile cross-section

Derived from interpreting the bore logs within the cross section, shown in Figure 6-37:
