technical report B  
**surface  
water.**

Environment Effects Statement | May 2021

**western outer  
ring main**

APA VTS (Operations) Pty Ltd  
Western Outer Ring Main Environment Effects Statement  
Surface Water Report

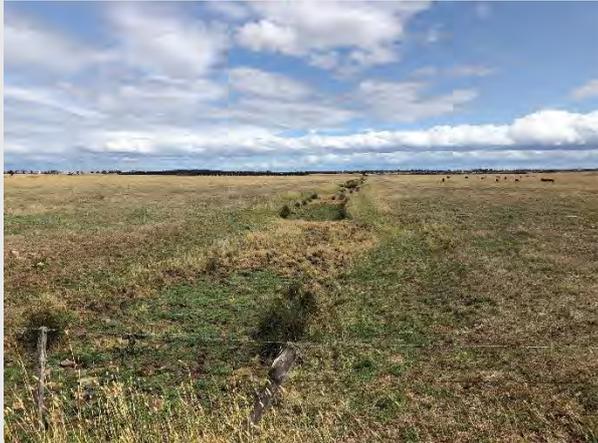
<p data-bbox="316 645 774 680"><i>Source: Site photo taken (GHD, 2020)</i></p>	<p data-bbox="959 197 1378 327">Kalkallo Creek looking south of Gunns Gully Road crossing at crossing location and a view of the wider flood plain.</p>

Kalkallo Creek was inspected near the location of the pipeline crossing on the 23<sup>rd</sup> of January 2020 the day immediately following heavy rainfall in the catchment. The photos presented below indicate the pipeline alignment (white stakes).

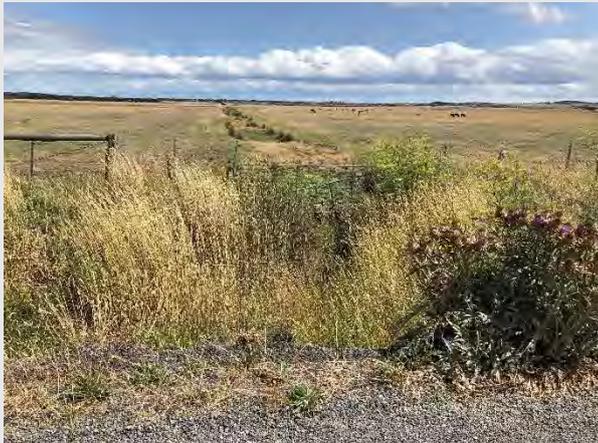
<p data-bbox="316 1133 774 1169"><i>Source: Site photo taken (GHD, 2020)</i></p>	<p data-bbox="959 685 1337 784">Kalkallo Creek looking south of Gunns Gully Rd crossing at crossing location.</p>

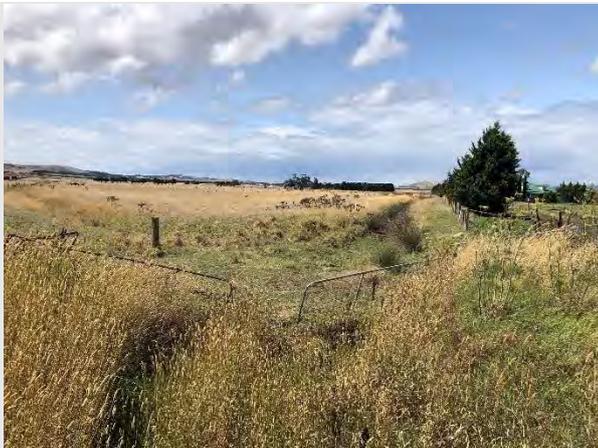
<p data-bbox="316 1626 774 1662"><i>Source: Site photo taken (GHD, 2020)</i></p>	<p data-bbox="959 1173 1383 1303">Kalkallo Creek looking immediately north of Gunns Gully Rd crossing including a view of the flood plain and connecting agricultural drains.</p>

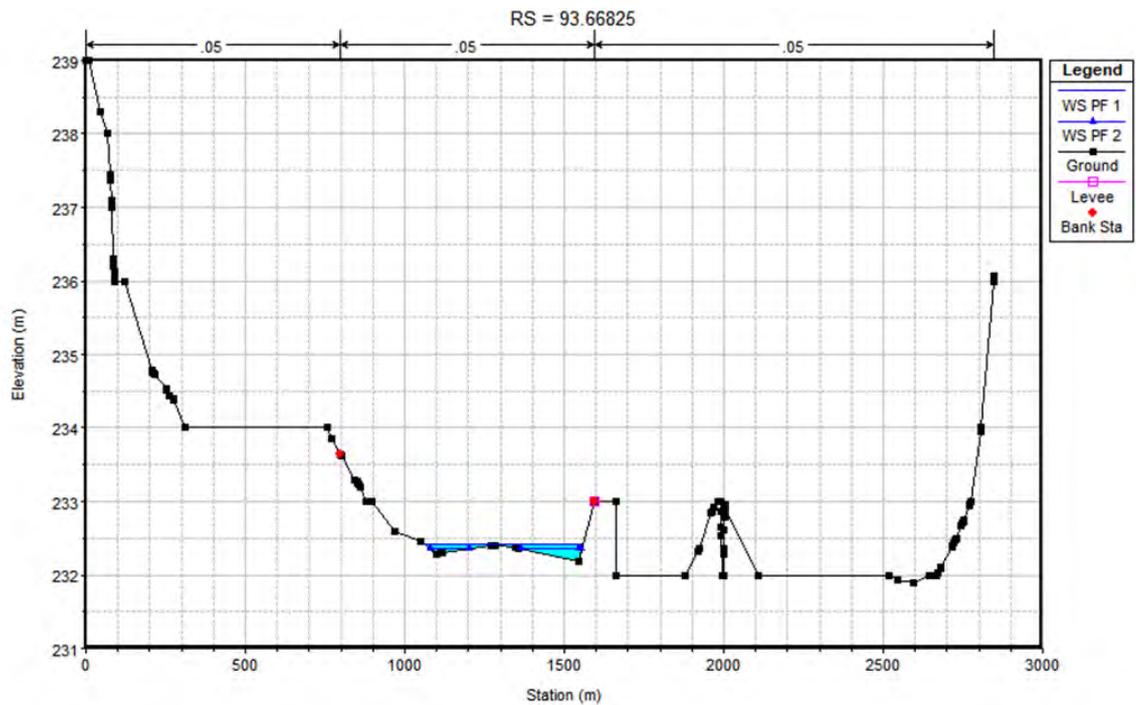
Figure 6-38 Kalkallo Creek flood levels at CH 93 (10 and 100 year ARI (PF2 and PF1 respectively)).

The main drains entering the retarding basin occur at station 1100, 1500 and 2000 in cross-section 93 and at station 1100 in cross-section 284. Results were interpreted at a representative cross section within the HEC-RAS models nearest to the location of the Project crossing. This is shown in Figure 6-38 and Figure 6-39 below for the Kalkallo Creek East and West drain models, respectively.

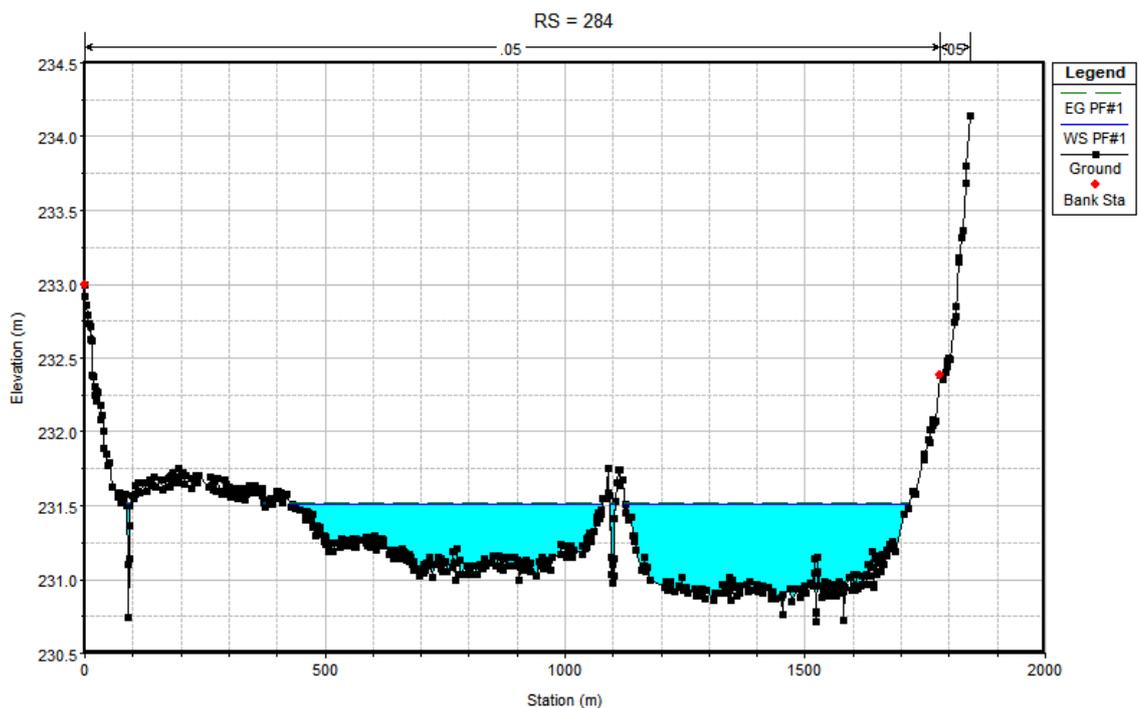
Figure 6-39 Kalkallo Creek flood levels at CH 284 (100 year ARI (PF1))

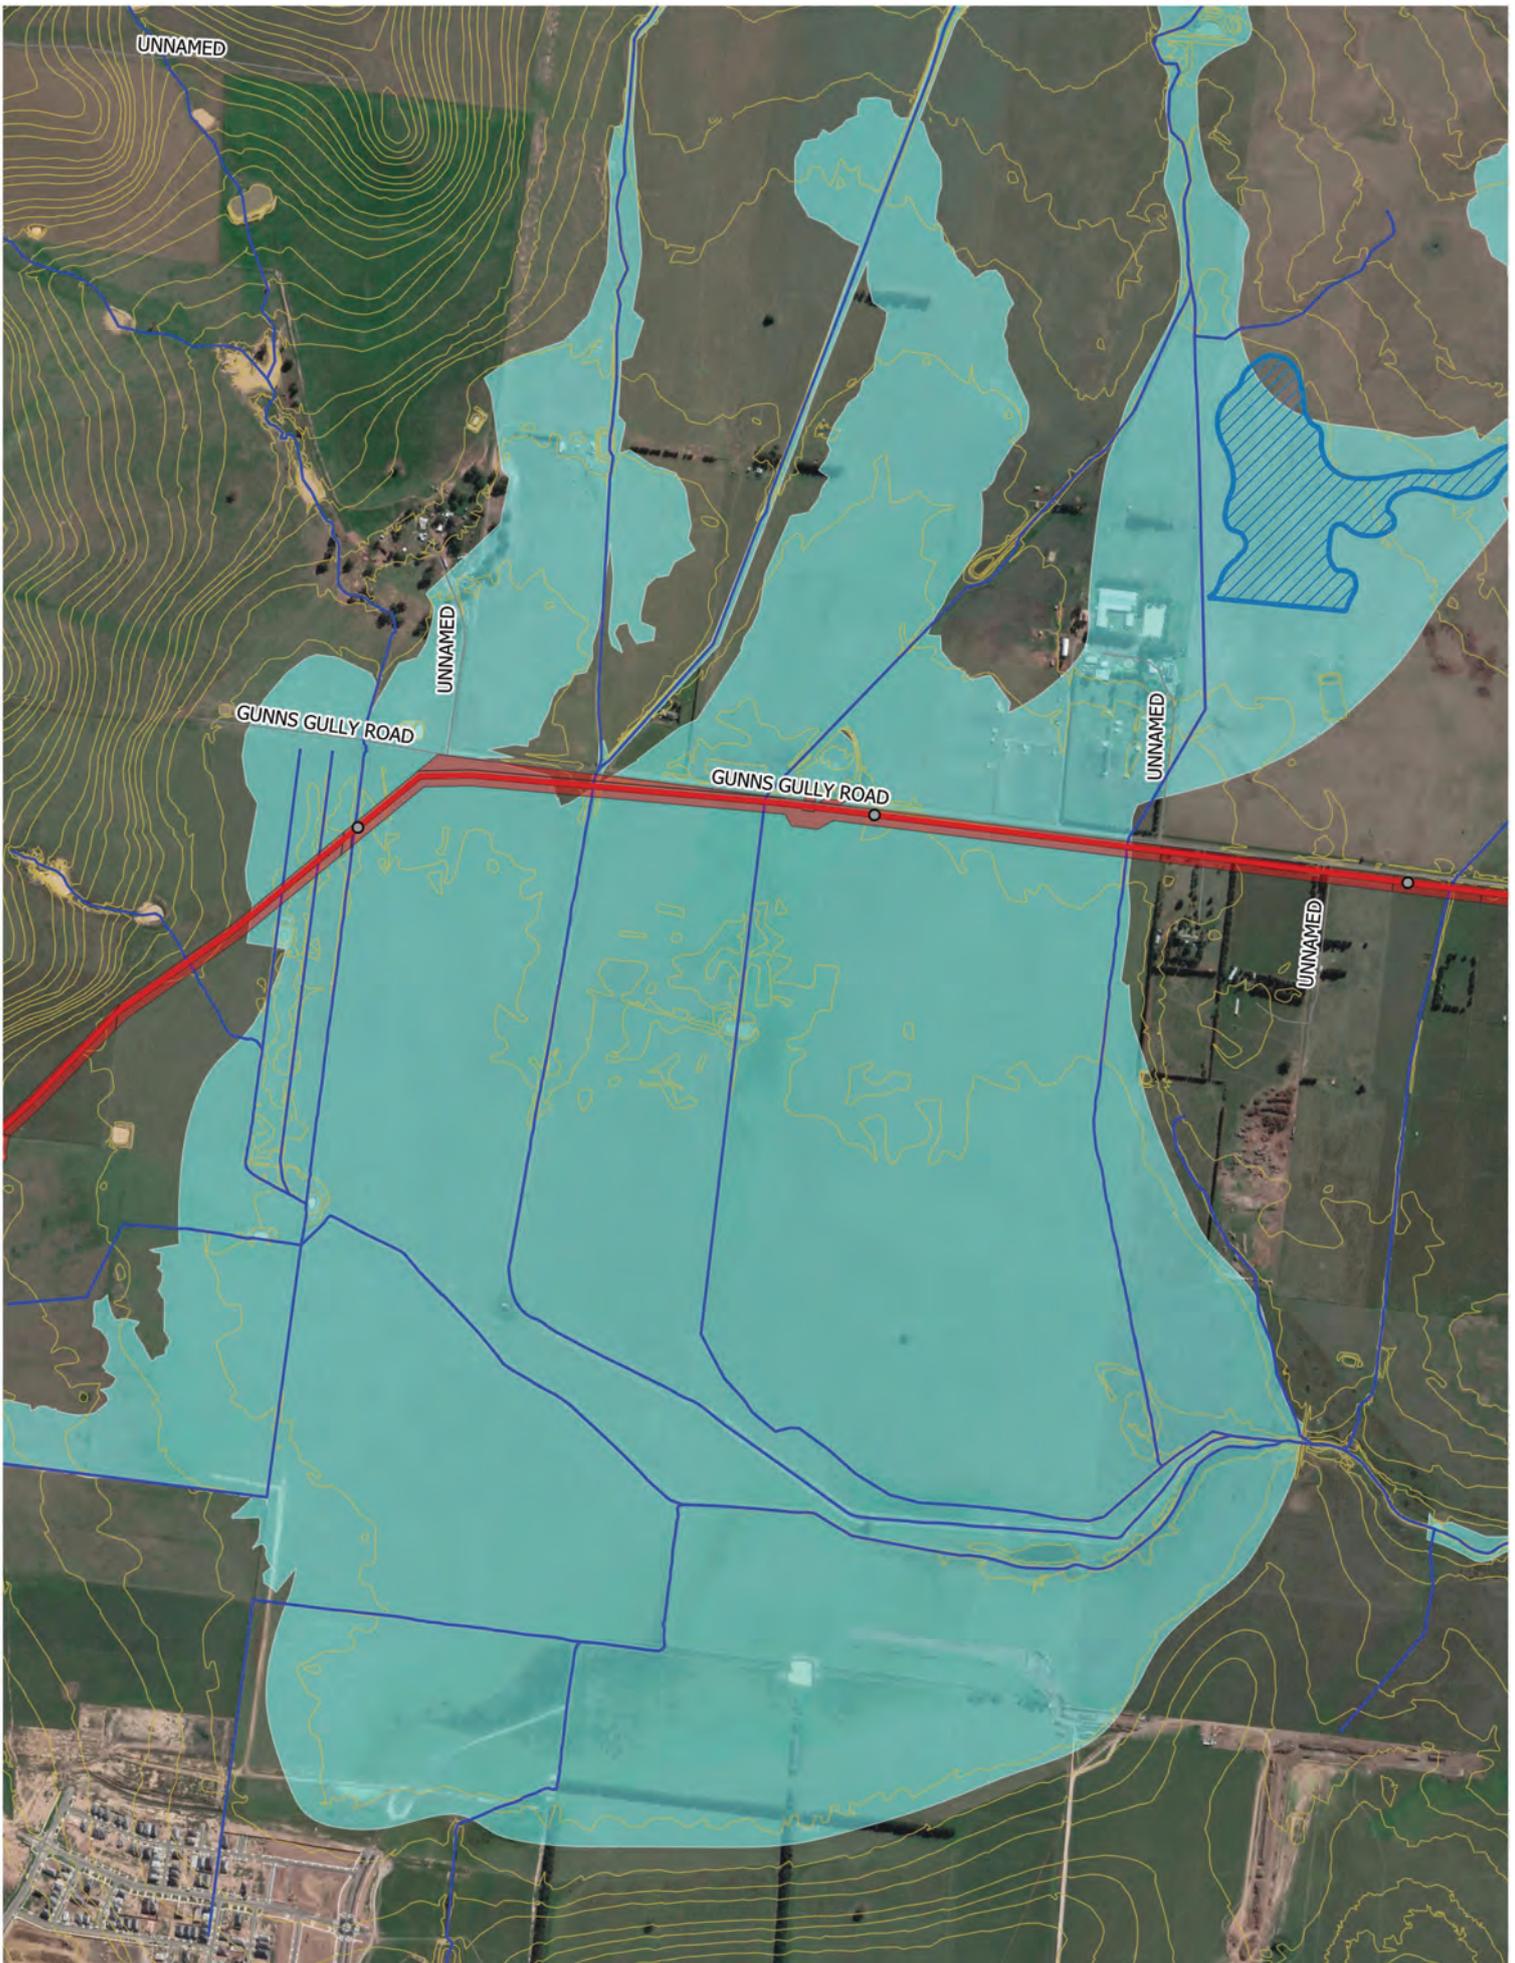
Flood mapping outputs were provided in the MWC data and the extent of flooding across Kalkallo Creek retarding basin is captured in Figure 6-40 below. As shown in Figure 6-40, the flood waters extend from the main Kalkallo Creek and other tributaries from the north and west. It then spreads out across the retarding basin storage area as well as backwater travelling north across Gunns Gully Road and further upstream.

APA VTS Australia WORM Pipeline	Job Number   12529997 Revision   A Date   16/12/2020
	<b>Kalkallo Creek - Crossing 16</b> <b>100yr ARI Flood Extent</b>	<b>Figure 6-40</b>

MWC provided two HEC-RAS models which cover the multiple drains that enter the Kalkallo Creek retarding basin. The two models, Kalkallo Creek East drain and Kalkallo Creek West drain, were completed in 2008 and 2013, respectively. The 2013 HEC-RAS model came with a pdf of the flood extent output from the model but neither came with a flood mapping report detailing the modelling completed. The 2008 model results matched the current 100 year ARI flood extent that GHD had already obtained from MWC prior to receiving the HEC-RAS model. Both flood extents relative to Project alignment is presented in Figure 6-40.

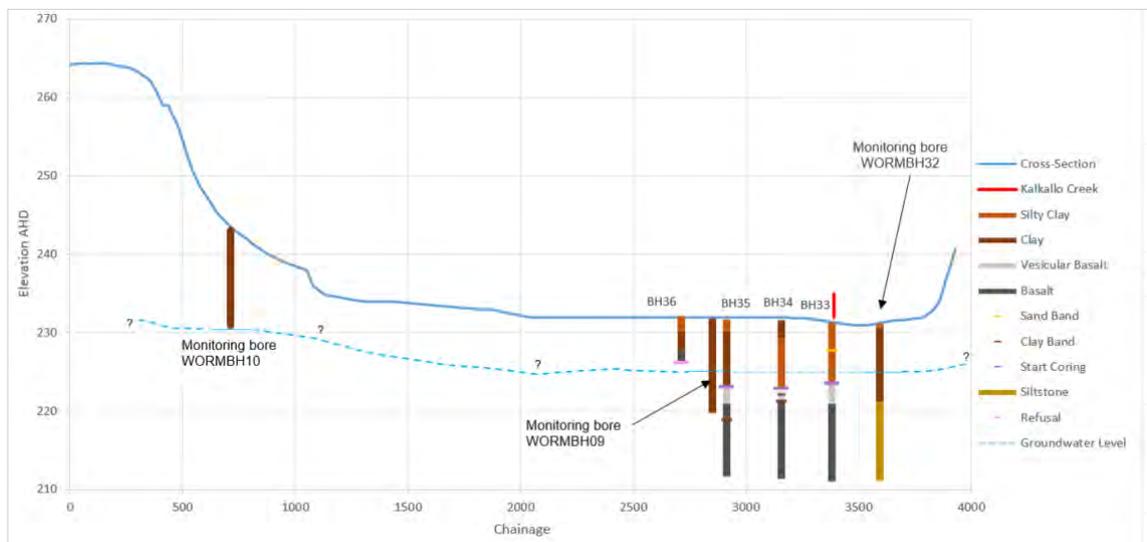
Geotechnical bore logs were obtained by Construction Sciences at 5 locations near Kalkallo Creek channel and floodplain, as shown in Figure 6-41. The bore logs are based on their coordinate locations which have been interpreted on a schematic cross section derived from LiDAR. The bore logs have been projected from the natural surface levels to their indicated depths.

Figure 6-41 Kalkallo Creek schematic soil profile cross section

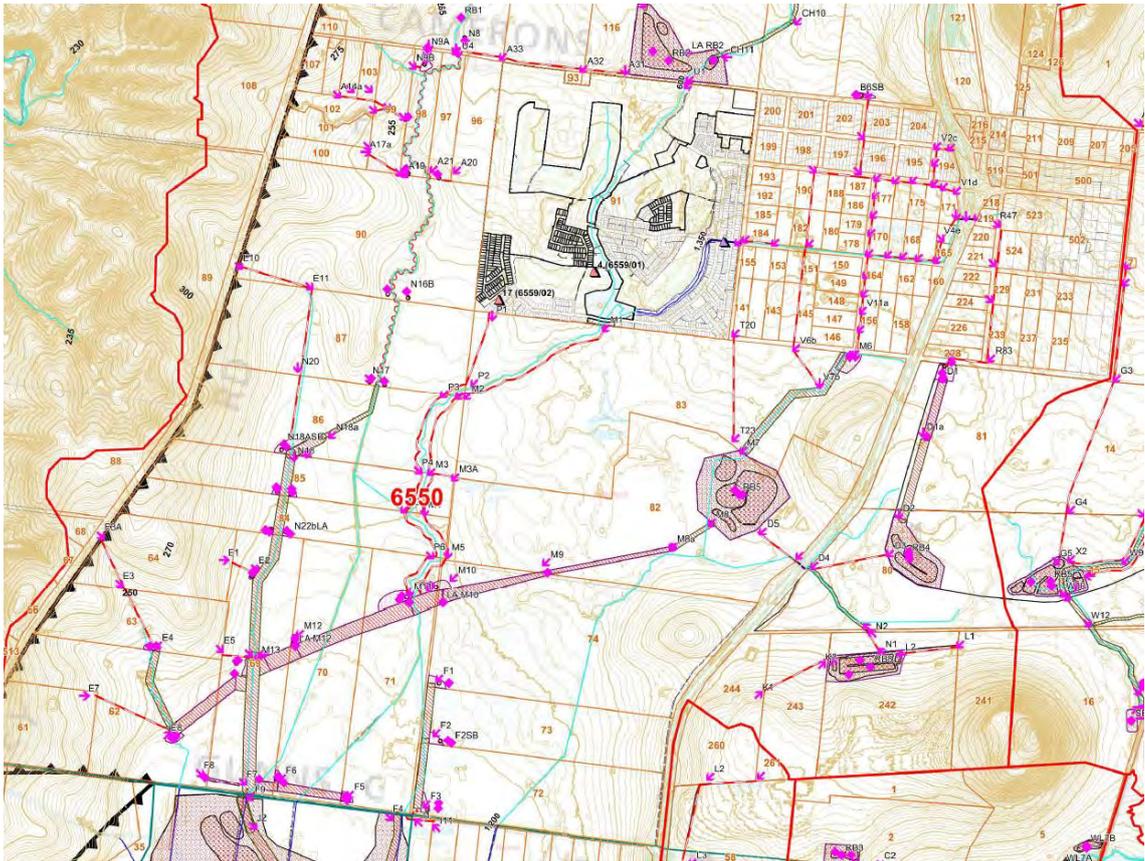
Much of the waterways that previously ran through Beveridge are now formalised into channels or underground pipe drainage which have been diverted to a realigned and widened channel that discharges into the retarding basin at the far west corner. Figure 6-42 displays the MWC DSS plan for Kalkallo Creek. As a result of the proposed diversion of waterways, many of the current drains will be made redundant, with the majority of Kalkallo Creek catchment flows now entering the retarding basin from the one location

Figure 6-42 Kalkallo Creek DSS plan

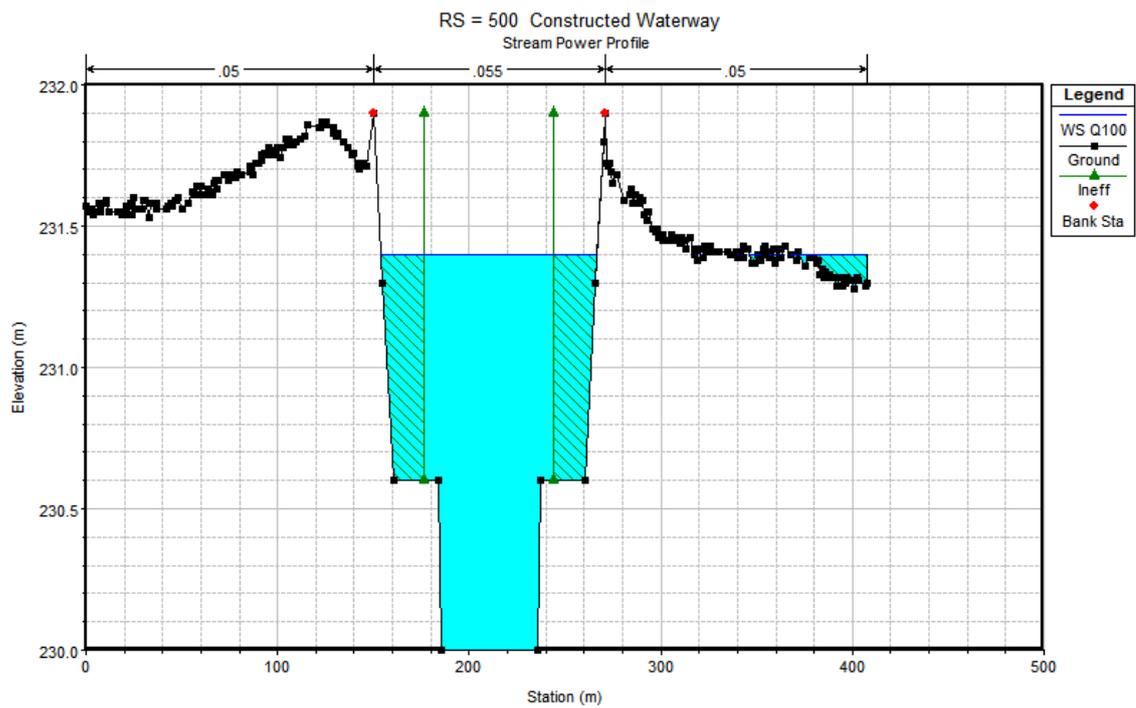
Figure 6-43 Proposed constructed channel entering Kalkallo Creek retarding basin

The trapezoidal channel is 1.8 metres deep and 140 metre wide at the surface and contains flows in the 100 year ARI event with a freeboard of 500 mm. Table 6-15 displays the design flow rates, velocities and stream powers at the pipeline crossing.

It should be noted that no report was provided with the Kalkallo Creek HEC RAS model and an interpretation of the model was required to inform the implications of future development. Figure 6-43 below displays the proposed constructed channel at the pipeline crossing which enters the retarding basin.

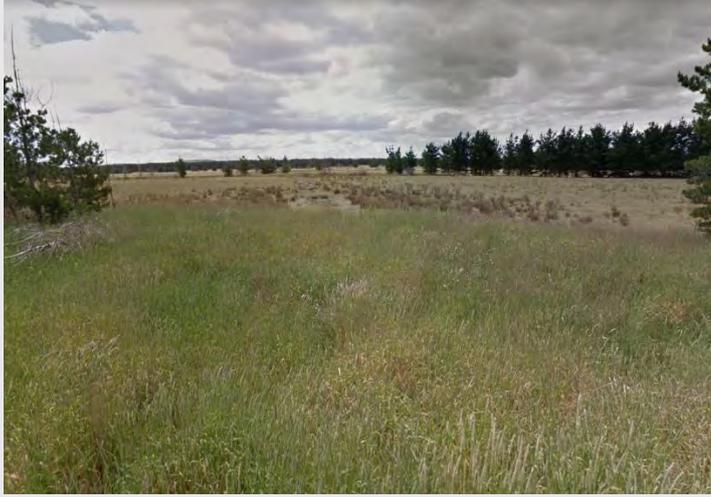
<p data-bbox="316 1413 727 1444">Source: Site photo taken (GHD, 2020)</p>	Tributary of Merri Creek looking north from the Donavan Lane – approximately 170 m north of the pipeline crossing

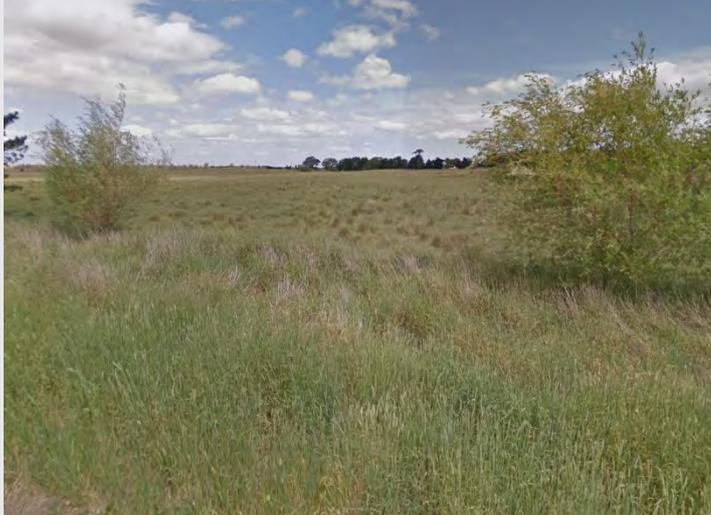
<p data-bbox="316 1973 727 2004">Source: Site photo taken (GHD, 2020)</p>	Tributary of Merri Creek looking south from the Donavan Lane – approximately 170 m north of the pipeline crossing

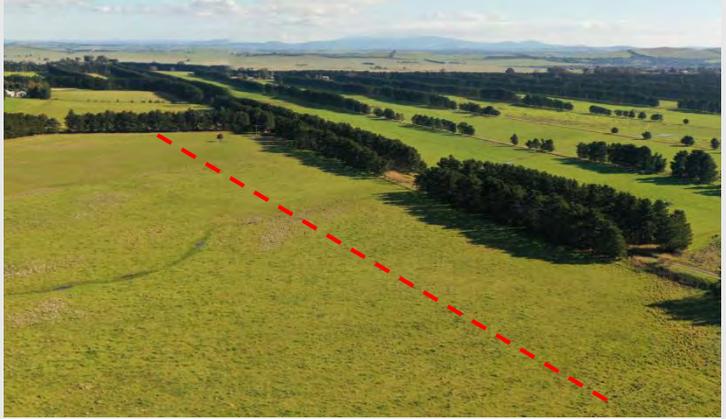
<p>Panosphere – Drone aerial imagery</p> <p>Looking north west of rail tracks at Tributary of Merri Creek looking at pipeline crossing location adjacent to Donovans Lane.</p> <p>Red dashed line = Indicative pipeline alignment.</p>
<p>Source: Panosphere screen capture (AUAV, 2020)</p>

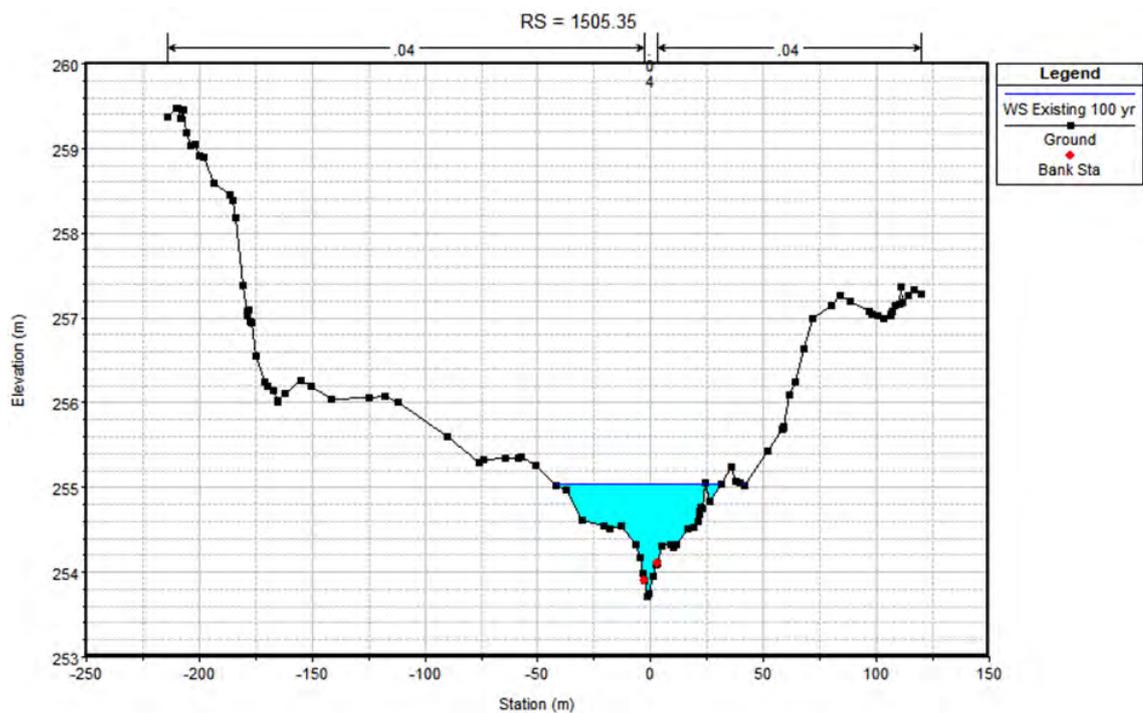
Figure 6-44 Tributary of Merri Creek flood levels at CH 1505.35 (100 year ARI)

The design flows were modelled in HEC-RAS and results interpreted at a representative cross section within the HEC-RAS model nearest to the location of the Project crossing as indicated in Figure 6-44 below.

From the interpretation of the estimated flood levels:

- There is no defined channel as such and the flows spread across the natural overland flow path and surrounding floodplain
- The estimated 1 in 100 year flood level is approximately 255 m AHD, and spreads across the floodplain terrace over a width of approximately 60 m

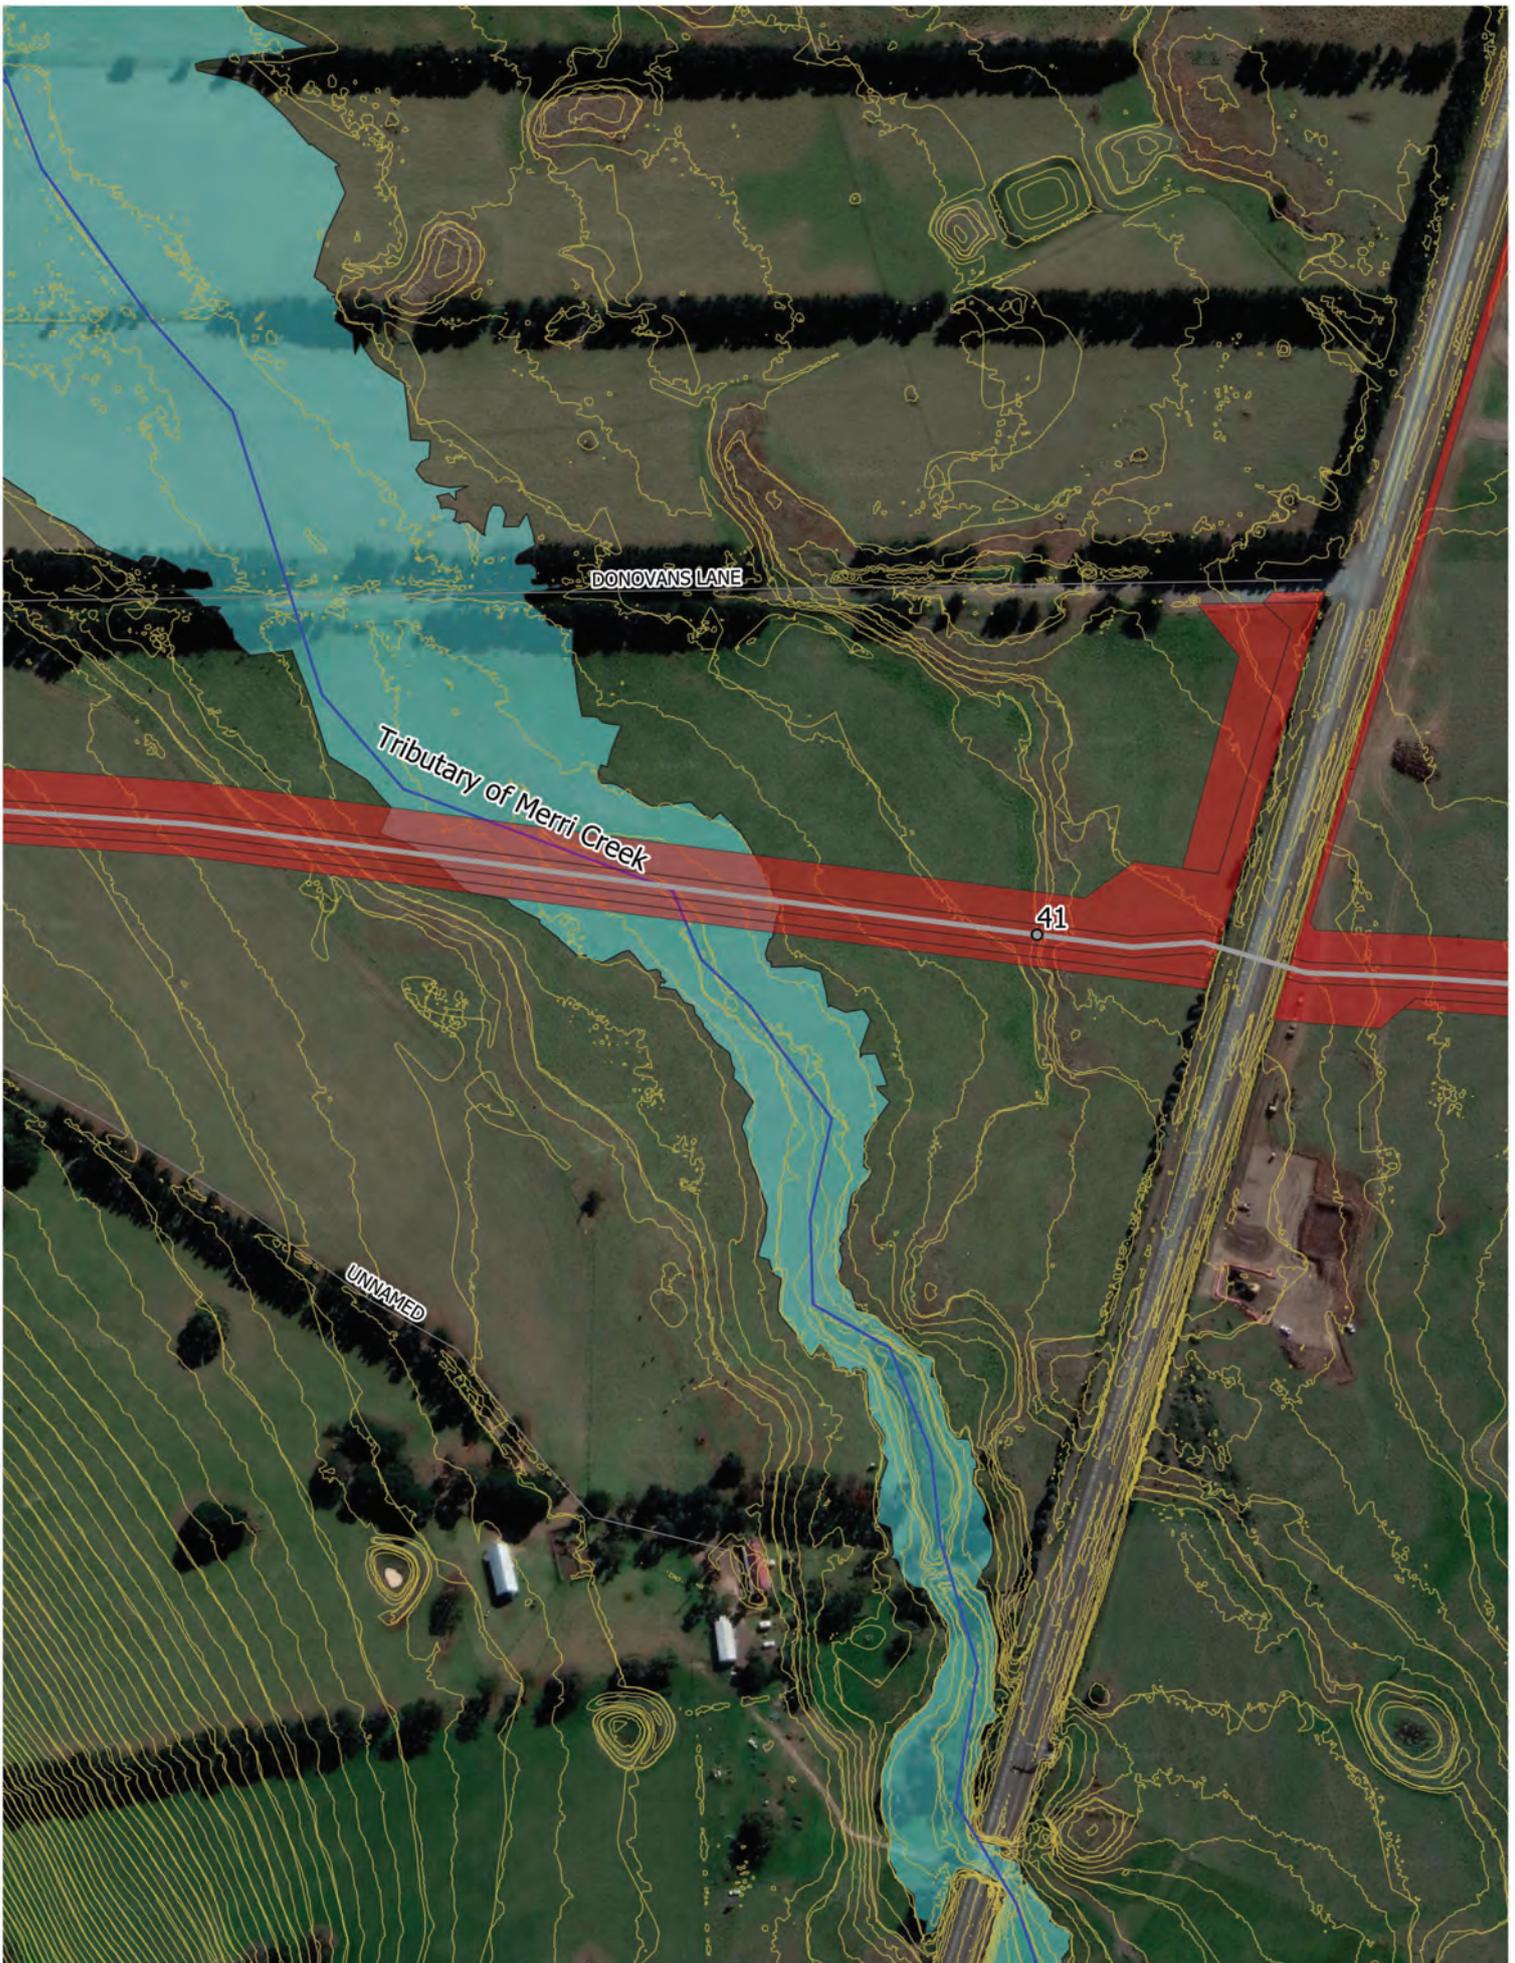
**Figure 6-45**

The current LSIO mapping was provided by MWC based on the modelling completed by GHD, as presented in Figure 6-45 below.

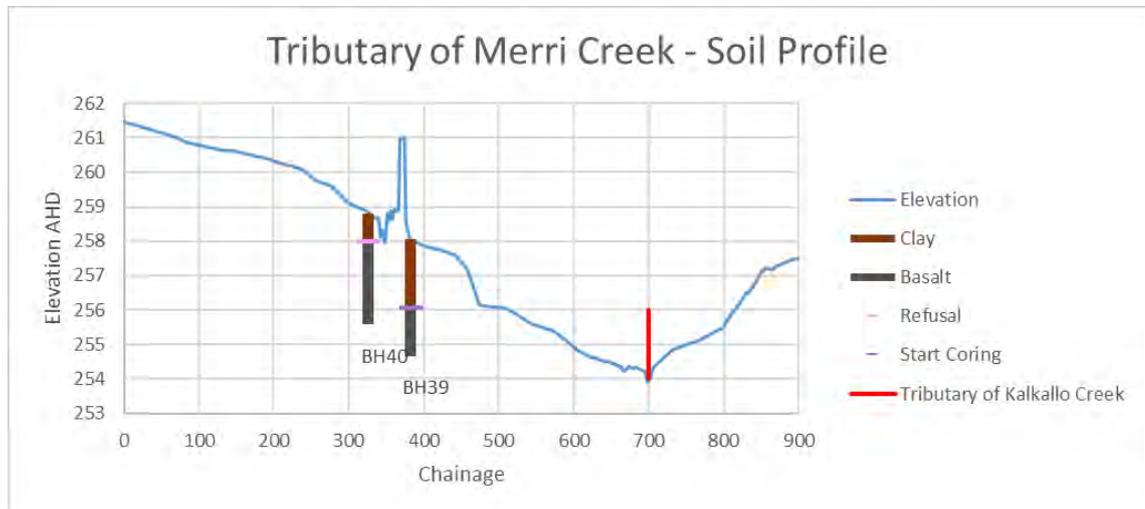
Figure 6-46 Tributary of Merri Creek schematic soil profile cross section

Geotechnical bore logs were obtained by Construction Sciences at 2 locations near the Tributary of Merri Creek channel and floodplain. The bore logs based on their coordinate locations have been interpreted on a schematic cross section interpreted from LiDAR as shown in Figure 6-46. The bore logs have been projected from the natural surface levels to their indicated depths.

From interpreting the nearest bore logs within the cross section approximately 300 m to the west of their crossing location:

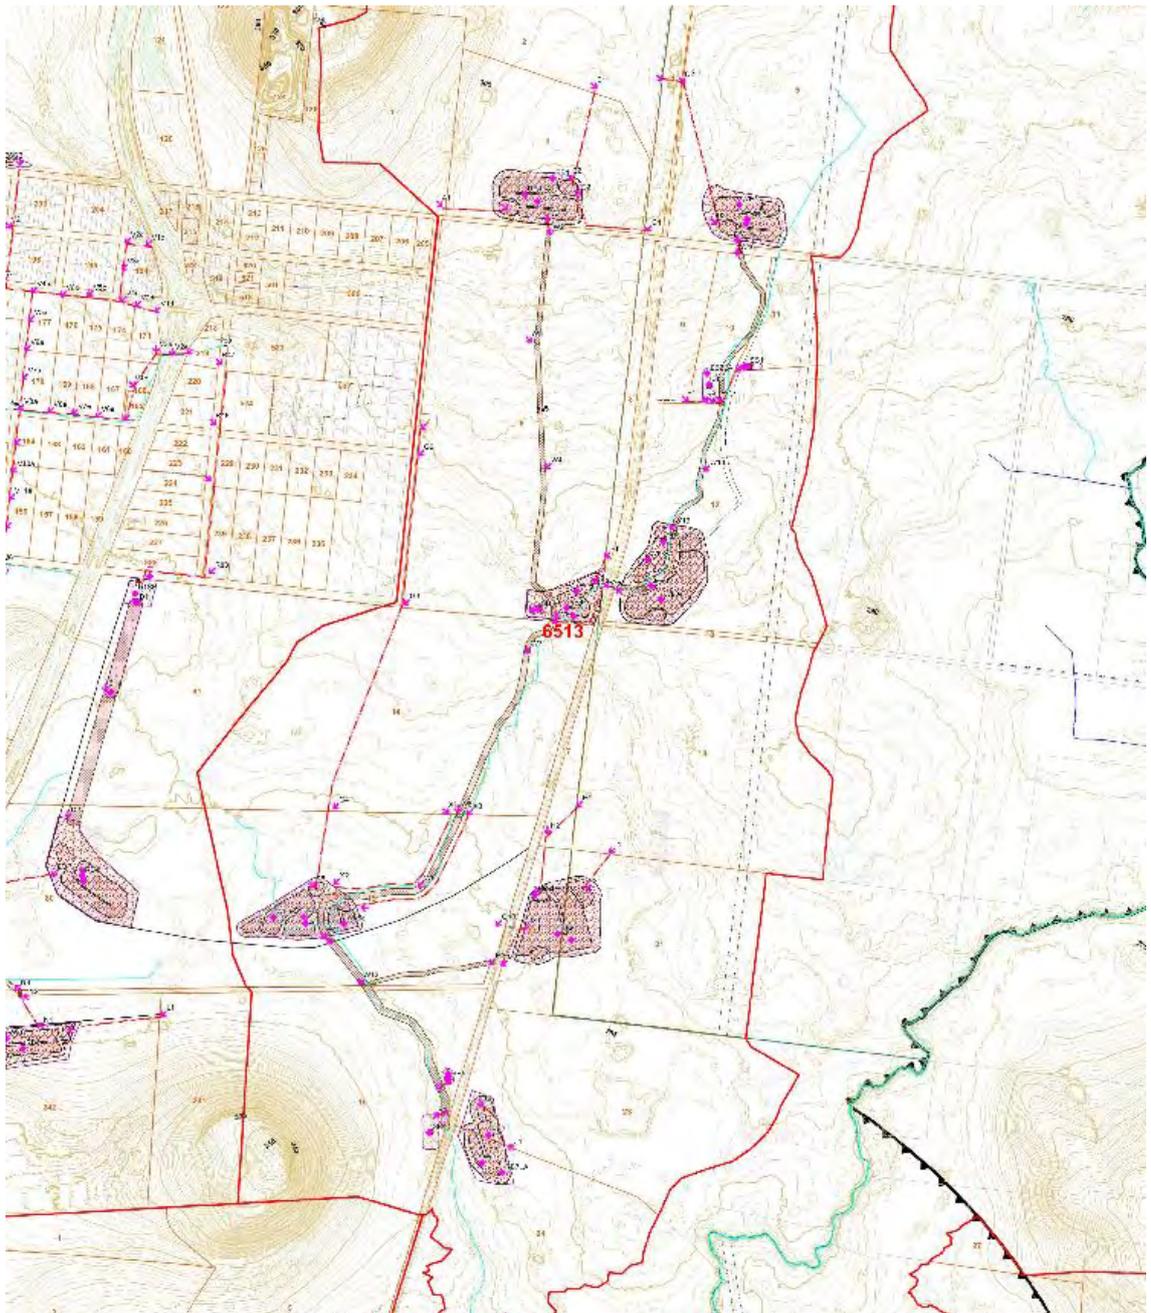
Figure 6-47 Beveridge East (6513) DSS Plan

The Tributary of Merri Creek catchment is within a Drainage Services Scheme (DSS) and will be subject to ongoing future development with various Precinct Structure Plans within the area. There is no explicit timeline for when the future developments will occur as the main purpose of the DSS is to guide the standards in which future developments will need to meet for flood protection, water quality and waterway health. As shown in the latest MWC DSS for Beveridge East (6513), there is a significant amount of proposed urban development across the entire catchment area of the Tributary. The DSS also presents indicative locations of future drainage assets which includes a number of wetlands, retarding basins and formalised channels located throughout the catchment. The MWC DSS plan for Beveridge East, as shown in Figure 6-47, proposes a formalised channel following the existing waterway alignment including a new constructed channel west of the rail tracks.

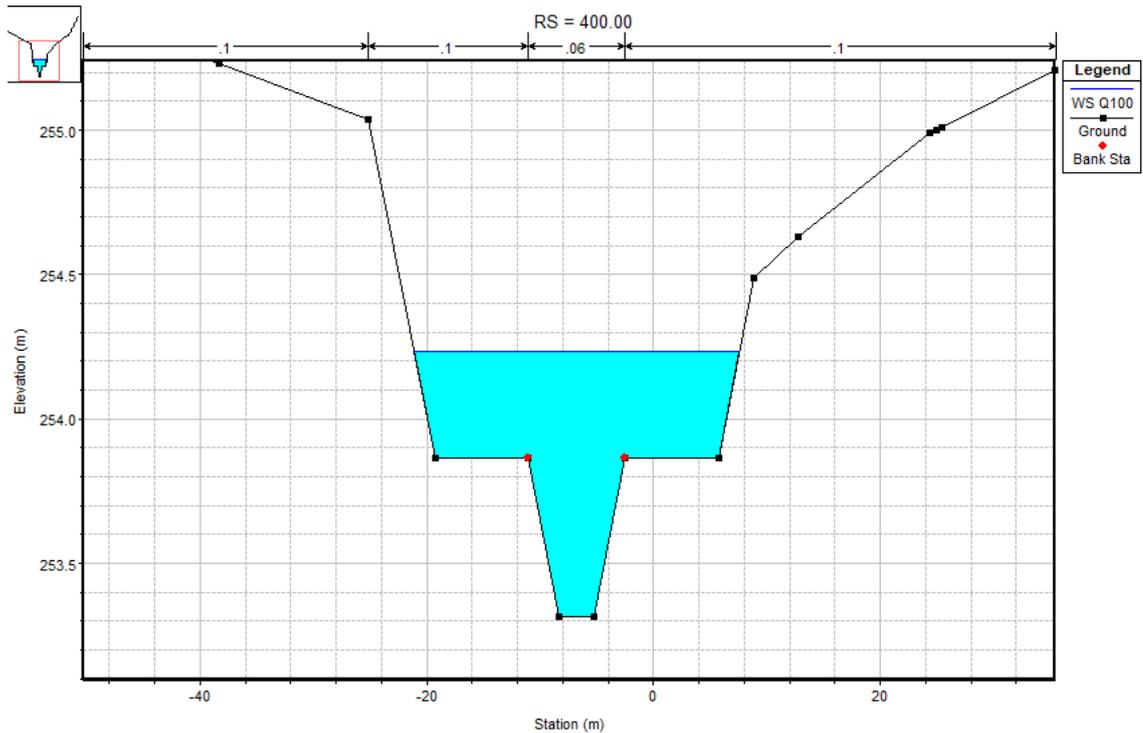
Figure 6-48 Proposed constructed channel at the pipeline crossing

Figure 6-48 presents a representative cross section of the proposed constructed channel at the proposed pipeline crossing.

The cross section of the trapezoidal channel at the site of interest is approximately 1.4 metres deep and 30 metre wide at the surface and contains flows in the 100 year ARI event with a freeboard of 300 mm to the top of the incised channel. Table 6-17 presents the design flow rates, velocities and stream powers at the pipeline crossing for the proposed constructed channel.

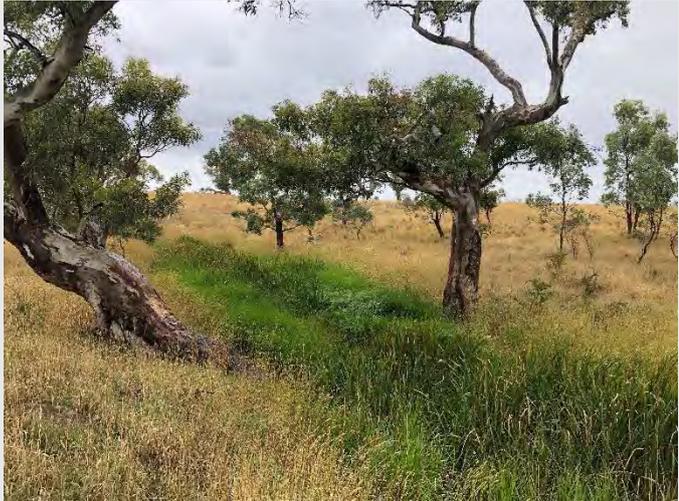
<p data-bbox="316 705 774 741"><i>Source: Site photo taken (GHD, 2020)</i></p>	<p data-bbox="1054 203 1366 389">Merri Creek looking immediately west of crossing location with evidence of dense vegetation within channel and established trees</p>

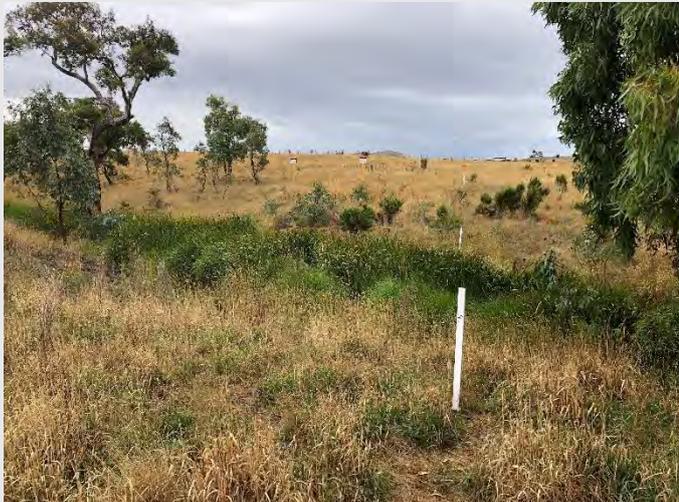
<p data-bbox="316 1254 774 1290"><i>Source: Site photo taken (GHD, 2020)</i></p>	<p data-bbox="1054 752 1339 813">Merri Creek at crossing location looking north.</p>

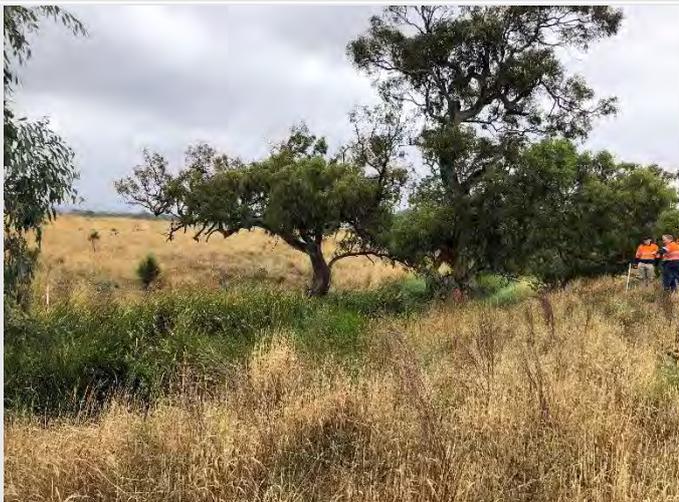
<p data-bbox="316 1803 774 1839"><i>Source: Site photo taken (GHD, 2020)</i></p>	<p data-bbox="1054 1301 1366 1487">Merri Creek looking immediately east of crossing location with evidence of dense vegetation within channel and established trees</p>

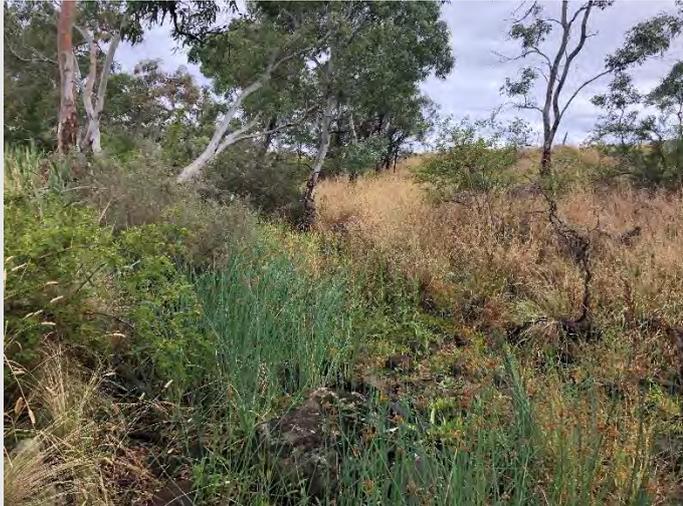
<p data-bbox="316 712 772 745"><i>Source: Site photo taken (GHD, 2020)</i></p>	<p data-bbox="1054 203 1382 327">Merri Creek channel with a rocky base, densely vegetated banks and deeply rooted trees</p>

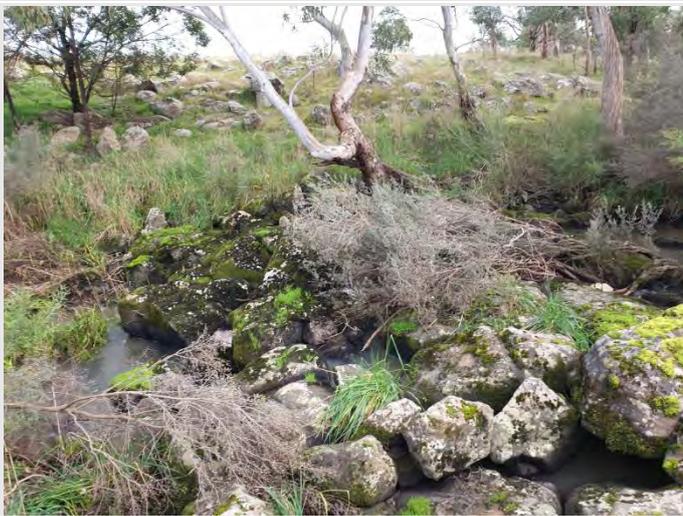
<p data-bbox="316 1270 772 1301"><i>Source: Site photo taken (GHD, 2020)</i></p>	<p data-bbox="1054 752 1390 913">Merri Creek observed rock boulder control feature downstream of the crossing location (shown in Figure 6-49 as Key Feature 4)</p>

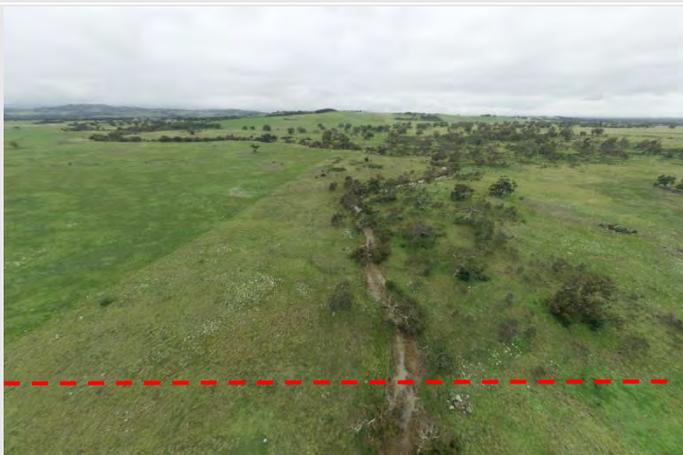
<p data-bbox="316 1765 922 1798"><i>Source: Panosphere screen capture (AUAV, 2020)</i></p>	<p data-bbox="1054 1308 1382 1375">Panosphere – Drone aerial imagery</p> <p data-bbox="1054 1382 1382 1442">Merri Creek looking east of the crossing location.</p> <p data-bbox="1054 1449 1278 1543">Red dashed line = Indicative pipeline alignment.</p>

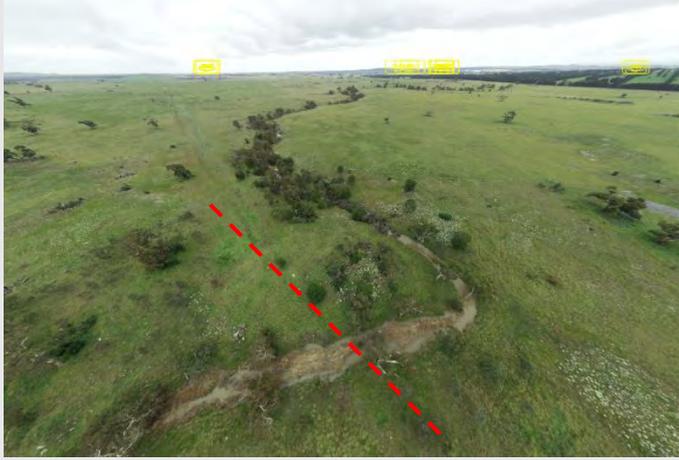
<p data-bbox="316 667 922 696">Source: Panosphere screen capture (AUAV, 2020)</p>	<p data-bbox="1054 203 1394 432">Panosphere – Drone aerial imagery Merri Creek looking southwest from crossing location. Red dashed line = Indicative pipeline alignment.</p>

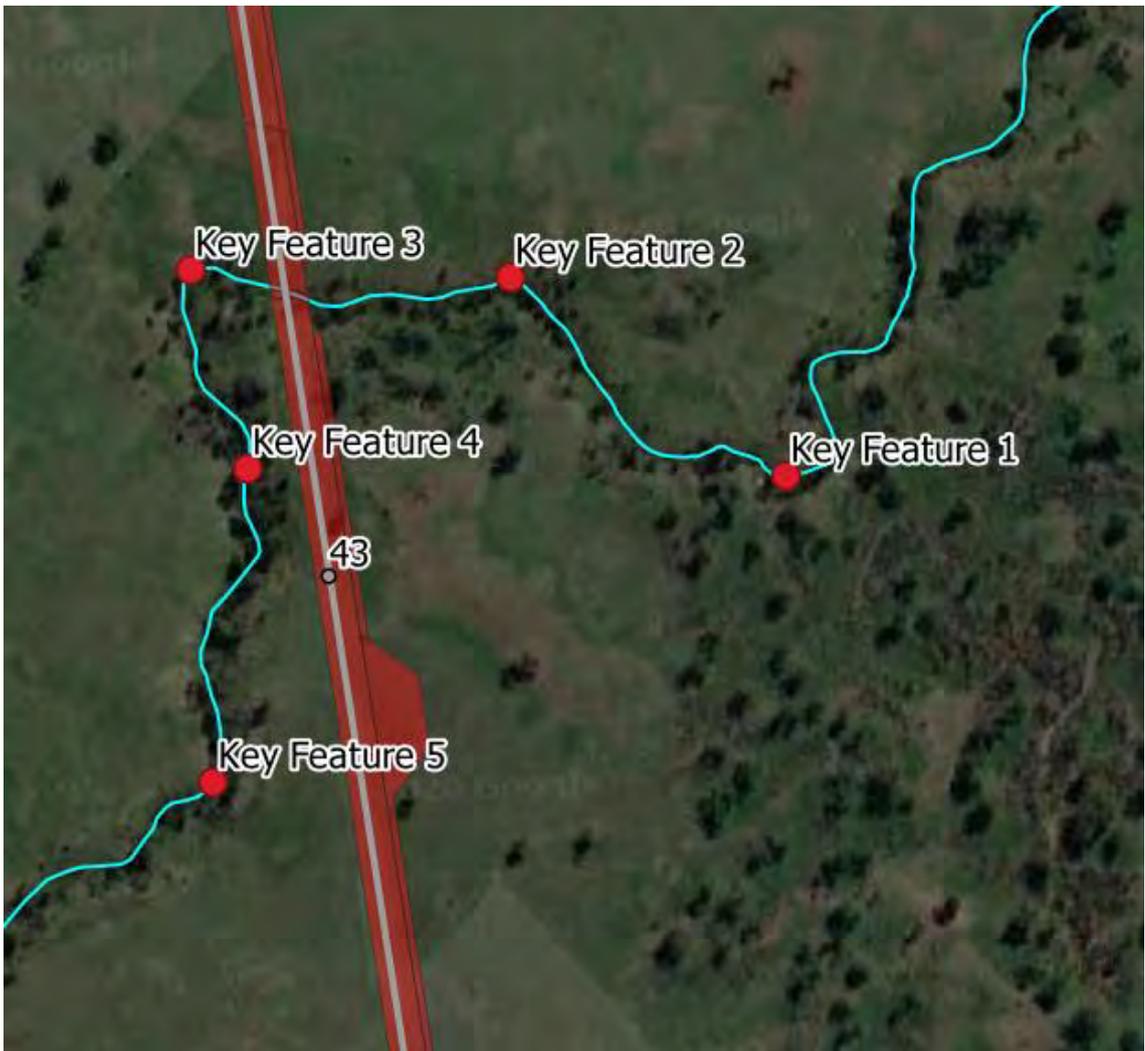
Figure 6-49 Plan view of Merri Creek waterway crossing with Key Features.

A number of key features were identified during the subsequent site inspection on 28 July 2020 in the vicinity of the crossing location, as outlined in Table 6-18. A key hydraulic control was observed approximately 230 m downstream of the crossing location. The location of this feature is marked on the plan view in Figure 6-49 as Key Feature 4 and indicated in the longitudinal profile in Figure 6-50. The rock boulder feature is expected to increase the Manning’s roughness of the channel and provide some level of backwater control to the site of interest at the pipeline crossing.

Key feature No.	Description
1	Meander in Merri Creek
2	Meander in Merri Creek
3	Meander in Merri Creek
4	Hydraulic Rock Boulder Control
5	Meander in Merri Creek
