technical report B  
**surface  
water.**

Environment Effects Statement | May 2021

**western outer  
ring main**

APA VTS (Operations) Pty Ltd  
Western Outer Ring Main Environment Effects Statement  
Surface Water Report

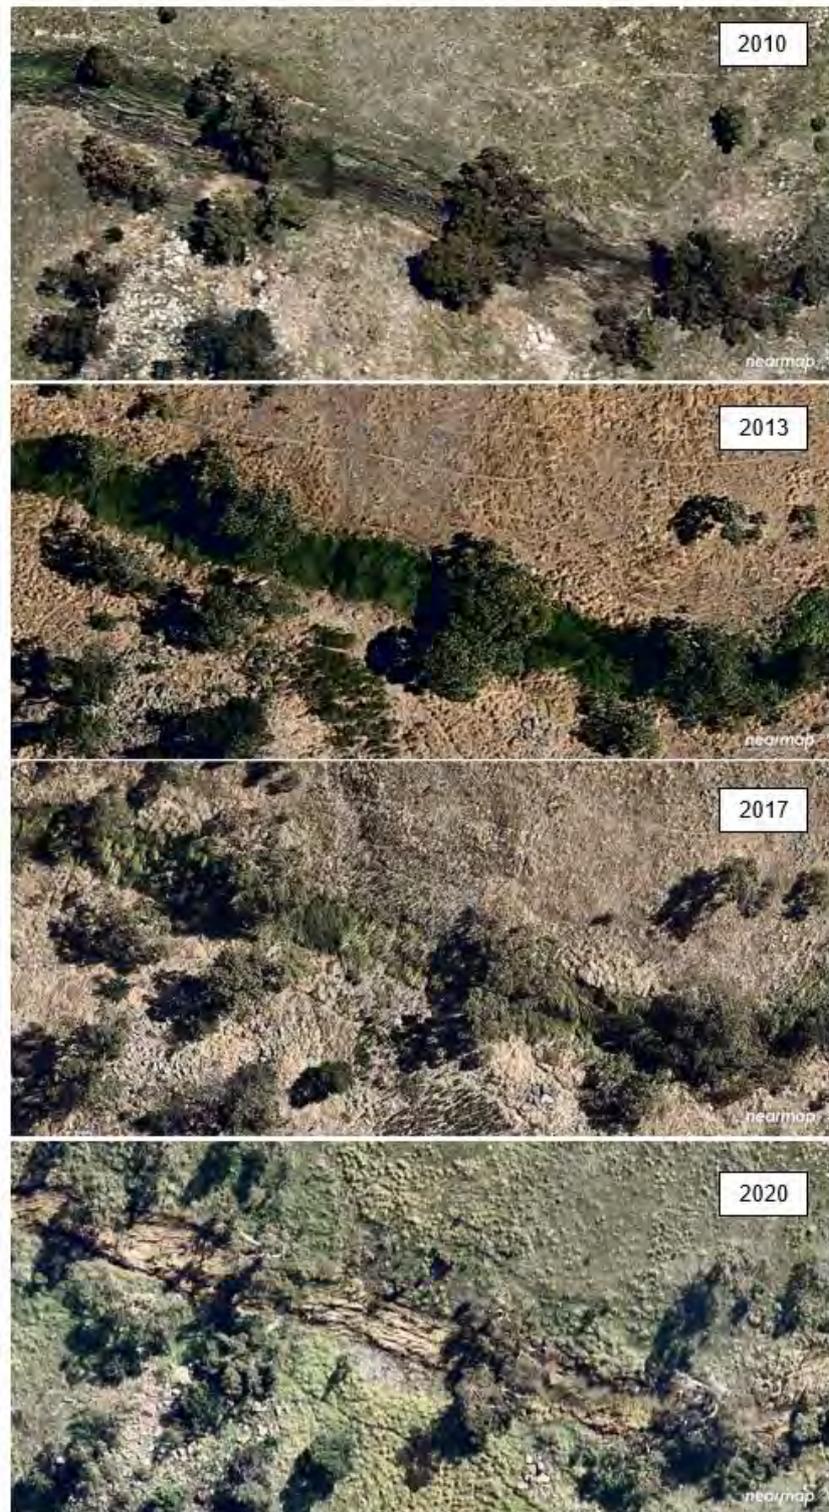
Figure 6-51 Nearmap images of Merri Creek at the crossing location over a 10-year period

Near map images were obtained for Merri Creek over a 10 year period, between 2010 and 2020, as shown in Figure 6-51. The time series images below concentrate mainly on the section of Merri Creek where the pipeline alignment crosses the waterway.

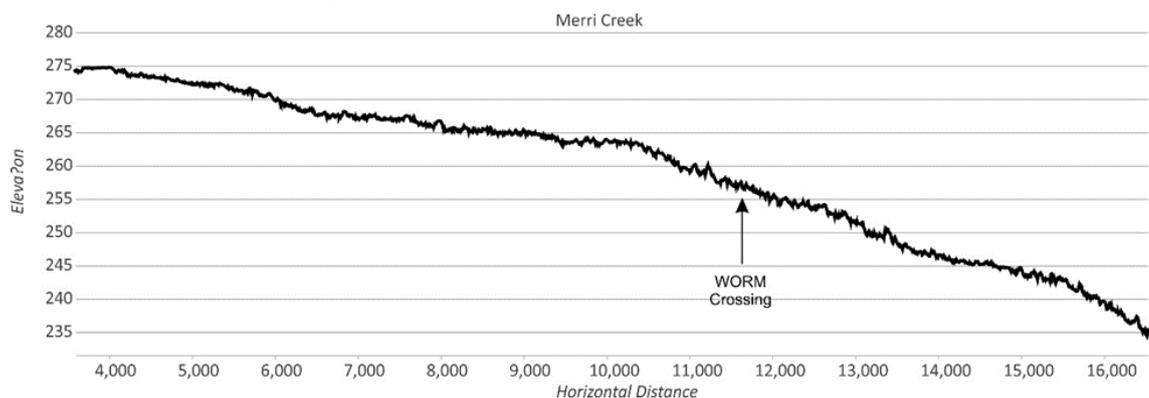
Figure 6-52 Merri Creek Stream Bed Profile

The upper 10 km of Merri Creek have a very low gradient, related to the stream's oblique traverse of the Mt. Fraser lava flow. This gradient increases abruptly near the location of the crossing, where the river passes across the crest of the lava flow and drains down the south side. This is indicated in Figure 6-52.

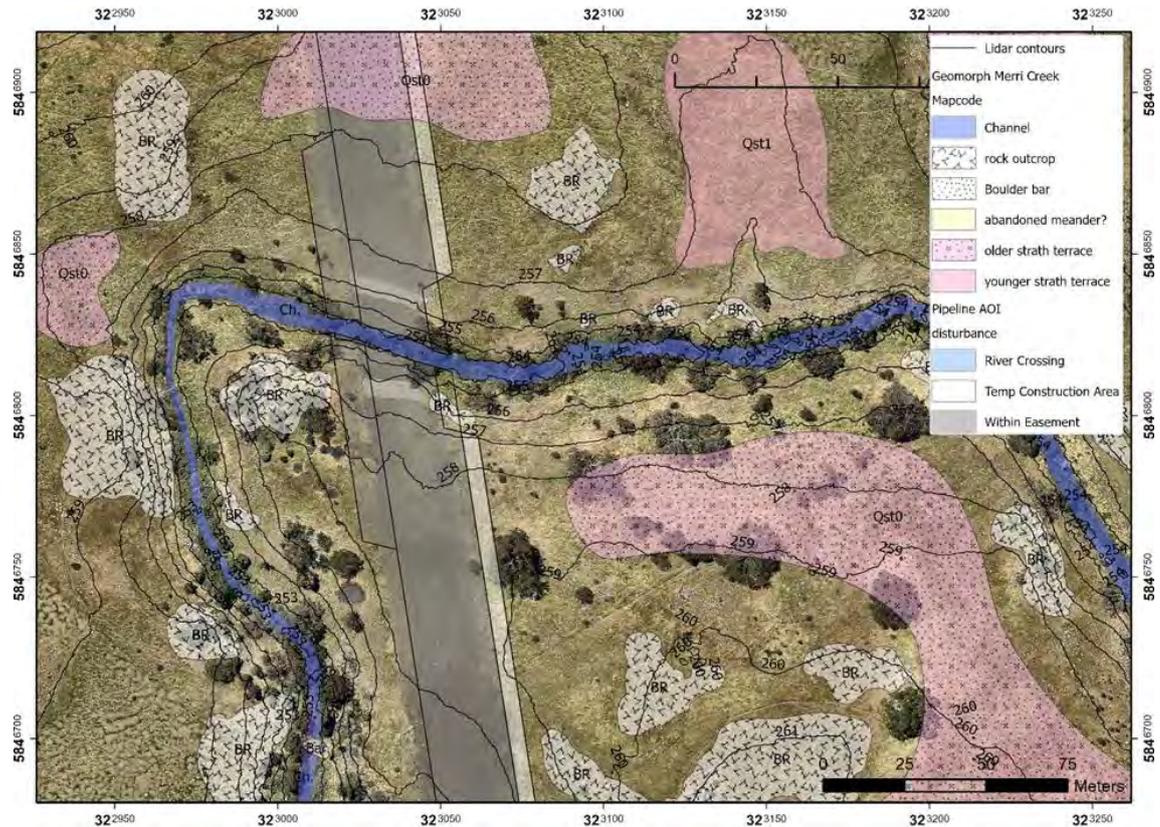
Figure 6-53 Geomorphological map of Merri Creek near crossing location

Geomorphically, this site is very different to Jacksons and Deep Creek. The site is situated on top of the lava flow and basalt is found everywhere across the site. It is visible in aerial photographs and the channel is notable for the large exposures of basalt in the channel walls, especially the west bank of the south-flowing reach of Merri Creek, downstream of the crossing. A geomorphological map is provided of Merri Creek of the inspected reach near the crossing location in Figure 6-53.

Overall, the channel has incised very slowly into the basalt. Based on the photographs obtained by an ecology survey in July 2020, the stream at the Merri Creek crossing consists of relatively passive flow conditions flowing through a thickly vegetated stream bed. Closer examination of the LiDAR suggests that the surface into which the stream is incised may be a more extensive abraded meander plain, incised into the basalt (noting the strath terraces are shown on Figure 6-53). Locally, such as 100 m upstream of the crossing, lower meander strath terraces may exist, with a bed elevation 2-3 m above the valley floor. However, none of these terraces appear to have an alluvial cover on them and the basaltic floor and walls of the valley, coupled with the relatively small catchment, make extensive lateral erosion or incision seem unlikely.

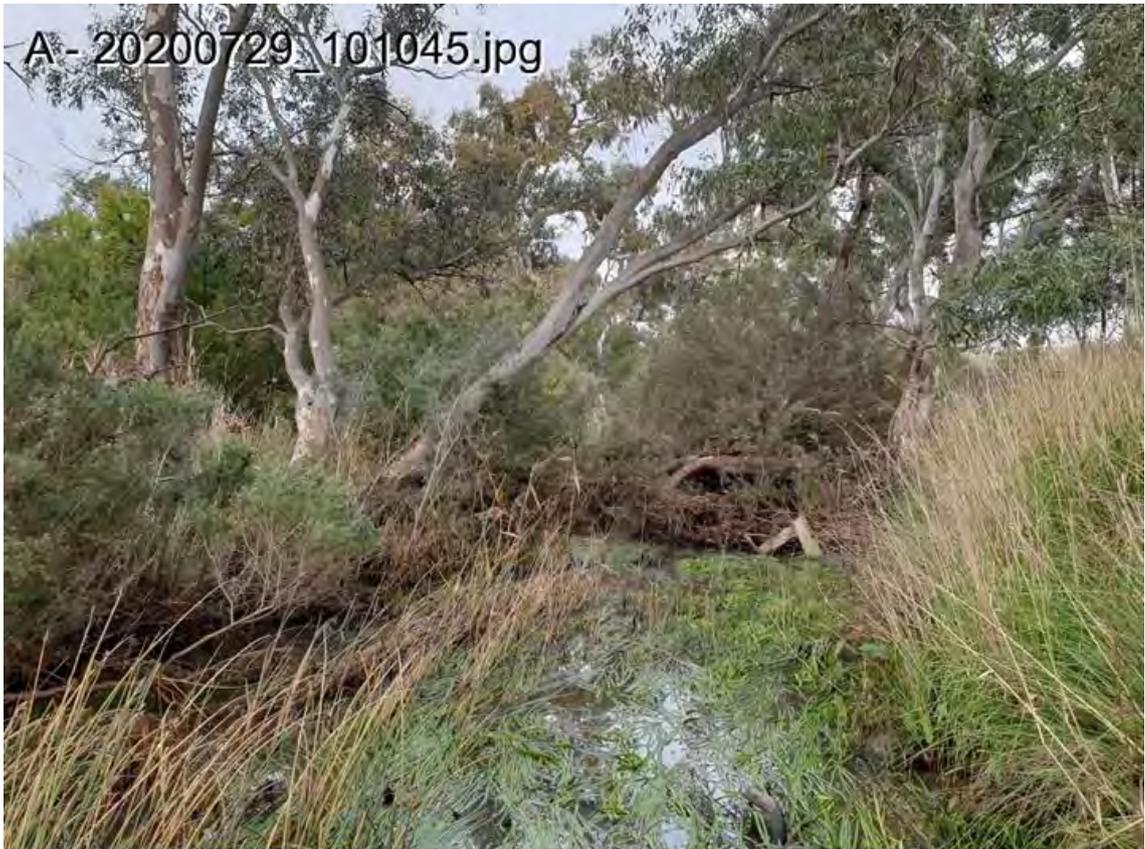
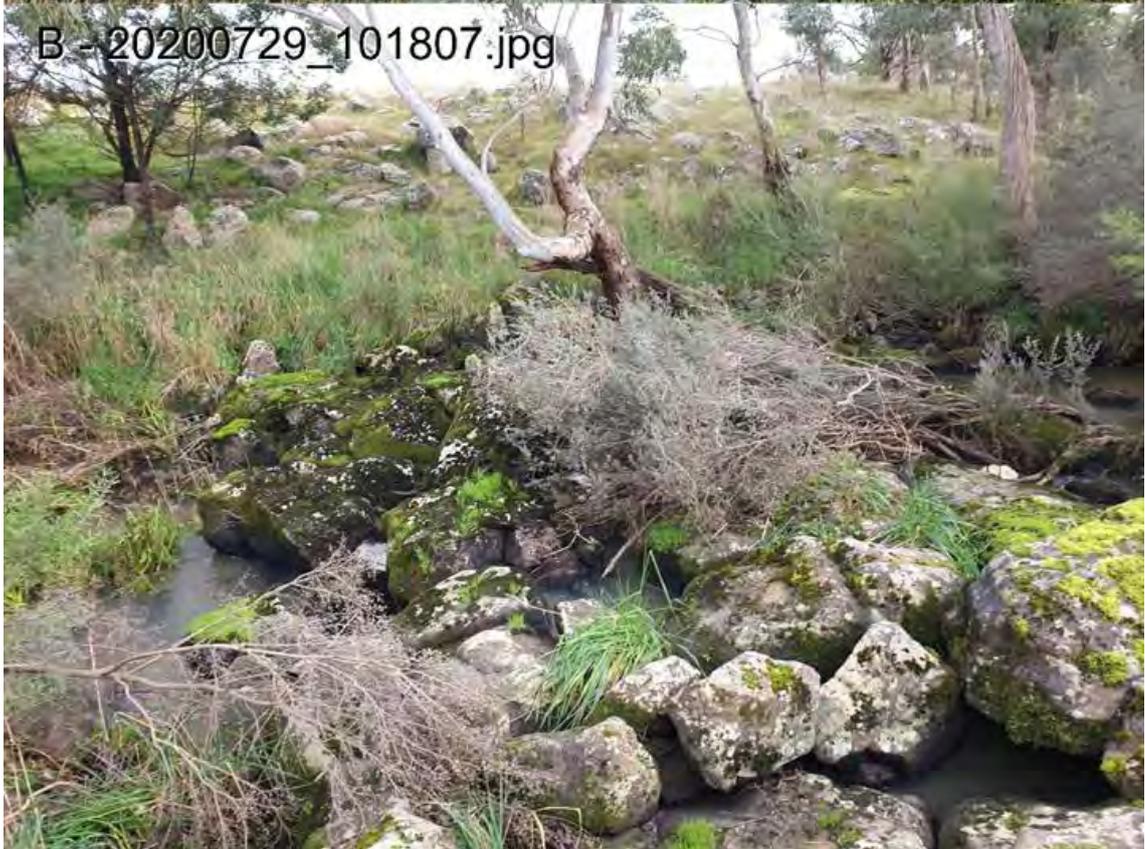
Figure 6-54 Riparian Vegetation and Rock Boulders

Within the channel, the stream at the Merri Creek crossing consists of relatively quiet water flowing through a thickly vegetated stream bed (Figure 6-54).

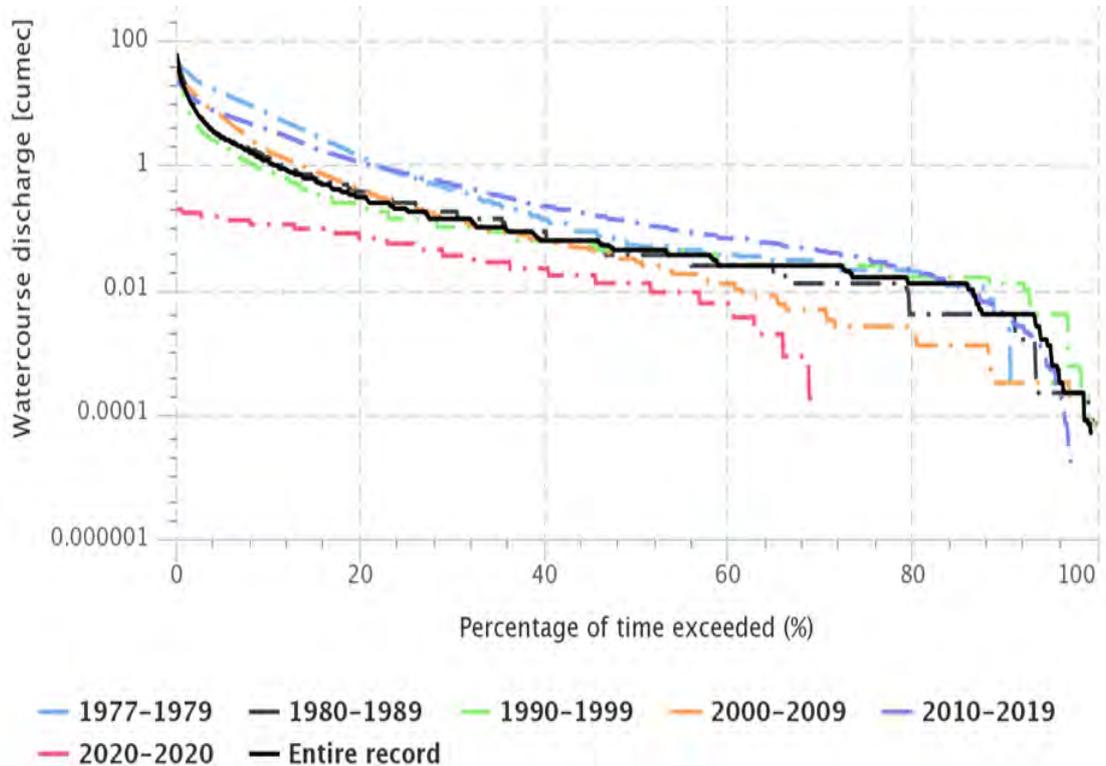
Figure 6-55 Merri Creek gauge station - Flow Duration Curve

From Figure 6-55 below, the mean annual flow is 0.04 m<sup>3</sup>/s, and the mean summer-autumn flow is 0.001 m<sup>3</sup>/s.

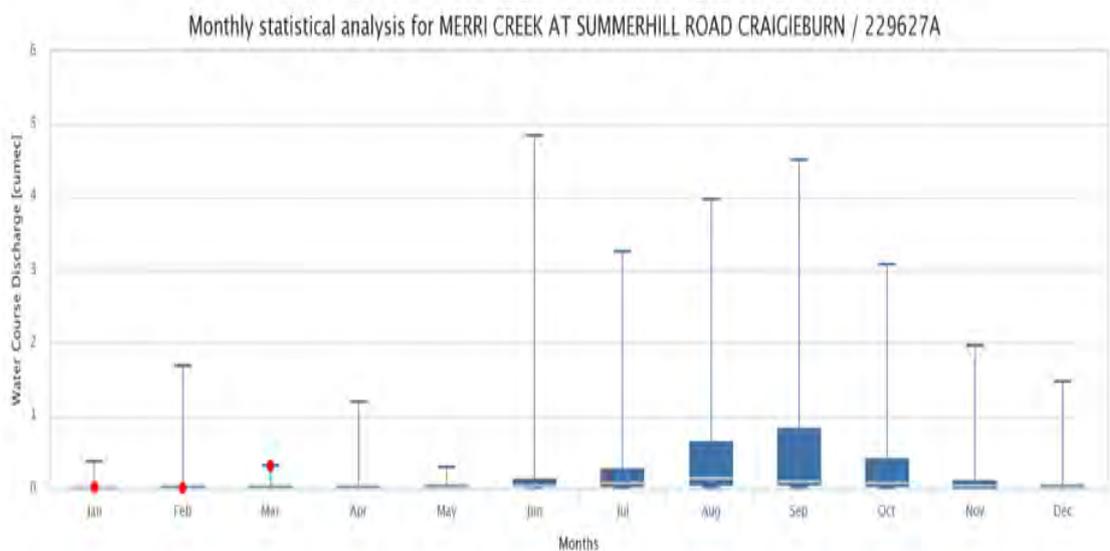
Figure 6-56 Merri Creek gauge station - Monthly Data

Figure 6-56 identifies the monthly flow recorded at this gauge station.

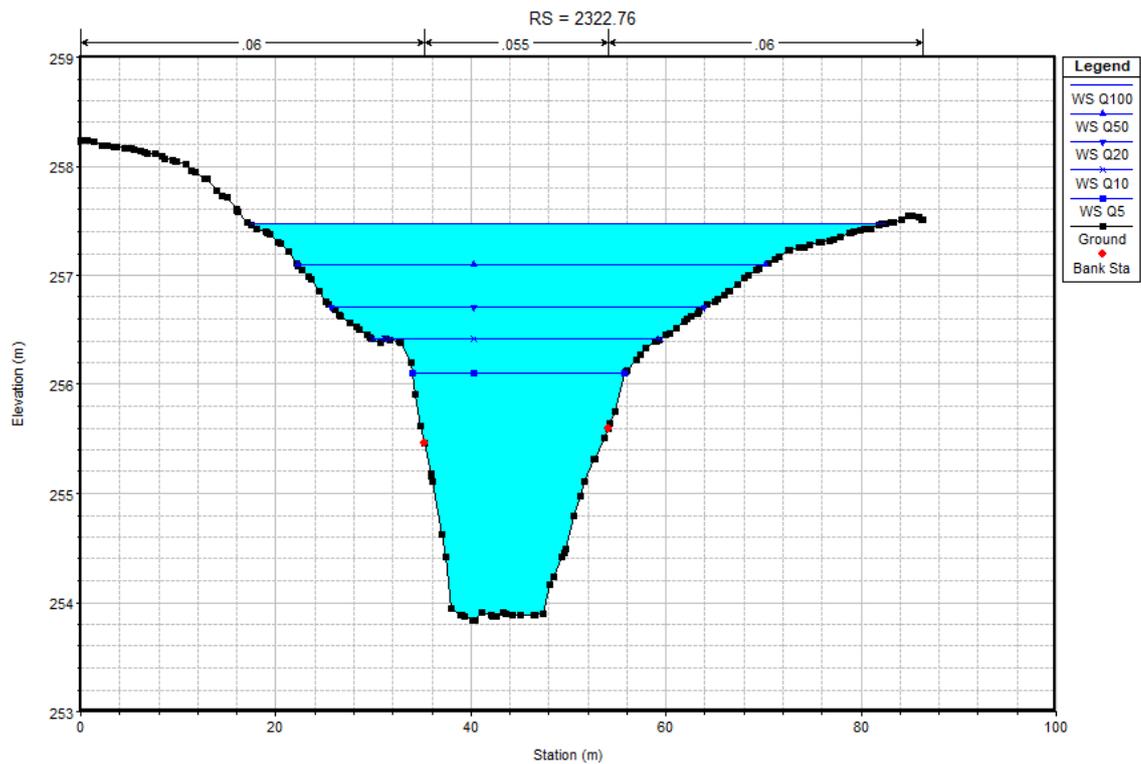
Figure 6-57 Merri Creek flood levels at CH 2322.76 (5, 10, 20, 50 and 100 year ARI)

The HEC-RAS results were interpreted at a representative cross section within the model nearest to the location of the Project crossing as indicated in Figure 6-57 below.

- The main channel has a less than 1 in 5 year ARI capacity
- The estimated 1 in 100 year ARI flood level is approximately 257.47 m AHD at the site of interest and spilling over the floodplain is expected along the left and right bank
- The floodplain is expected to be engaged frequently

Design flows were modelled and subsequent flood levels and extents were estimated from HEC-RAS. The modelled channel velocities for the 1% AEP and 2% AEP exceed 2 m/s with the stream powers less than 300 Nm<sup>2</sup>. The velocities indicate a moderate potential for stream bed and bank erosion. Flow, Velocity and Stream Power profiles along the modelled reaches are displayed in Appendix E which capture hydraulic changes along the reach.

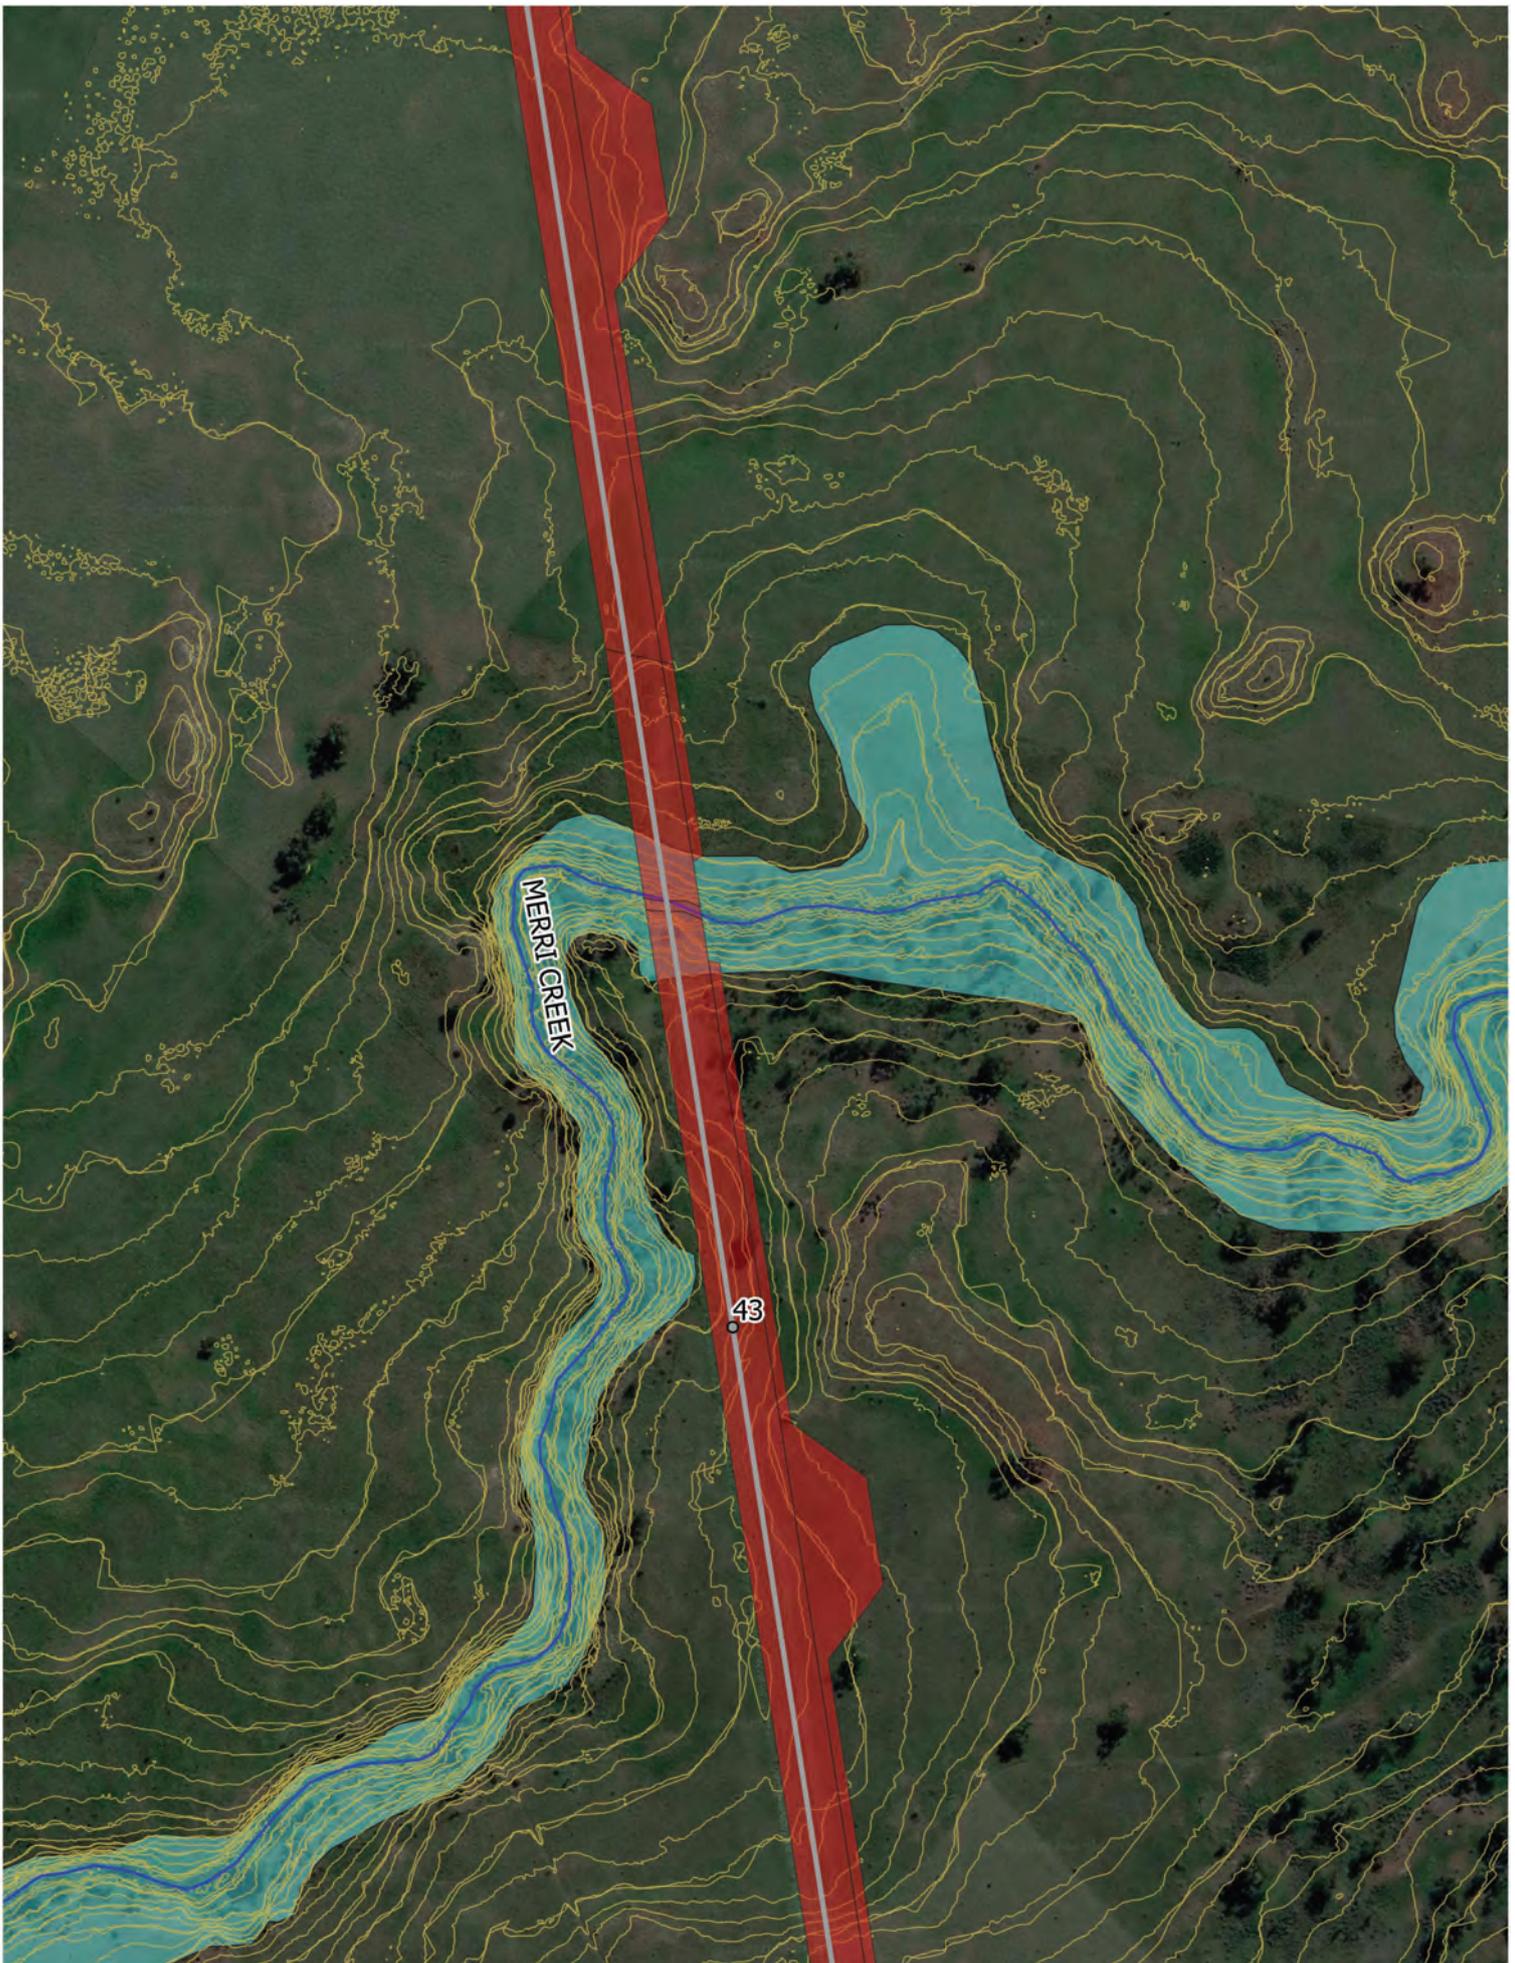
**Figure 6-58**

Flood mapping outputs were provided in the MWC data as presented in Figure 6-58 below.

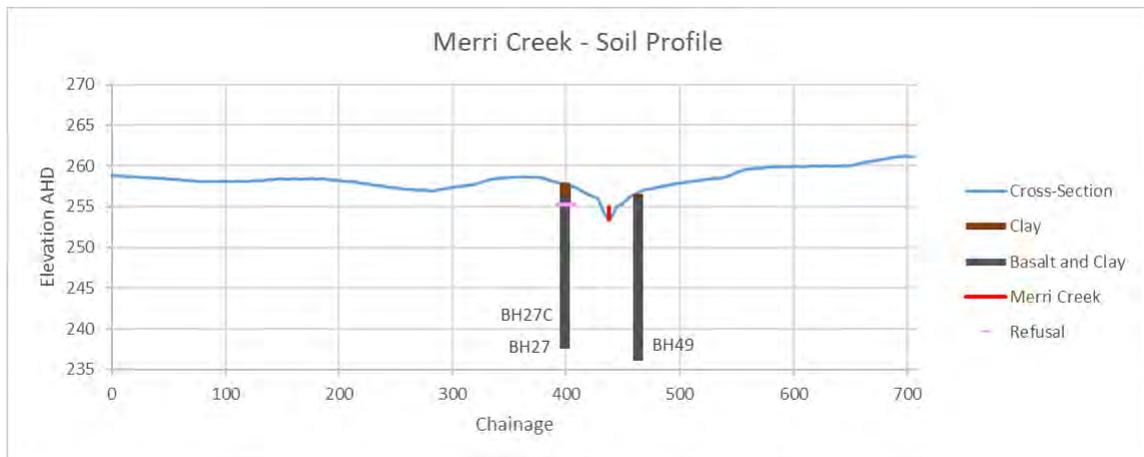
Figure 6-59 Merri Creek schematic soil profile cross-section

Geotechnical bore logs were obtained by Construction Sciences at 2 locations near the Merri Creek channel and floodplain, as shown in Figure 6-59. The bore logs are based on their coordinate locations which have been interpreted on a schematic cross section derived from LiDAR. The bore logs have been projected from the natural surface levels to their indicated depths. It should be noted that bore hole 27 was terminated after a few metres and borehole 27C was completed at a later date to complete the log.

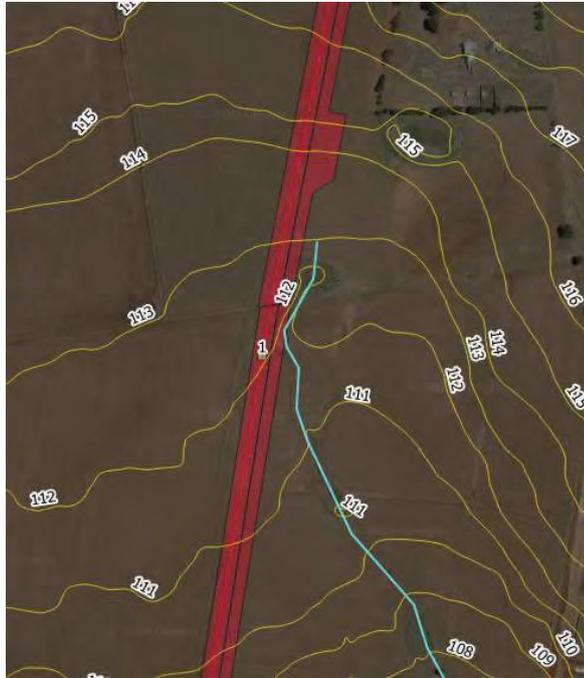
#### Pipe alignment & waterway location

The waterway for Crossing 1 runs relatively straight and discharges into Kororoit Creek to the south-east past Taylors Road. The the APA pipeline does not actually intersect the channel that flows parallel within the works zone near KP 1. The waterway is an underfined channel within a defined valley, with occasional areas of ponding from man made features. The waterway is surrounded by agricultural land, with no discerning vegetation present within the riparian zone. Near the crossing location, the tributary has an averaged grade of 1 in 85. The catchment area upstream of the pipeline crossing is roughly 1.41 km<sup>2</sup>, consisting primarily of agricultural land and scattered rural residential properties.

Location (KP Chainage)	1
Waterway status	Minor gully tributary
Stream Order	1st
Stream type classification	Intact valley fill
Approx. Crossing Length (m)	n/a
Catchment Area (km <sup>2</sup> )	1.41
1 in 100 year Flow (m <sup>3</sup> /s)	4.18
LSIO Impact (1 in 100yr) (m wide)	n/a
River Grade (averaged)	1 in 85
Stream Velocity (m/s)	0.47
Erosion Hazard	Low
Flood Hazard	Low

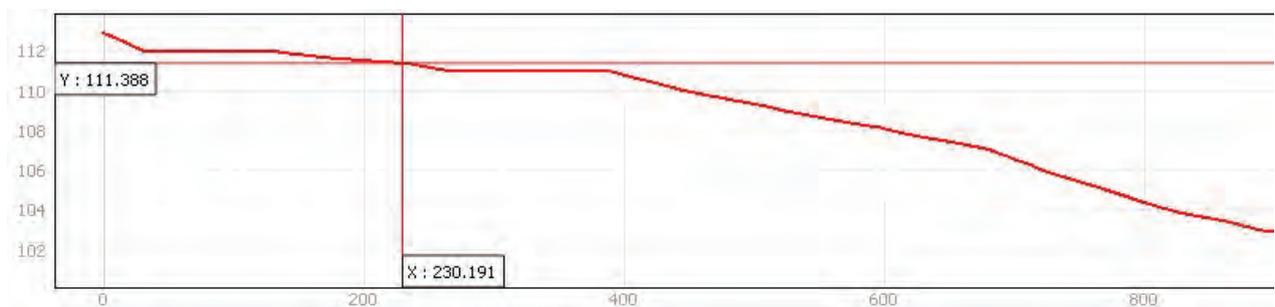
#### Interpreted Longitudinal Profile

Outcome: Standard design, construction methodology and site controls.

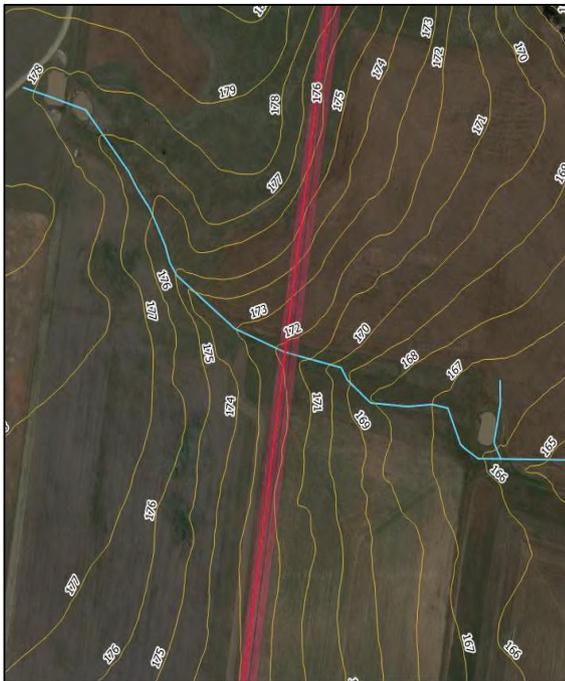
#### Pipe alignment & waterway location

The waterway for Crossing 2 runs relatively straight from a series of agricultural ponds, then flowing into a secondary stream before discharging into Jacksons Creek. The stream intersects perpendicular with the APA pipeline at KP 7.5. The stream's width at the point of crossing is less than 5m, with occasional ponding of water. The stream is an undefined channel with grass coverage and no discernible vegetation has been identified within the riparian zone. Located close to the highest point in the catchment, the stream has an average grade of 1 in 60. The catchment area upstream of the pipeline is 1.33 km<sup>2</sup>, consisting primarily of unpaved, pervious agricultural land.

Location (KP Chainage)	7.5
Waterway status	Minor gully tributary
Stream Order	1st
Stream type classification	Confined discontinuous
Approx. Crossing Length (m)	30
Catchment Area (km <sup>2</sup> )	1.33
1 in 100 year Flow (m <sup>3</sup> /s)	4.04
LSIO Impact (1 in 100yr) (m wide)	n/a
River Grade (averaged)	1 in 60
Stream Velocity (m/s)	0.92
Erosion Hazard	Low
Flood Hazard	Low

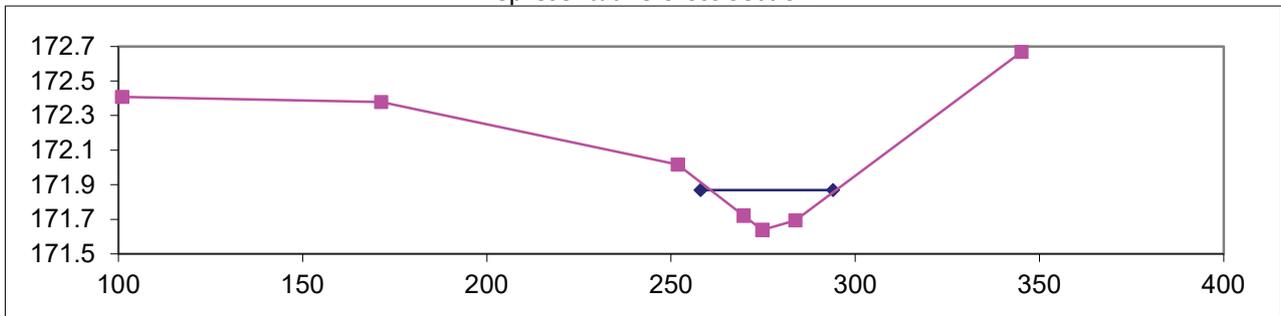
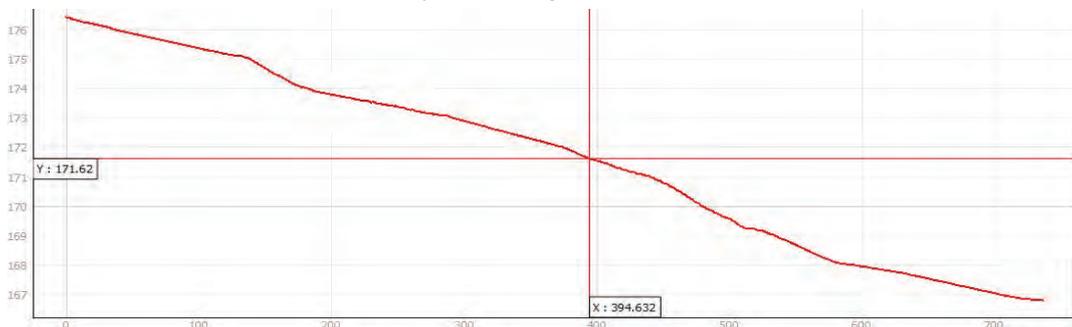
#### Representative Cross Section

#### Interpreted Longitudinal Profile

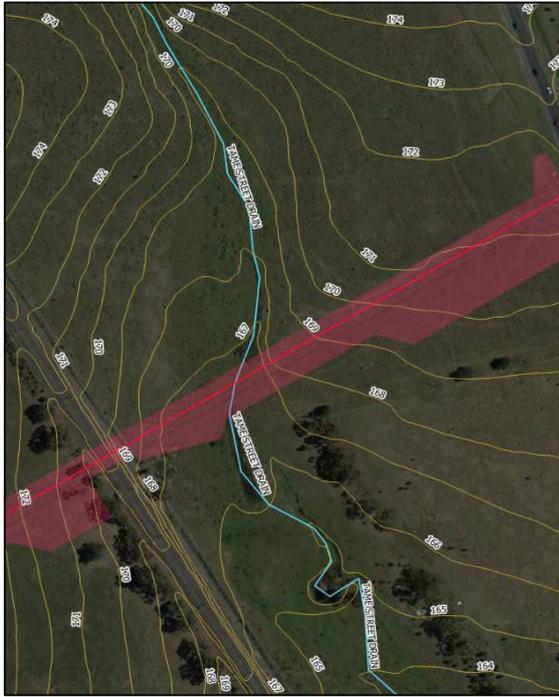
#### Pipe alignment & waterway location

The waterway for Crossing 3, Tame Street Drain, runs relatively straight from Diggers Rest, discharging into Jacksons Creek to the southeast. The drain intersects perpendicular with the APA pipeline at KP 8.36. The drains width at the crossing is around 20 meters and is defined channel with occasional ponding of water. Covered by grass, the drain has no discernible vegetation within the confines of the riparian zone. Near the crossing, the drain has an average grade of 1 in 150. The catchment area upstream of the pipeline crossing is roughly 8.72 km<sup>2</sup> and is 50% residential and 50% agricultural. The residential area of Diggers Rest and the Calder Fwy are located within Tame Street Drain catchment.

Location (KP Chainage)	8.36
Waterway status	Main Drain channel
Stream Order	2nd
Stream type classification	Confined discontinuous
Approx. Crossing Length (m)	< 5
Catchment Area (km <sup>2</sup> )	8.27
1 in 100 year Flow (m <sup>3</sup> /s)	16.9
LSIO Impact (1 in 100yr) (m wide)	80
River Grade (averaged)	1 in 150
Stream Velocity (m/s)	0.87
Erosion Hazard	Potential
Flood Hazard	Potential

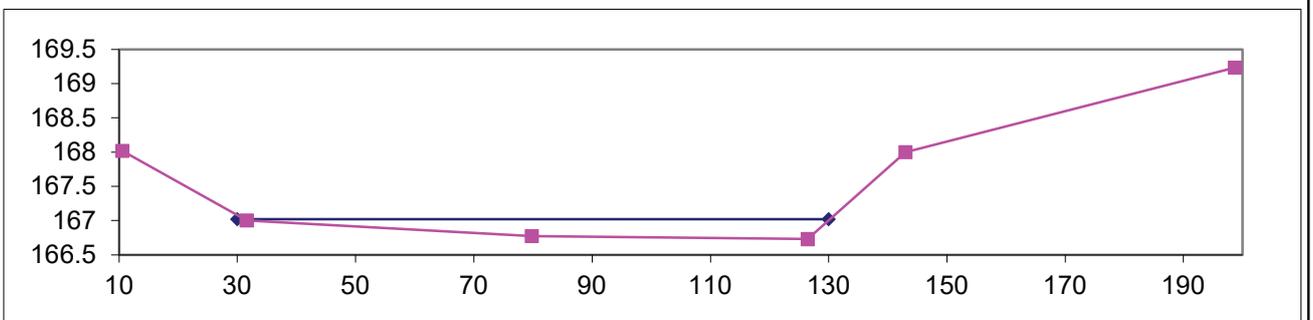
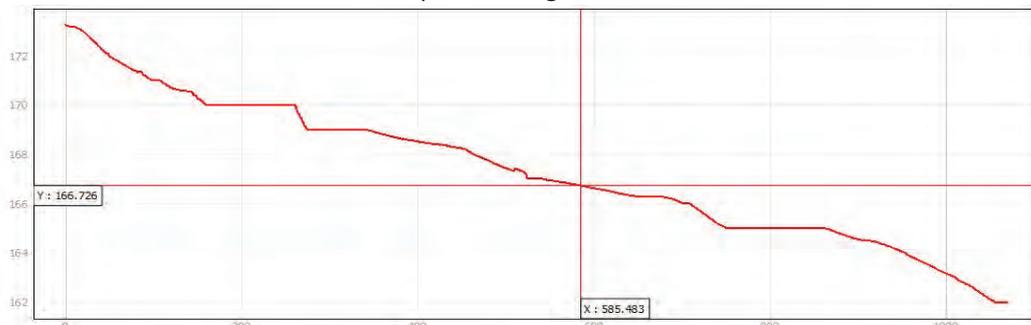
#### Representative Cross Section

#### Interpreted Longitudinal Profile

Outcome: Potential hazard to pipe asset, further assessment required.

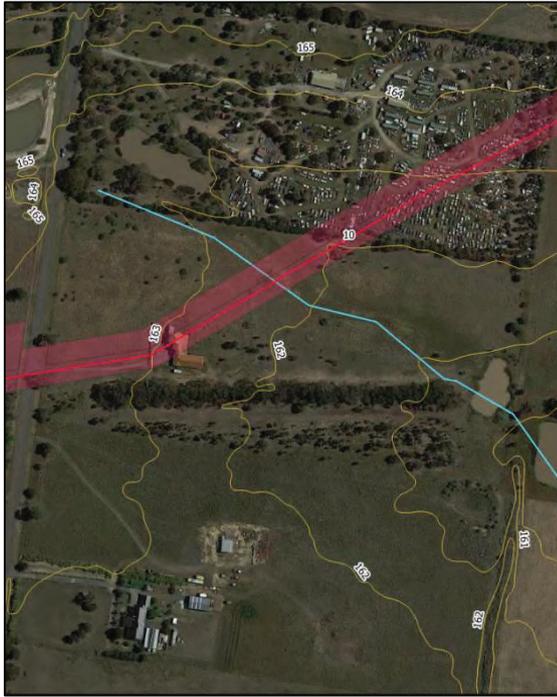
#### Pipe alignment & waterway location

The waterway for Crossing 4 runs relatively straight, east from the Calder Fwy and discharges into Jacksons Creek to the southeast. The tributary intersects perpendicular with the APA pipeline at KP 9.9. The tributaries width at the crossing is approximately 5m, with a minor defined streambed and occasional ponding of flow. Covered by grass, the drain has no discernible vegetation within the confines of the riparian zone. Near the crossing, the drain has a grade of 1 in 100. The catchment area upstream of the pipeline crossing is roughly 2km<sup>2</sup> and is covered predominantly with agricultural land. Minor residences are present within the catchment area though they appear largely unpaved.

Location (KP Chainage)	9.9
Waterway status	Minor gully tributary
Stream Order	1st
Stream type classification	Intact valley fill
Approx. Crossing Length (m)	< 5
Catchment Area (km <sup>2</sup> )	2.00
1 in 100 year Flow (m <sup>3</sup> /s)	5.48
LSIO Impact (1 in 100yr) (m wide)	n/a
River Grade (averaged)	1 in 100
Stream Velocity (m/s)	0.59
Erosion Hazard	Low
Flood Hazard	Low

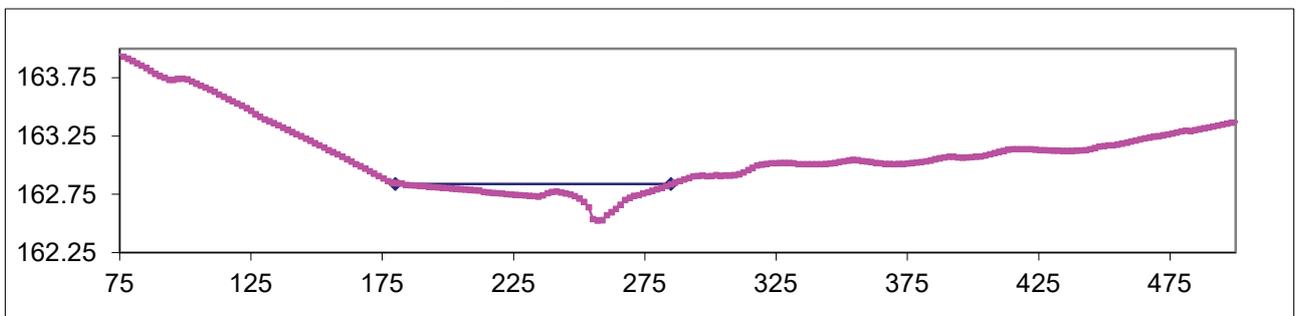
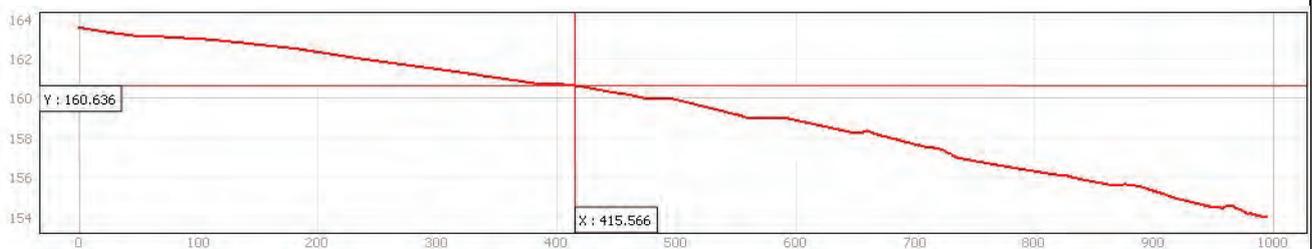
#### Representative Cross Section

#### Interpreted Longitudinal Profile

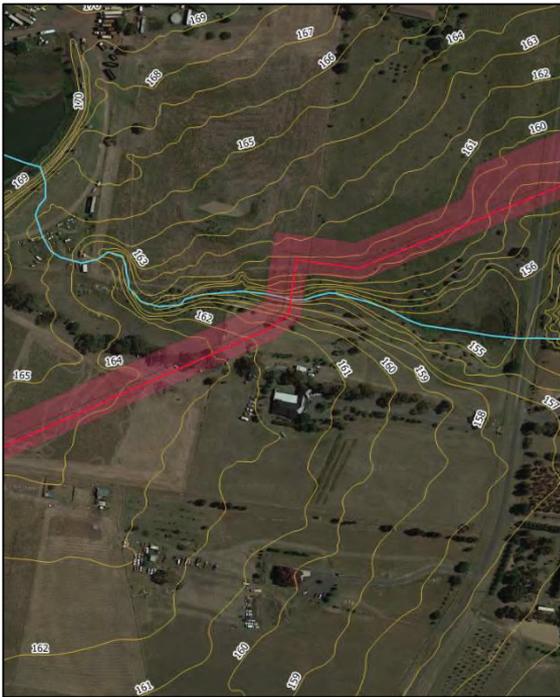
#### Pipe alignment & waterway location

The waterway for Crossing 5 runs south-east, relatively straight from Bulla-Diggers Rest Rd, flowing through a series of ponds into a secondary stream before discharging into Jacksons Creek. The tributary intersects perpendicular with the APA pipeline at KP 10.6. The tributary is an underdefined channel within a defined valley, with occasional ponding of water. The estimated velocity does not take into account the water storage (i.e. ponds, dams). A stream velocity is expected to be much less than 2.02 m/s due to the attenuation of flows along the tributary. The flow path is covered in grass with intermittent vegetation identified within the riparian zone, found primarily around the perimeter of the ponds. Near the crossing, the tributary has an average grade of 1 in 45. The catchment area upstream of the crossing is roughly 2.77 km<sup>2</sup> and is covered predominantly with agricultural land. Minor residencies are present within the catchment area though they appear largely unpaved.

Location (KP Chainage)	10.6
Waterway status	Minor gully tributary
Stream Order	1st
Stream type classification	Confined discontinuous
Approx. Crossing Length (m)	< 5
Catchment Area (km <sup>2</sup> )	2.77
1 in 100 year Flow (m <sup>3</sup> /s)	7.14
LSIO Impact (1 in 100yr) (m wide)	n/a
River Grade (averaged)	1 in 45
Stream Velocity (m/s)	2.02
Erosion Hazard	High
Flood Hazard	Low

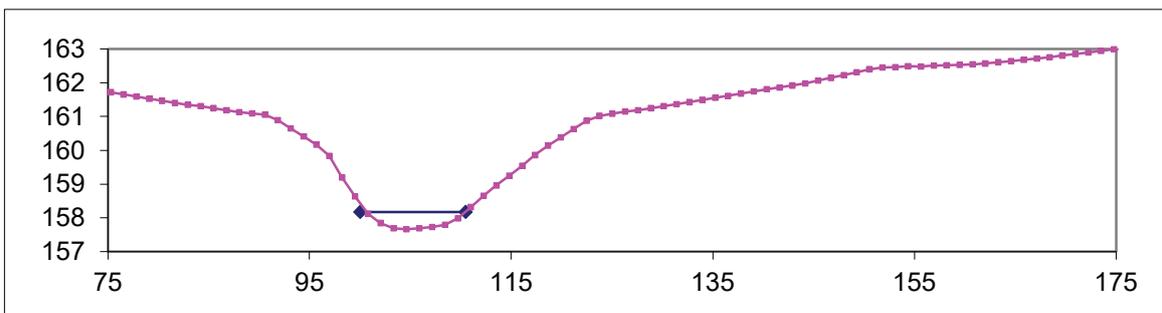
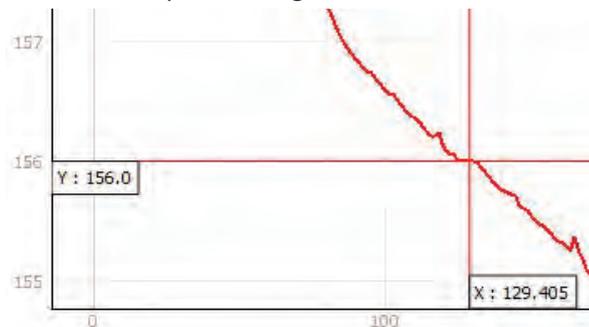
Representative Cross Section

Interpreted Longitudinal Profile

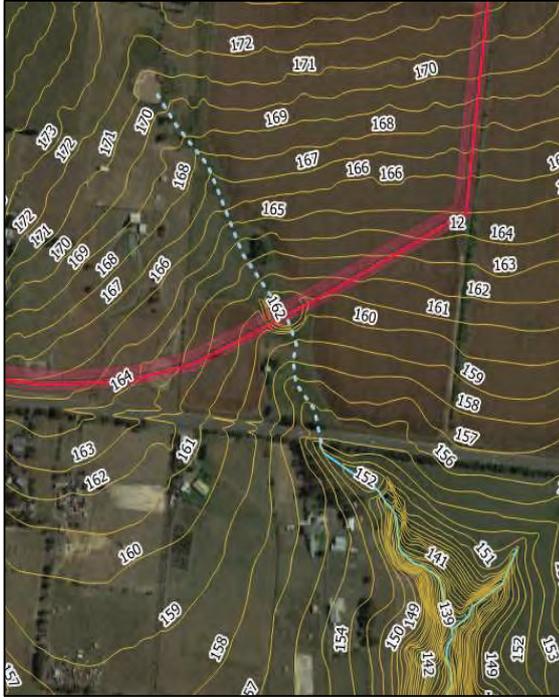
#### Pipe alignment & waterway location

The waterway for Crossing 6 runs south, relatively straight from Bulla-Diggers Rest Rd, flowing through a series of minor dams before discharging into Jacksons Creek. The dam crossing intersects perpendicular with the APA pipeline at KP 11.7. The dam crossing has an approximate width at the intersection of 40m with no defined flow path north of Bulla-Diggers Rest Rd. Definition of flow path increases on the southern side of Bulla-Diggers Rest Rd as the gully increase in steepness. Flow path is covered with grass, with minor vegetation identified within the riparian zone. Near the crossing, the tributary has an average grade of 1 in 40. The catchment area upstream of the crossing is roughly 1.32 km<sup>2</sup> and is covered predominantly with agricultural land.

Location (KP Chainage)	11.7
Waterway status	Minor gully tributary (farm dam )
Stream Order	1st
Stream type classification	Intact valley fill
Approx. Crossing Length (m)	40
Catchment Area (km <sup>2</sup> )	1.32
1 in 100 year Flow (m <sup>3</sup> /s)	3.9
LSIO Impact (1 in 100yr) (m wide)	n/a
River Grade (averaged)	1 in 40
Stream Velocity (m/s)	0.79
Erosion Hazard	Low
Flood Hazard	Low

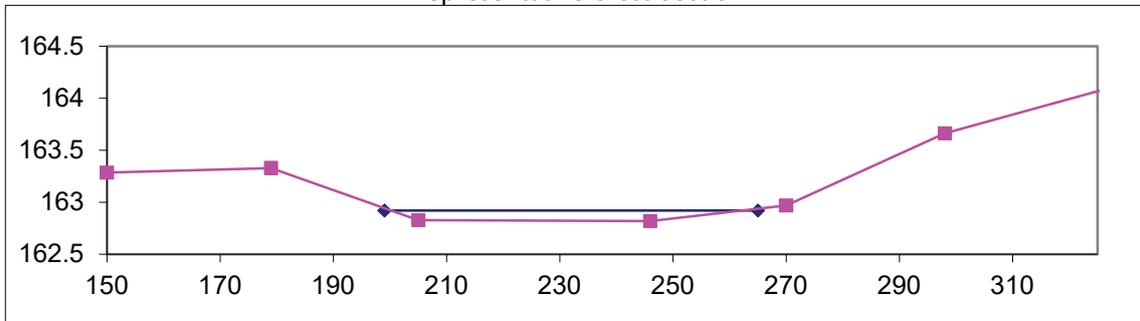
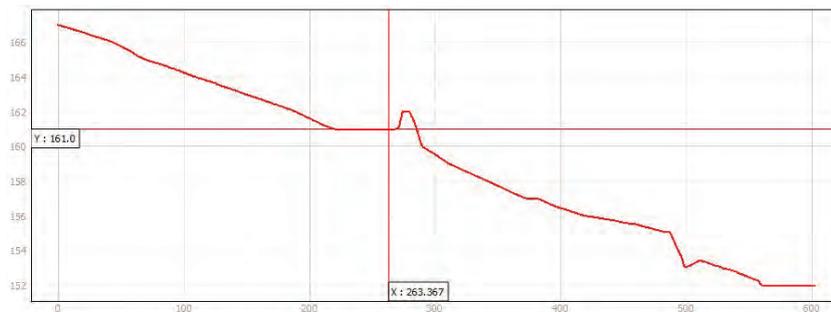
#### Representative Cross Section

#### Interpreted Longitudinal Profile

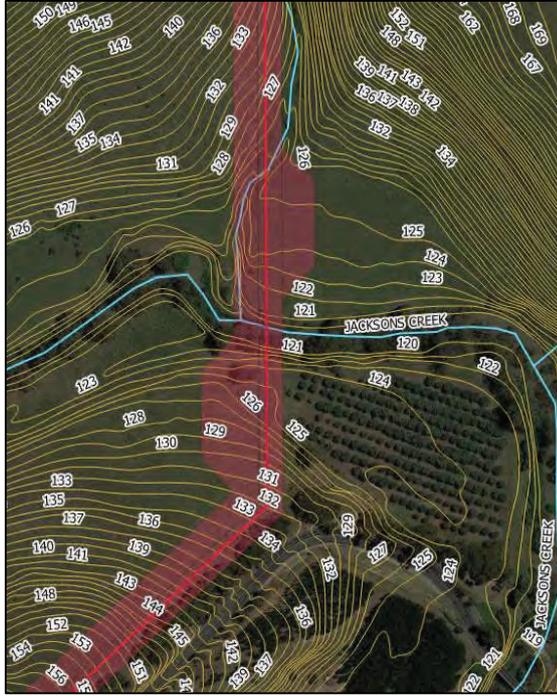
#### Pipe alignment & waterway location

The waterway for Crossing 7, Jacksons Creek, runs south-east, meandering roughly parallel with Sunbury road, discharging into the Maribyrnong River. The crossing intersects perpendicular with the APA pipeline at KP 13.8. The creek has an approximate width at the intersection of 22.8m with a well-defined channel set into steep embankments. The flow path is covered with grass and significant vegetation within the riparian zone. Near the crossing has an average grade of 1 in 75. The catchment area upstream of the crossing is roughly 580 km<sup>2</sup> and is a mix of agricultural land, state park land whilst also capturing some major residential zones such as Sunbury, Gisborne and Macedon.

Location (KP Chainage)	13.8
Waterway status	Major waterway
Stream Order	3rd
Stream type classification	Incised channel
Approx. Crossing Length (m)	22.8
Catchment Area (km <sup>2</sup> )	580.30
1 in 100 year Flow (m <sup>3</sup> /s)	387.93
LSIO Impact (1 in 100yr) (m wide)	100
River Grade (averaged)	1 in 75
Stream Velocity (m/s)	4.53
Erosion Hazard	High
Flood Hazard	High

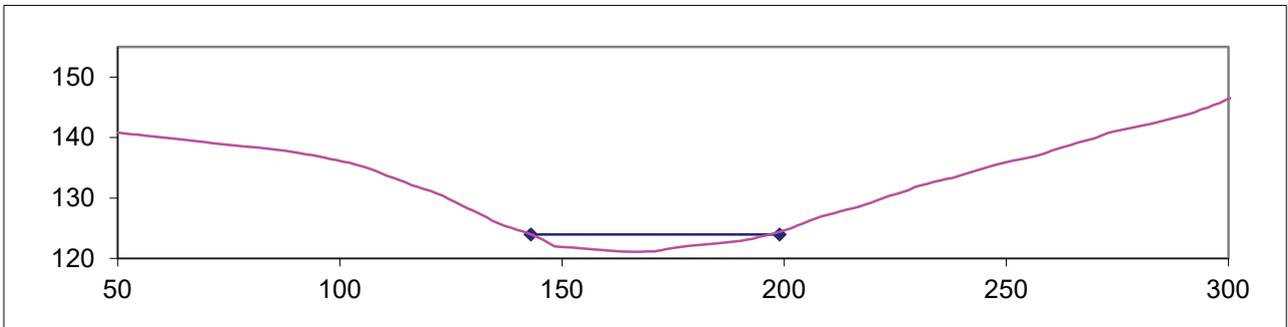
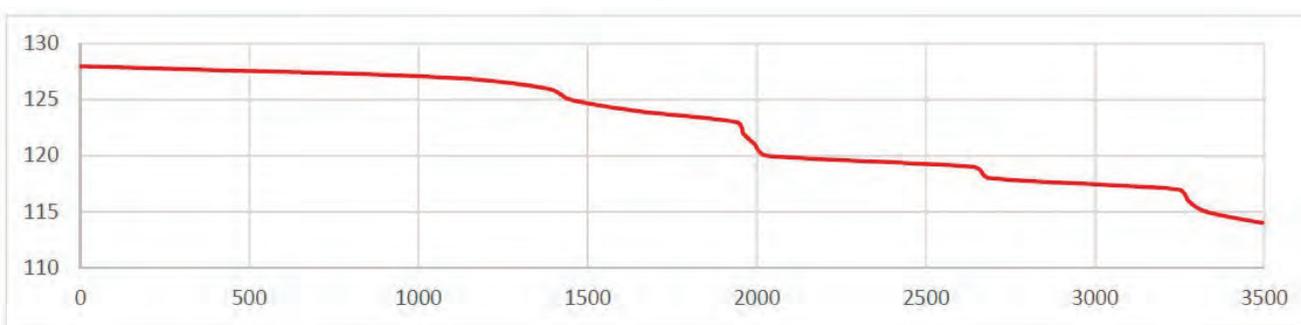
#### Representative Cross Section

#### Interpreted Longitudinal Profile

Outcome: Expected hazard to asset, further assessment required

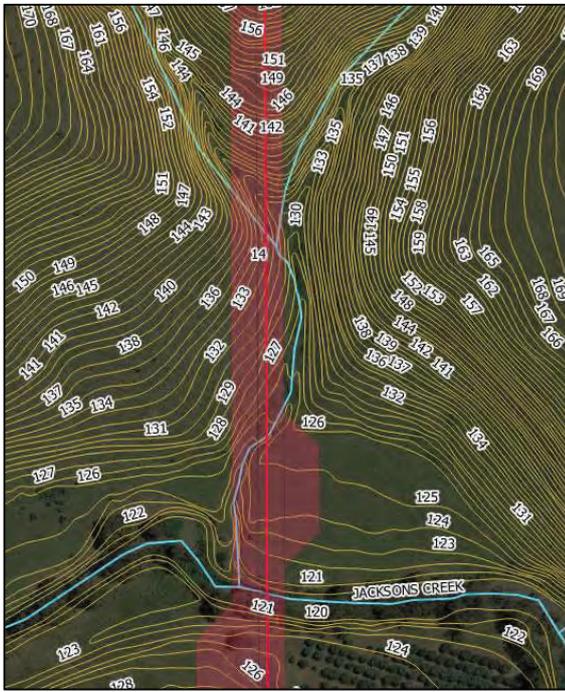
**Pipe alignment & waterway location**

The waterway for Crossing 8 runs south from Sunbury road, relatively straight. The intersection incorporates 2 unnamed 1st order streams which flow into a 2nd order stream before discharging into Jacksons Creek. The tributary intersects with the APA pipeline at KP 13.9 and 14 and runs parallel to the works zone between these 2 points over a distance of 230m. The tributary has an approximate width at the intersection of 15m with minor defined streambed. The stream is grass covered and no discernible vegetation has been identified within the riparian zone. Near the crossing, the tributary has an average grade of 1 in 10. The catchment area upstream of the crossing is roughly 4.36 km<sup>2</sup> and is covered predominantly with agricultural land but also includes a section of Sunbury Rd.

Location (KP Chainage)	14
Waterway status	Gully tributary
Stream Order	2nd
Stream type classification	Confined discontinuous
Approx. Crossing Length (m)	230
Catchment Area (km <sup>2</sup> )	4.36
1 in 100 year Flow (m <sup>3</sup> /s)	10.20
LSIO Impact (1 in 100yr) (m wide)	n/a
River Grade (averaged)	1 in 10
Stream Velocity (m/s)	3.29
Erosion Hazard	High
Flood Hazard	Low
