technical report B  
**surface  
water.**

Environment Effects Statement | May 2021

**western outer  
ring main**

APA VTS (Operations) Pty Ltd  
Western Outer Ring Main Environment Effects Statement  
Surface Water Report

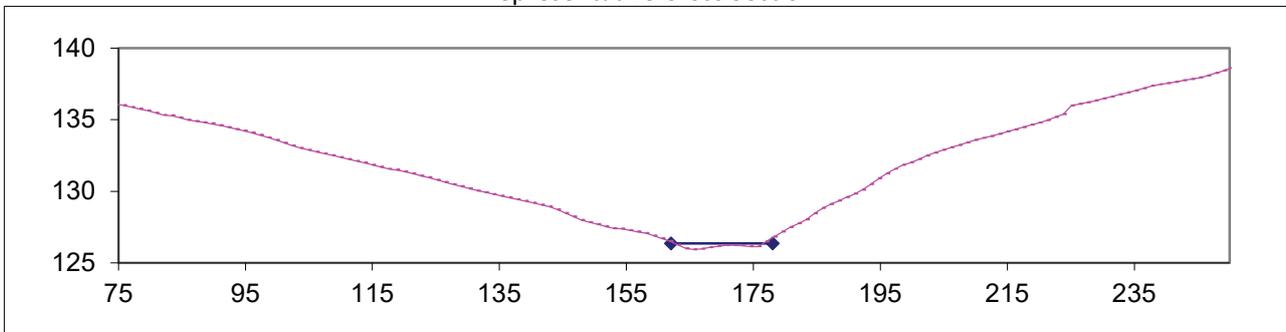
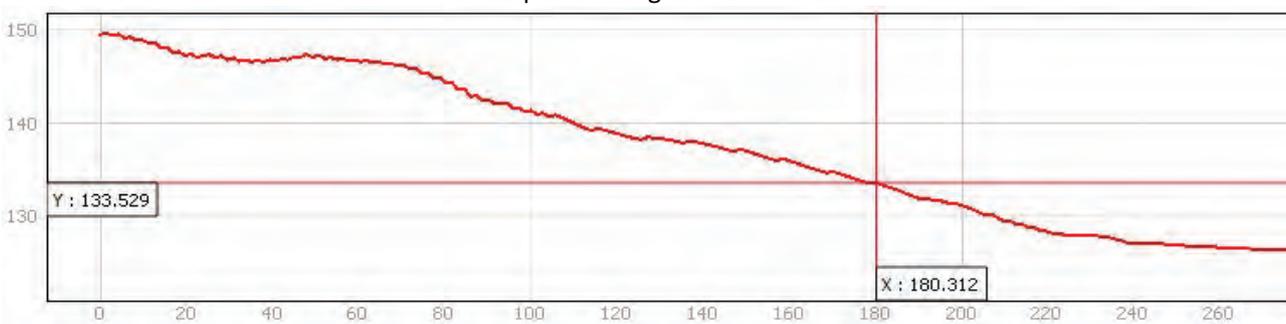
Representative Cross Section

Interpreted Longitudinal Profile

**Outcome:** Expected hazard to asset, further assessment required which will be included within the Jacksons Creek assessment

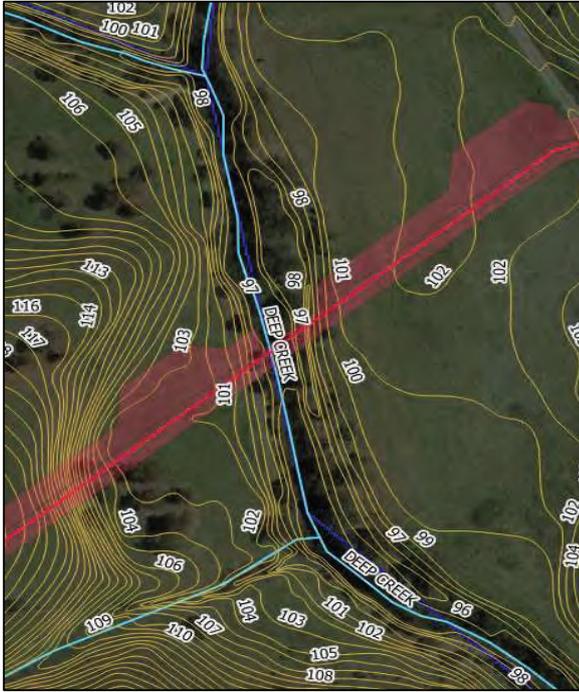
#### Pipe alignment & waterway location

The waterway for Crossing 9, Deep Creek, meanders south from Wildwood Rd towards Sunbury Rd, discharging into the Maribyrnong River. The crossing intersects diagonally with the APA pipeline at KP 17.1. The creek has an approximate width at the intersection of 13.2m with a well-defined channel and a relatively wide flood plain. There is significant vegetation throughout the riparian zone. Near the crossing, the creek has an average grade of 1 in 300. The catchment area upstream of the crossing is roughly 1,356 km<sup>2</sup> and is a mix of agricultural land, state park land whilst also capturing some residential zones such as Romsey and Lancefield.

Location (KP Chainage)	17.1
Waterway status	Major waterway
Stream Order	5th
Stream type classification	Incised Channel
Approx. Crossing Length (m)	13.2
Catchment Area (km <sup>2</sup> )	1356.00
1 in 100 year Flow (m <sup>3</sup> /s)	570.00
LSIO Impact (1 in 100yr) (m wide)	300
River Grade (averaged)	1 in 300
Stream Velocity (m/s)	1.80
Erosion Hazard	High
Flood Hazard	High

Deep Creek	<p><b>Geotechnical</b> – Erosive soils (gravels) in upper profile, and no depth to basalt was encountered.</p> <p><b>Waterway</b> - Perennially flowing, generally passive flow conditions with minor riffle sequences along the reach defined by a rock outcrop control ~200m downstream.</p> <p><b>Water Quality and beneficial uses</b> –Water quality samples collected from the upstream gauges had elevated concentrations of turbidity, nitrate, total nitrogen, phosphate, total phosphorus, chromium, copper, lead, nickel and zinc. The upstream gauges are located within an agricultural catchment where elevated levels of nitrogen and phosphorus may be present. The downstream gauge provided similar results to the upstream gauges but with noncompliant electrical conductivity and pH.</p> <p>Beneficial Uses downstream may include water dependent ecosystems and species, agriculture and irrigation, water-based recreation (aesthetic enjoyment) and Traditional Owner cultural values</p> <p><b>Geomorphology</b> – Stable configuration of stream, with some minor lateral widening, but no significant change in stream morphology in 50 years. Slightly meandering low flow with stable bar configuration and ephemeral parallel secondary channel occupied in moderate floods. Deep scour common in secondary channels and if disturbed could trigger a permanent change in the main flow path.</p>

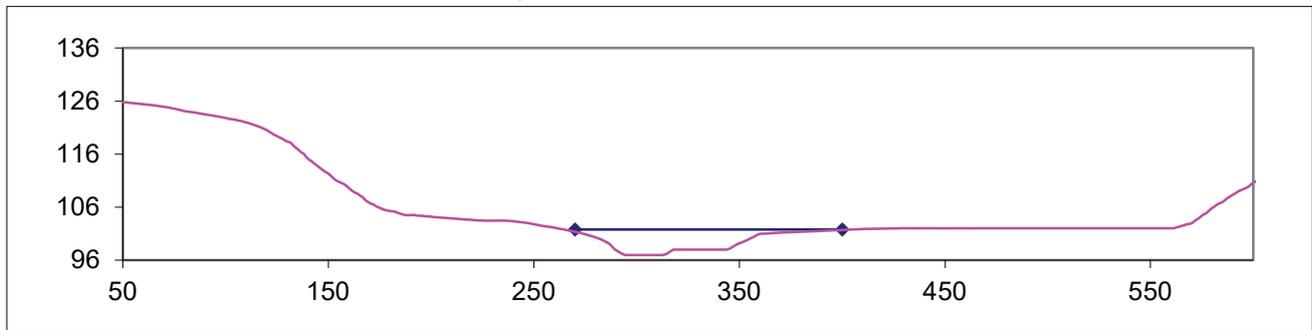
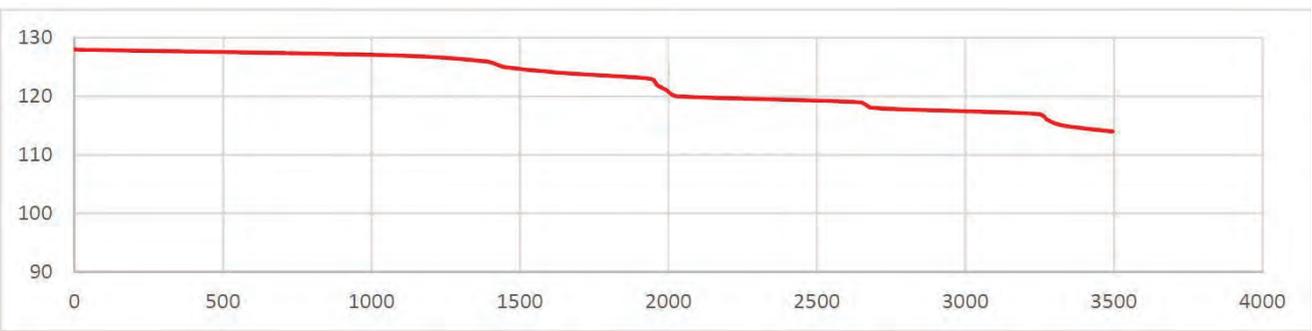
#### Representative Cross Section

#### Interpreted Longitudinal Profile

Outcome: Potential hazard to asset, further assessment required.

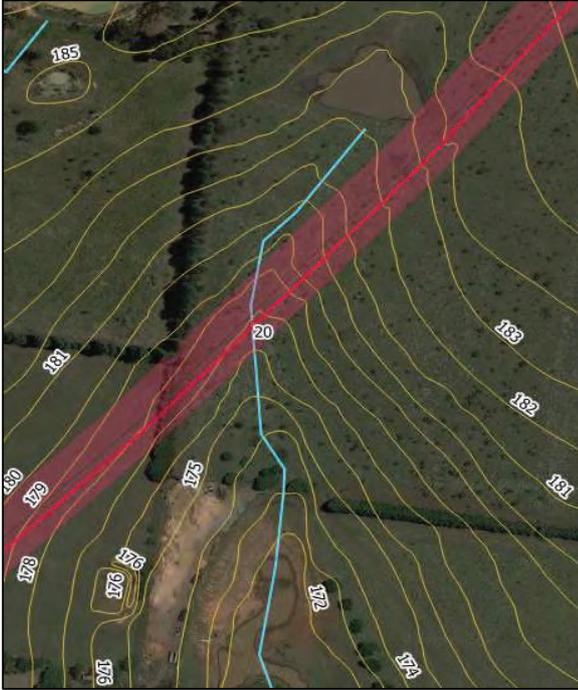
#### Pipe alignment & waterway location

The waterway for Crossing 10 runs south, relatively straight between Wildwood Rd and Oaklands, flowing through a series of ponds before discharging into Moonee Ponds Creek. The tributary intersects diagonally with the APA pipeline at KP 19.5. The tributary is an undefined channel within a defined valley with occasional ponding of water. Flow path is covered with grass with no discernible vegetation within the confines of the riparian zone. Near the crossing, the tributary has an average grade of 1 in 35. The catchment area upstream of the crossing is roughly 0.68 km<sup>2</sup> and is covered predominantly with agricultural land.

Location (KP Chainage)	19.5
Waterway status	Minor gully tributary
Stream Order	1st
Stream type classification	Confined discontinuous
Approx. Crossing Length (m)	< 5
Catchment Area (km <sup>2</sup> )	0.68
1 in 100 year Flow (m <sup>3</sup> /s)	3.22
LSIO Impact (1 in 100yr) (m wide)	n/a
River Grade (averaged)	1 in 35
Stream Velocity (m/s)	1.37
Erosion Hazard	Potential
Flood Hazard	Low

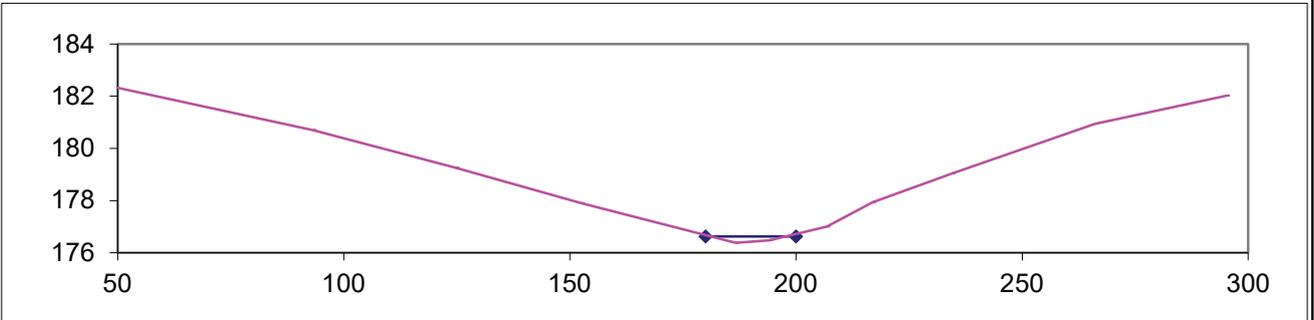
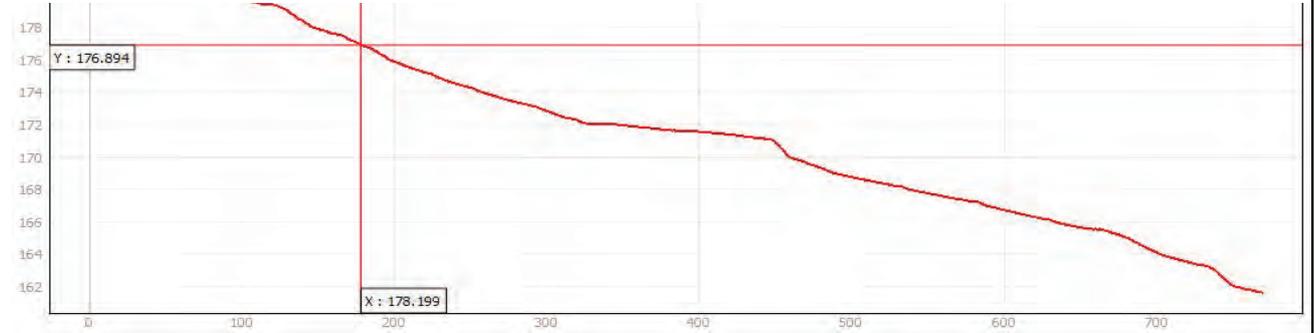
#### Representative Cross Section

#### Interpreted Longitudinal Profile

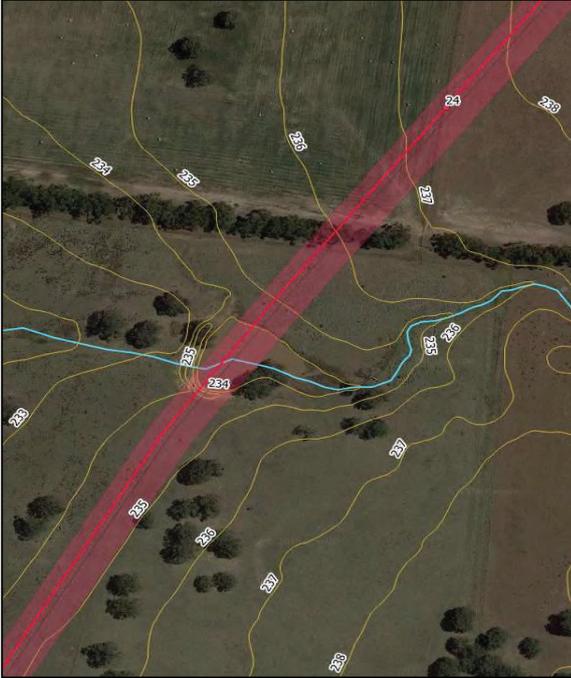
#### Pipe alignment & waterway location

The waterway for Crossing 11 runs north-west, relatively straight from Mickleham Rd towards Konagaderra Rd, flowing through a series of ponds before discharging into Deep Creek. This intersection sees the pipeline run through a pond of width 55m at KP 23.4. The waterway is covered with grass and minor vegetation is found within the confines of the riparian zone. Near the crossing, the tributary has an average grade of 1 in 110. The catchment area upstream of the crossing is roughly 3.16 km<sup>2</sup> and is covered predominantly with agricultural land.

Location (KP Chainage)	23.4
Waterway status	Minor gully tributary (farm dam)
Stream Order	1st
Stream type classification	Confined discontinuous
Approx. Crossing Length (m)	55
Catchment Area (km <sup>2</sup> )	3.16
1 in 100 year Flow (m <sup>3</sup> /s)	7.93
LSIO Impact (1 in 100yr) (m wide)	n/a
River Grade (averaged)	1 in 110
Stream Velocity (m/s)	1.10
Erosion Hazard	Potential
Flood Hazard	Low

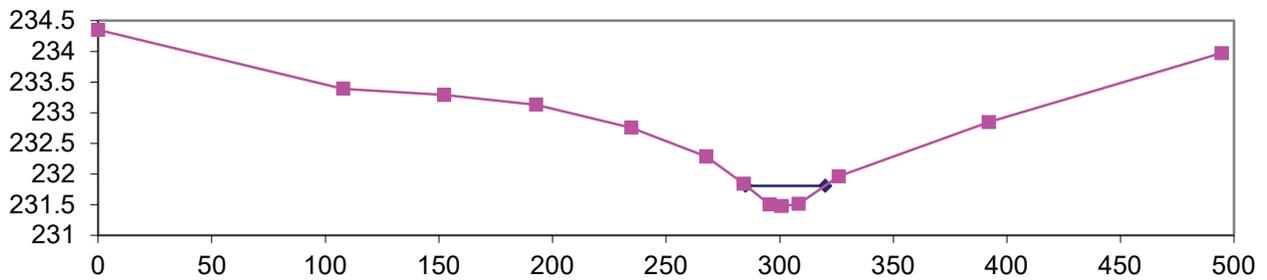
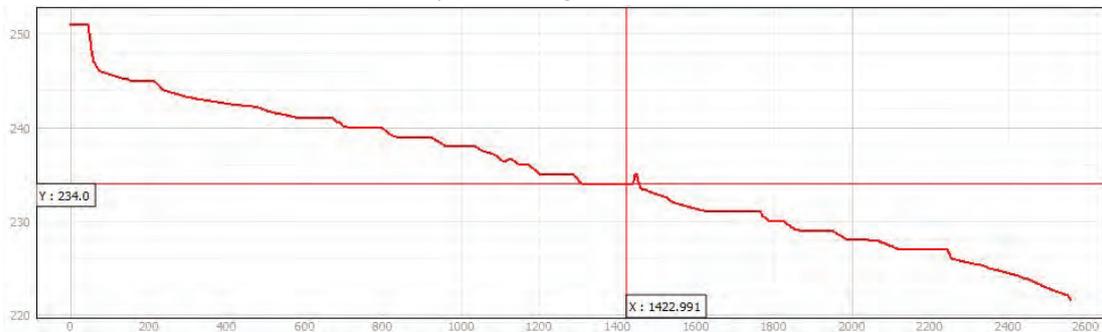
#### Representative Cross Section

#### Interpreted Longitudinal Profile

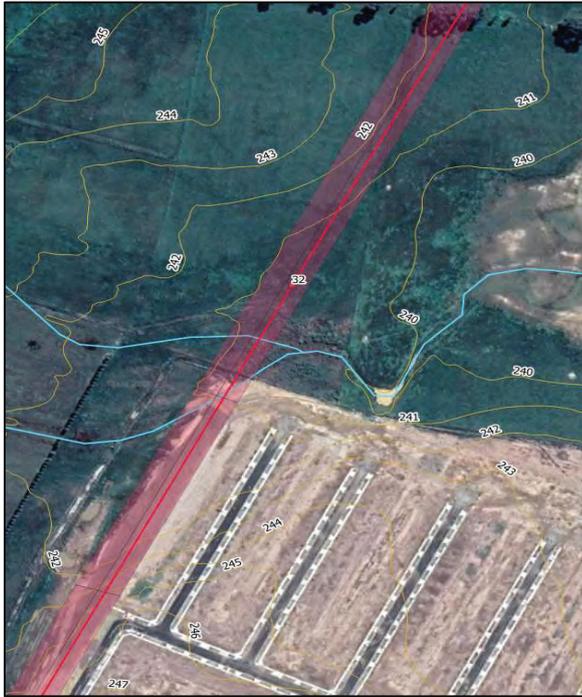
#### Pipe alignment & waterway location

The waterway for Crossing 12 runs north-east, relatively straight from Old Sydney Rd, flowing through a series of ponds before discharging into a reservoir. There are 2, 1st order tributaries intersecting with the APA pipeline at KP 31.9. Both tributaries have an approximate width at the intersection of 5m and is either an undefined channel or is obstructed by a newly developed residential area. The stream is grass covered and no discernible vegetation has been identified. Near the crossing, the tributary has an average grade of 1 in 60. The catchment area upstream of the crossing is roughly 1.80 km<sup>2</sup> and is covered predominantly with agricultural land. Merrifield development is situated southeast of the intersection on the border of this catchment and possibly affects the flow at this intersection.

Location (KP Chainage)	31.9
Waterway status	minor tributary
Stream Order	1st
Stream type classification	Confined discontinuous
Approx. Crossing Length (m)	< 5
Catchment Area (km <sup>2</sup> )	1.80
1 in 100 year Flow (m <sup>3</sup> /s)	5.43
LSIO Impact (1 in 100yr) (m wide)	n/a
River Grade (averaged)	1 in 60
Stream Velocity (m/s)	0.48
Erosion Hazard	Low
Flood Hazard	Low

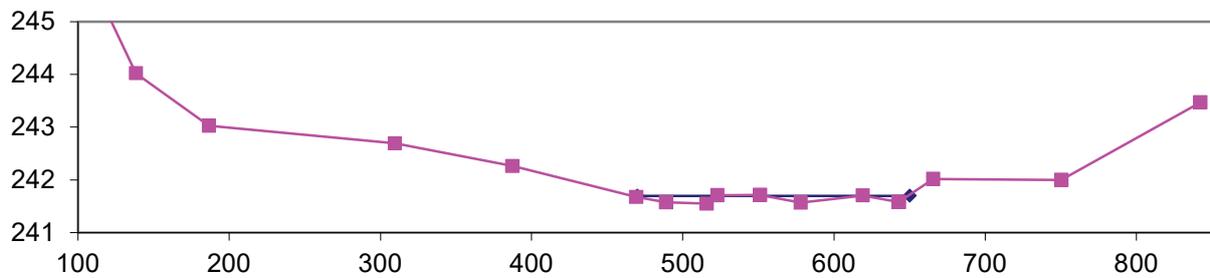
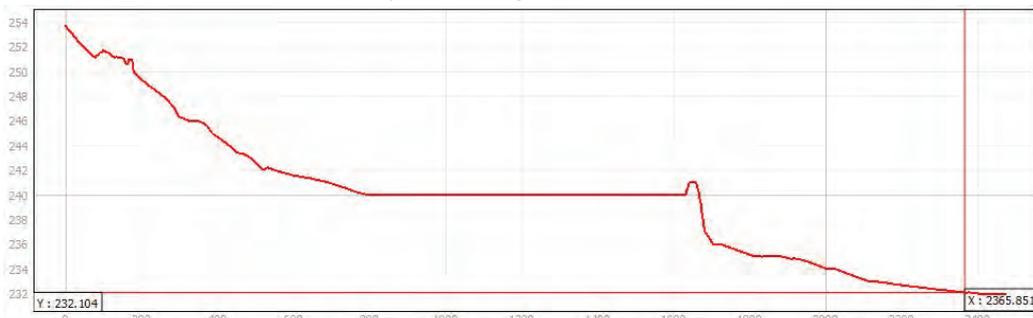
#### Representative Cross Section

#### Interpreted Longitudinal Profile

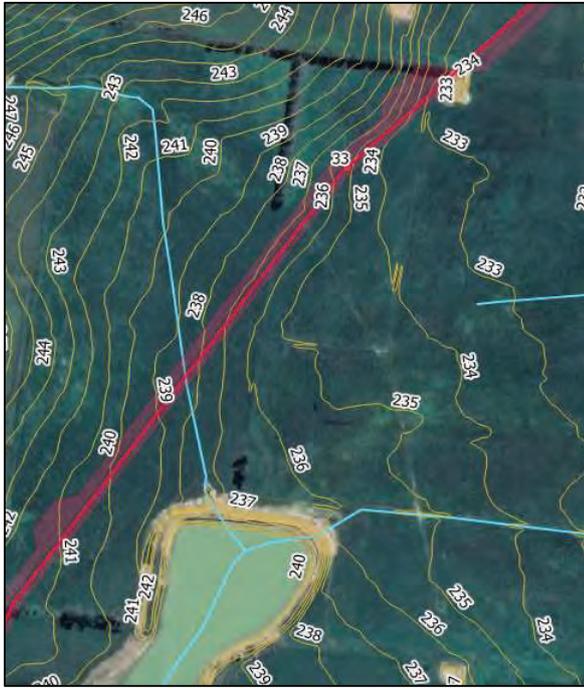
#### Pipe alignment & waterway location

The waterway for Crossing 13 runs southeast, relatively straight from Old Sydney Rd, flowing through a series of dams before discharging into a reservoir. The tributary intersects perpendicularly with the with the APA pipeline at KP 32.6. The tributary is an underdefined channel which has an approximate width at the intersection of 5m. The stream is grass covered and no discernible vegetation. Near the crossing, the tributary has an average grade of 1 in 50. The catchment area upstream of the crossing is roughly 1.31 km<sup>2</sup> and is covered predominantly with agricultural land.

Location (KP Chainage)	32.6
Waterway status	minor tributary
Stream Order	1st
Stream type classification	Confined discontinuous
Approx. Crossing Length (m)	< 5
Catchment Area (km <sup>2</sup> )	1.31
1 in 100 year Flow (m <sup>3</sup> /s)	3.74
LSIO Impact (1 in 100yr) (m wide)	n/a
River Grade (averaged)	1 in 50
Stream Velocity (m/s)	1.80
Erosion Hazard	Potential
Flood Hazard	Low

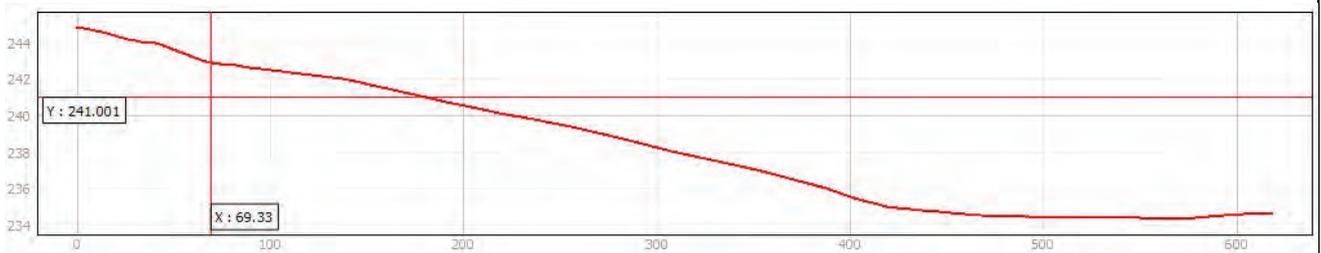
#### Interpreted Longitudinal Profile

Outcome: Standard design, construction methodology and site controls.

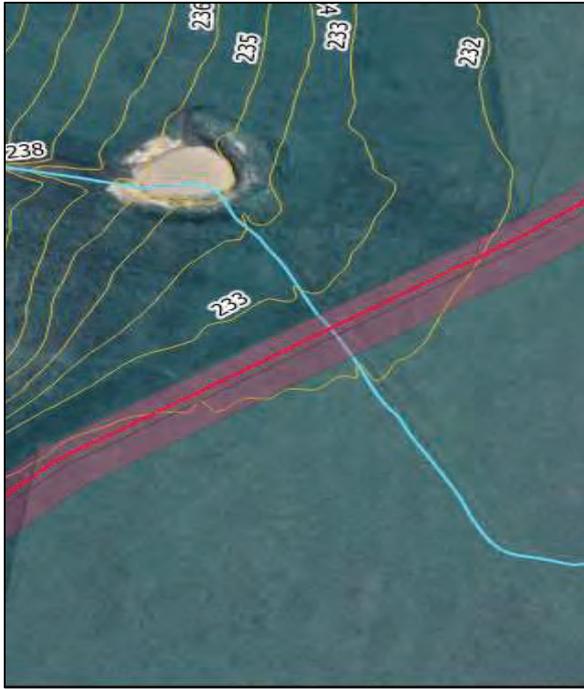
#### Pipe alignment & waterway location

The waterway for Crossing 14 runs south-east, relatively straight from Old Sydney Rd, flowing through a series of ponds then connecting to a series of irrigation channels before discharging into the Kalkallo Creek. The tributary intersects perpendicularly with the APA pipeline at KP 33.7. The tributary is an undefined channel with a width at the intersection of less than 5m. The stream is grass covered and no discernible vegetation has been identified near the tributary. Near the crossing, the tributary has an average grade of 1 in 65. The catchment area upstream of the crossing is roughly 0.88 km<sup>2</sup> and is covered predominantly with agricultural land.

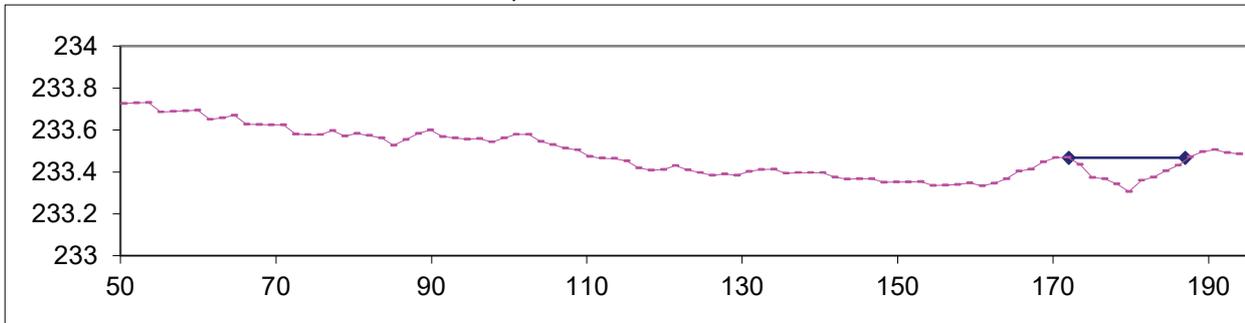
#### Representative Cross Section

Location (KP Chainage)	33.7
Waterway status	Gully stream
Stream Order	1st
Stream type classification	Confined discontinuous
Approx. Crossing Length (m)	< 5
Catchment Area (km <sup>2</sup> )	0.88
1 in 100 year Flow (m <sup>3</sup> /s)	3.74
LSIO Impact (1 in 100yr) (m wide)	n/a
River Grade (averaged)	1 in 65
Stream Velocity (m/s)	0.64
Erosion Hazard	Low
Flood Hazard	Low

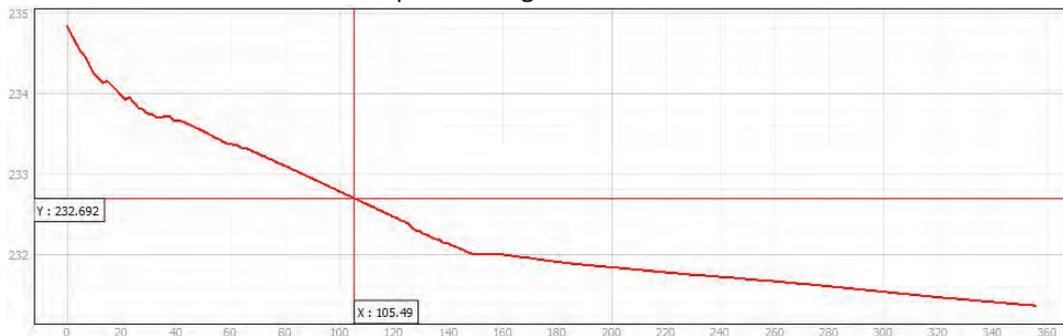
#### Interpreted Longitudinal Profile

Outcome: Standard design, construction methodology and site controls.

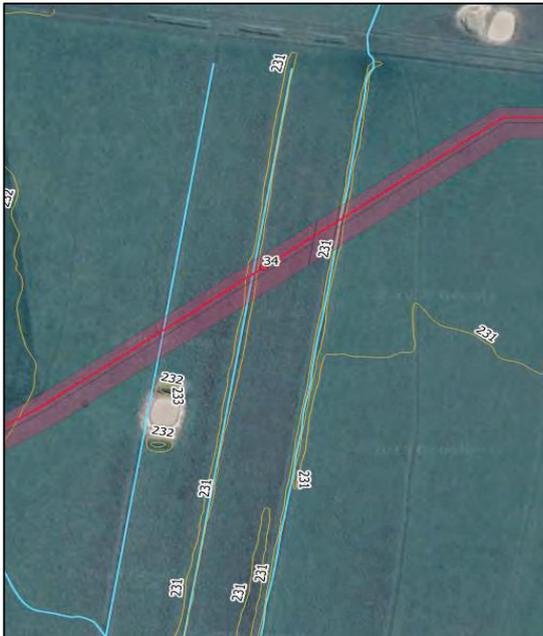
#### Pipe alignment & waterway location

The waterway for Crossing 15 contains 3 agricultural drains and runs south, straight from Gunns Gully Rd towards Donnybrook Rd. Two 1st order drains (KP 33.9 and KP 34) flow into a 2nd order drain (KP 34.1), which discharges into Kalkallo Creek. The drains intersect diagonally with the with the APA pipeline at KP 33.9-34.1. The drains are defined channels which have an approximate width at the intersection of 5m. The drains are used for conveying water across a large retarding basin which is inundated with flood waters up to 231.5 mAHD in a 1 in 100 year ARI flood event. Therefore, the depth of water is at least 1m at the crossing. The retarding basin has an embankment wall further to the south of the crossing. The two 1st order drains are grass covered and no discernible vegetation has been identified within flood plain. The 2nd order drain is grass covered with intermittent vegetation identified upstream of the intersection within the riparian zone. Near the crossing, the tributary has an average grade of 1 in 1200. The catchment area upstream of the crossing is roughly 3.18 km<sup>2</sup> and is covered predominantly with agricultural land.

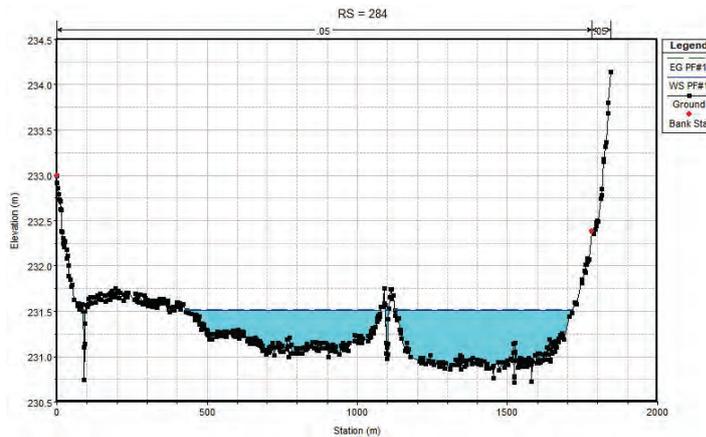
#### Representative Cross Section

Location (KP Chainage)	33.9 - 34.1
Waterway status	Constructed drains
Stream Order	1st & 2nd
Stream type classification	straightened channelised
Approx. Crossing Length (m)	< 5
Catchment Area (km <sup>2</sup> )	3.18
1 in 100 year Flow (m <sup>3</sup> /s)	8.54
LSIO Impact (1 in 100yr) (m wide)	1000
River Grade (averaged)	1 in 1200
Stream Velocity (m/s)	0.25
Erosion Hazard	Low
Flood Hazard	High

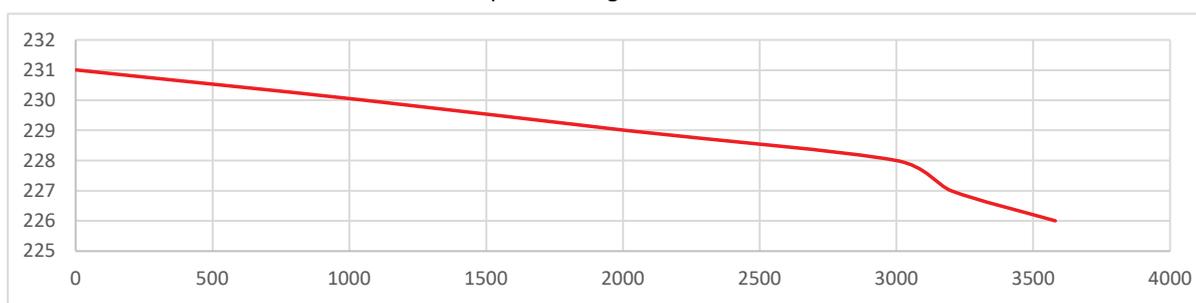
#### Interpreted Longitudinal Profile

Outcome: Potential hazard to asset, further assessment required which will be included within the Kalkallo Creek assessment.

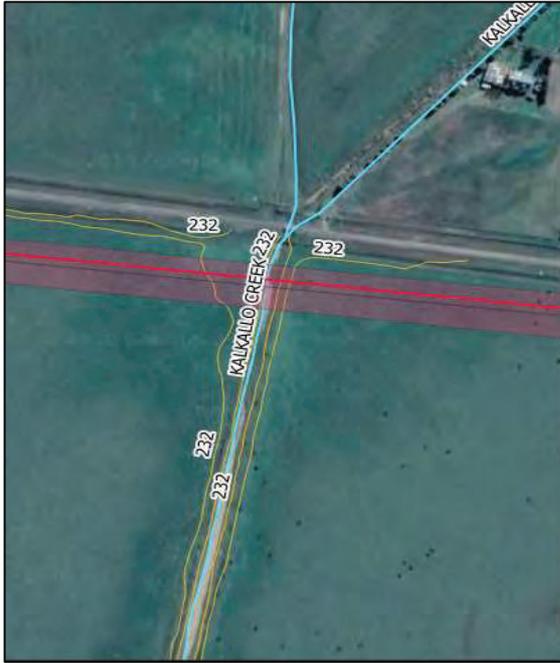
#### Pipe alignment & waterway location

The waterway for Crossing 16, Kalkallo Creek, runs south, relatively straight from Old Sydney Rd, parallel to the Hume Hwy, flowing through a series of dams and discharging into Merri Creek. The creek intersects perpendicular with the APA pipeline at KP 34.5. The creek is an defined channel which has an approximate width at the intersection of 10m. The drains are used for conveying water across a large retarding basin which is inundated with flood waters up to 231.5 mAHD in a 1 in 100 year ARI flood event. Therefore, the depth of water is at least 1m at the crossing. The retarding basin has an embankment wall further to the south of the crossing. The creek is grass covered and vegetation has been identified within the riparian zone upstream and downstream of the intersection. Near the crossing location, the creek has an average grade of 1 in 600. The catchment area upstream of the crossing is roughly 25.4 km<sup>2</sup> and is covered predominantly with agricultural land.

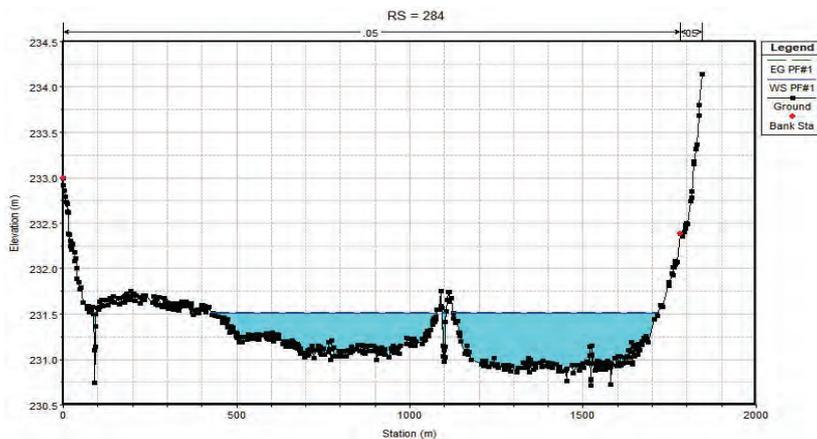
#### Representative Cross Section

Location (KP Chainage)	34.5
Waterway status	Constructed Drain
Stream Order	3rd
Stream type classification	straightened channelised
Approx. Crossing Length (m)	10
Catchment Area (km <sup>2</sup> )	25.40
1 in 100 year Flow (m <sup>3</sup> /s)	71.80
LSIO Impact (1 in 100yr) (m wide)	1000
River Grade (averaged)	1 in 600
Stream Velocity (m/s)	0.29
Erosion Hazard	Potential
Flood Hazard	High

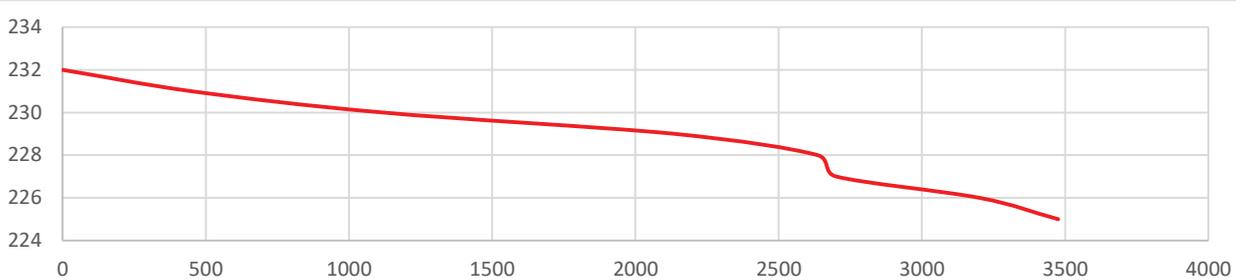
#### Interpreted Longitudinal Profile

Outcome: Potential hazard to asset, further assessment required.

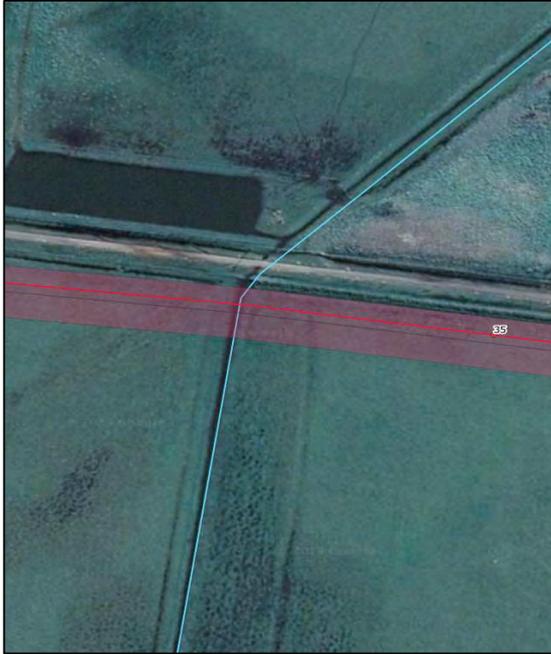
#### Pipe alignment & waterway location

The waterway for Crossing 17 runs south, relatively straight between Old Sydney Rd and the Hume Hwy. Flowing through a series of dams and a small residential development, this drain discharges into Kalkallo Creek, which discharges into Merri Creek. The drain intersects perpendicularly with the APA pipeline at KP 34.9. The drain has a defined channel with an approximate width at the intersection of 5m. The drains are used for conveying water across a large retarding basin which is inundated with flood waters up to 231.5 mAHD in a 1 in 100 year ARI flood event. Therefore, the depth of water is at least 1m at the crossing. The retarding basin has an embankment wall further to the south of the crossing. The drain is grass covered with no significant vegetation identified within the riparian zone. Near the crossing location, the drain has an average grade of 1 in 360. The catchment area upstream of the crossing is roughly 11.8 km<sup>2</sup> and covered predominantly with agricultural land but also contains a minor residential development.

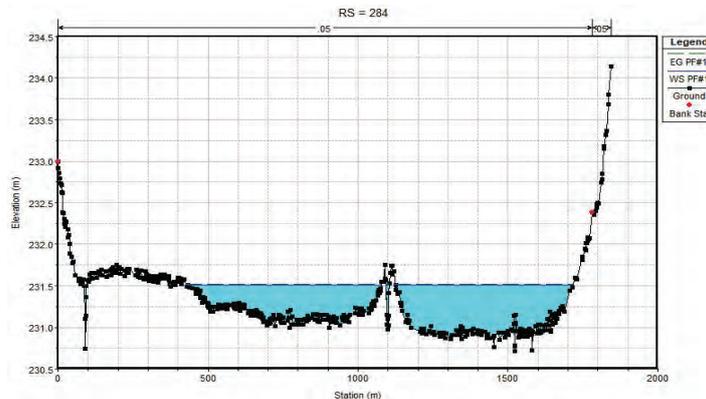
#### Representative Cross Section

Location (KP Chainage)	34.9
Waterway status	Constructed Drain
Stream Order	3rd
Stream type classification	straightened channelised
Approx. Crossing Length (m)	< 5
Catchment Area (km <sup>2</sup> )	11.80
1 in 100 year Flow (m <sup>3</sup> /s)	23.00
LSIO Impact (1 in 100yr) (m wide)	1000
River Grade (averaged)	1 in 360
Stream Velocity (m/s)	0.21
Erosion Hazard	Low
Flood Hazard	High

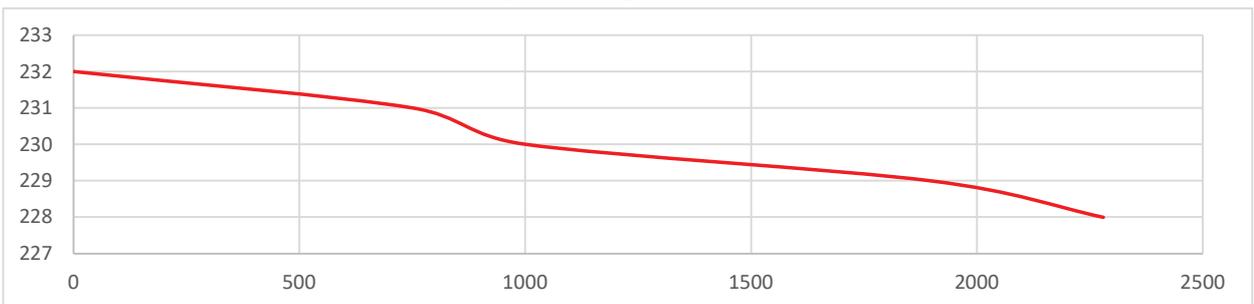
#### Interpreted Longitudinal Profile

Outcome: Potential hazard to asset, further assessment required which will be included within the Kalkallo Creek assessment.

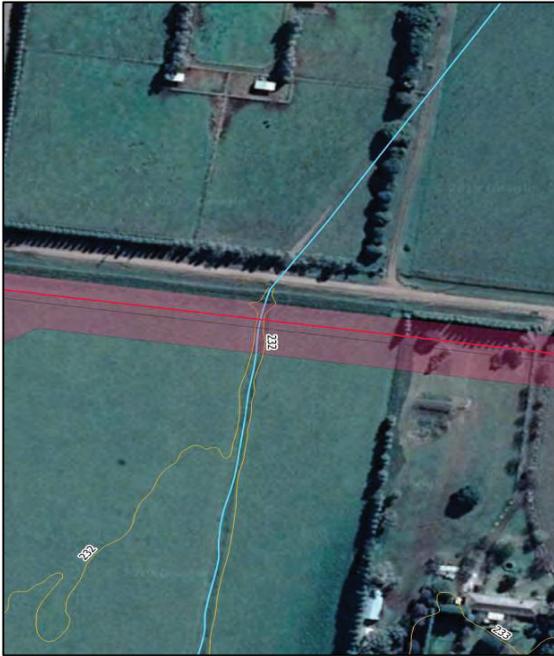
#### Pipe alignment & waterway location

The waterway for Crossing 18 runs south, relatively straight between Old Sydney Rd and the Hume Hwy. Flowing through a series of dams and a small residential development, this drain discharges into the Kalkallo Creek, which discharges into Merri Creek. The drain intersects perpendicularly with the with the APA pipeline at KP 35.5. The drain has a defined channel with an approximate width at the intersection of 5m. The drains are used for conveying water across a large retarding basin which is inundated with flood waters up to 231.5 mAHD in a 1 in 100 year ARI flood event. Therefore, the depth of water is at least 1m at the crossing. The retarding basin has an embankment wall further to the south of the crossing. The drain is grass covered with no significant vegetation identified within the riparian zone. Near the crossing location, the drain has an average grade of 1 in 320. The catchment area upstream of the crossing is roughly 11.8 km<sup>2</sup> and covered predominantly with agricultural land but also contains a minor residential development.

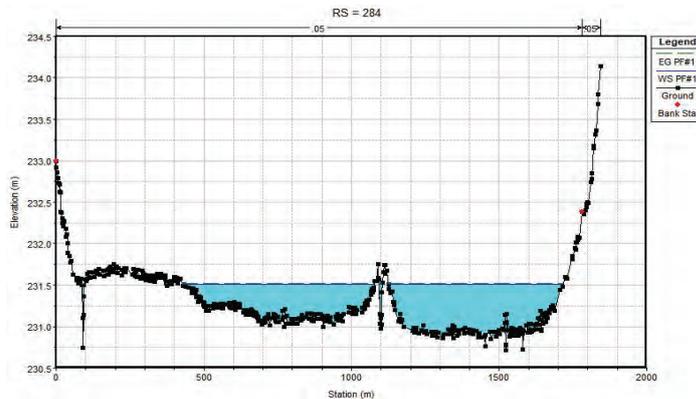
#### Representative Cross Section

Location (KP Chainage)	35.5
Waterway status	Constructed Drain
Stream Order	2nd
Stream type classification	straightened channelised
Approx. Crossing Length (m)	< 5
Catchment Area (km <sup>2</sup> )	11.80
1 in 100 year Flow (m <sup>3</sup> /s)	22.90
LSIO Impact (1 in 100yr) (m wide)	1000
River Grade (averaged)	1 in 320
Stream Velocity (m/s)	0.20
Erosion Hazard	Low
Flood Hazard	High

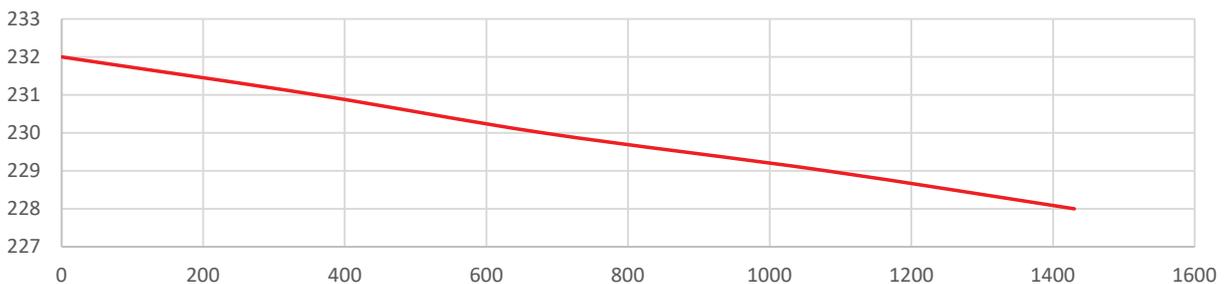
#### Interpreted Longitudinal Profile

**Outcome:** Potential hazard to asset, further assessment required which will be included within the Kalkallo Creek assessment.

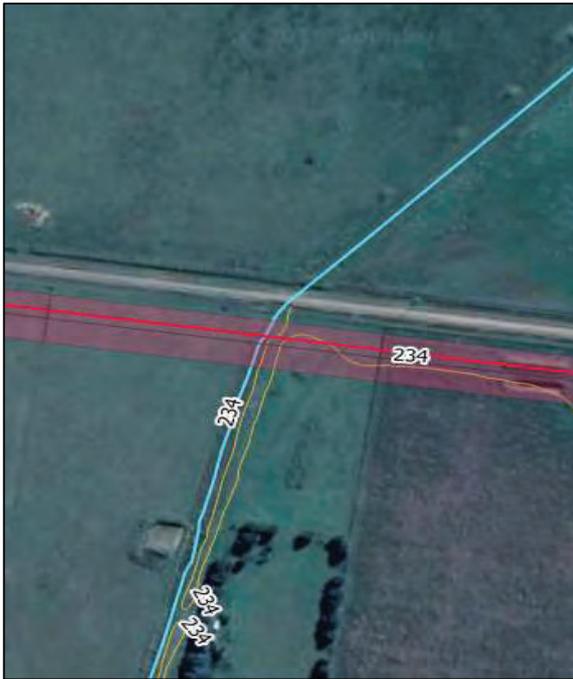
#### Pipe alignment & waterway location

The waterway for Crossing 19 runs south from Whiteside St, relatively straight between Old Sydney Rd and the Hume Hwy. This drain flows through a series of ponds and collects water from numerous agricultural drains west of the Hume Hwy. The drain intersects perpendicularly with the with the APA pipeline at KP 36.2. The unnamed agricultural drain discharges to Kalkallo Creek downstream of the retarding basin, after which it flows for 3 km's before discharging into Merri Creek. The drain has a defined channel with an an approximate width at the intersection of 5m. The creek is grass covered with no discernible vegetation identified within the riparian zone. Near the crossing location, the drain has an average grade of 1 in 180. The catchment area upstream of the crossing is roughly 11.8 km<sup>2</sup> and is covered predominantly with agricultural land as well as a section of the Hume Hwy.

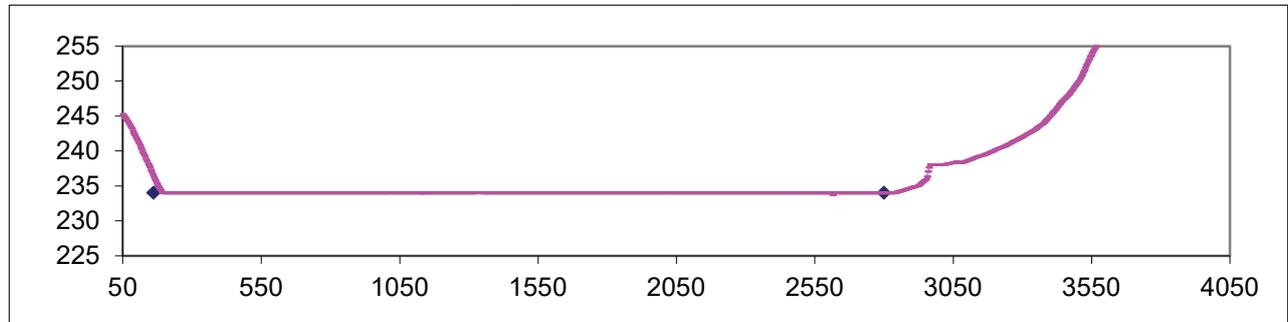
#### Representative Cross Section

Location (KP Chainage)	36.2
Waterway status	Constructed Drain
Stream Order	2nd
Stream type classification	straightened channelised
Approx. Crossing Length (m)	< 5
Catchment Area (km <sup>2</sup> )	12.60
1 in 100 year Flow (m <sup>3</sup> /s)	24.50
LSIO Impact (1 in 100yr) (m wide)	n/a
River Grade (averaged)	1 in 180
Stream Velocity (m/s)	0.27
Erosion Hazard	Low
Flood Hazard	Low

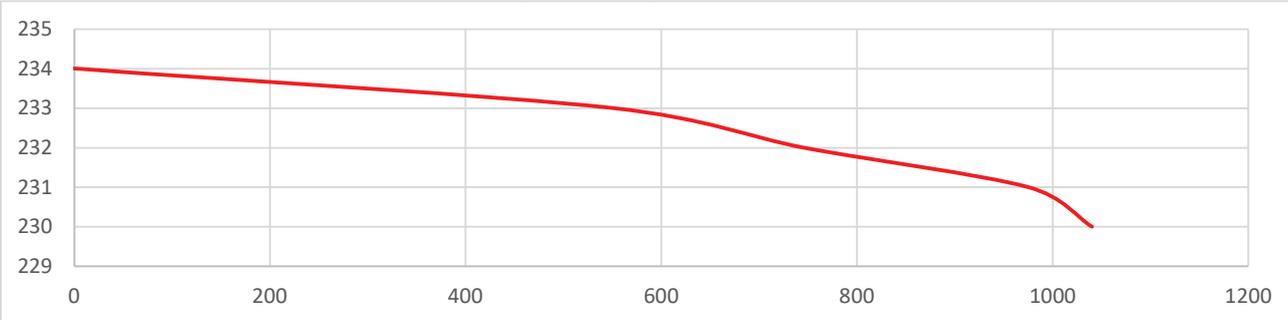
#### Interpreted Longitudinal Profile

Outcome: Standard design, construction methodology and site controls.

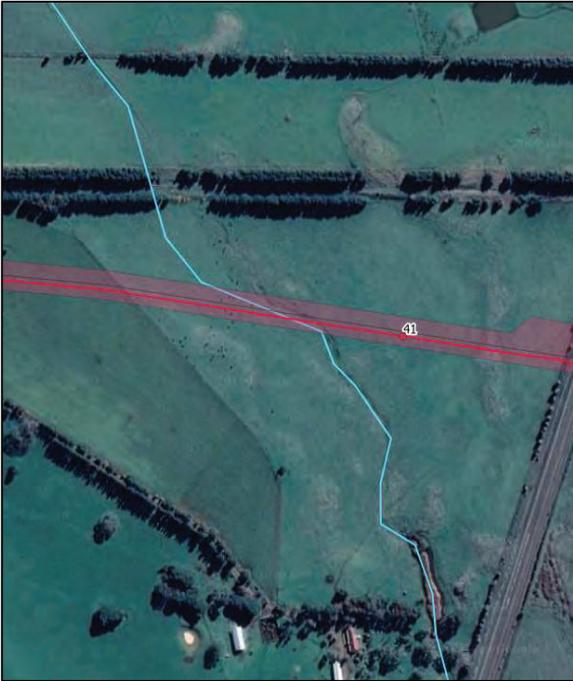
#### Pipe alignment & waterway location

The waterway for Crossing 20 runs south, relatively straight from Beveridge Rd between the Hume Hwy and Merriang Rd. Flowing through a series of dams, the tributary crosses Donovan's Lane before discharging into Merri Creek. The tributary intersects diagonally with the APA pipeline at KP 40.8. At the crossing, the stream has an undefined channel with an approximate width at the crossing is 60m. The stream is covered with grass and minor vegetation. Near the crossing, the tributary has an average grade of 1 in 1100. The catchment area upstream of the crossing is roughly 4.36 km<sup>2</sup> and is covered predominantly with agricultural land as well as capturing a small section of a residential development.

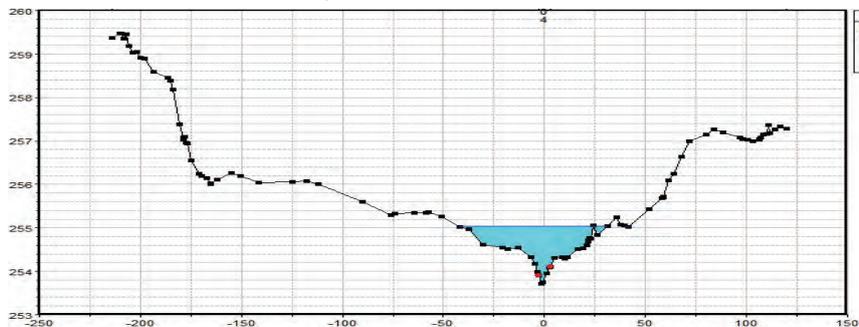
#### Representative Cross Section

Location (KP Chainage)	40.8
Waterway status	Tributary creek
Stream Order	2nd
Stream type classification	intact valley fill
Approx. Crossing Length (m)	< 5
Catchment Area (km <sup>2</sup> )	60.00
1 in 100 year Flow (m <sup>3</sup> /s)	26.12
LSIO Impact (1 in 100yr) (m wide)	180
River Grade (averaged)	1 in 1100
Stream Velocity (m/s)	1.08
Erosion Hazard	Potential
Flood Hazard	Low

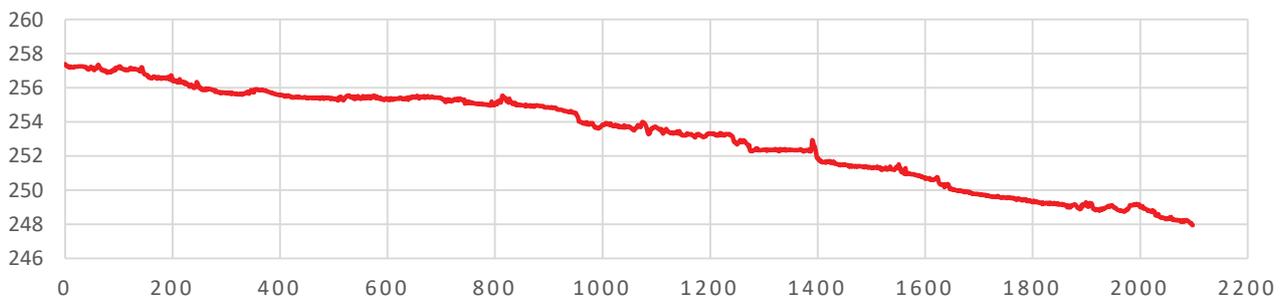
#### Interpreted Longitudinal Profile

Outcome: Potential hazard to asset, further assessmet required.

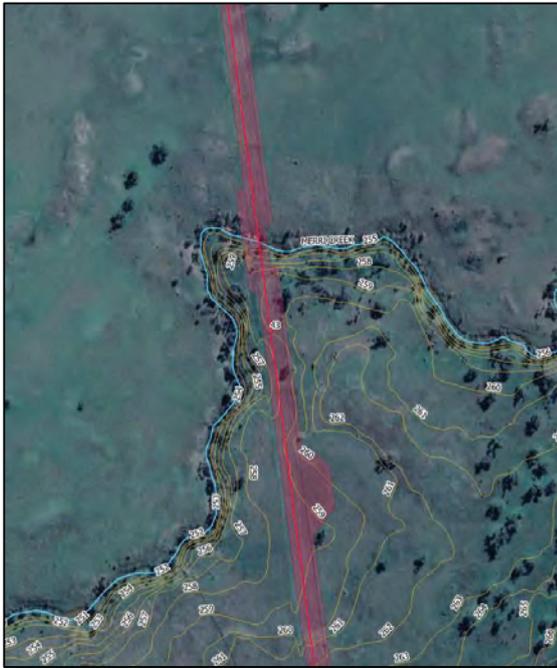
#### Pipe alignment & waterway location

The waterway for Crossing 21, Merri Creek, is one of Melbourne's major waterways. The creek meanders south towards Donnybrook Rd, between the Hume Hwy and Merriang Rd, discharging into the Yarra River. The crossing intersects perpendicularly with the APA pipeline at KP 42.9. The creek has an approximate width at the intersection of 40m with a well-defined channel. The creek is covered with grass and significant vegetation has been identified within the riparian zone. Near the crossing, the tributary has an average grade of 1 in 285. The catchment area upstream of the crossing is roughly 127.7 km<sup>2</sup> and is approximately 60% agricultural land, 10% state park and 30% paved residential zone, namely Wallan.

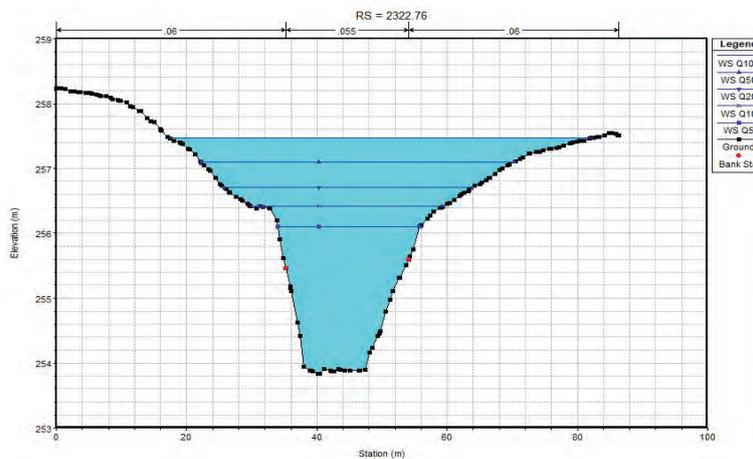
#### Representative Cross Section

Location (KP Chainage)	42.9
Waterway status	major waterway
Stream Order	4th
Stream type classification	Incised meander channel
Approx. Crossing Length (m)	40
Catchment Area (km <sup>2</sup> )	127.70
1 in 100 year Flow (m <sup>3</sup> /s)	141.00
LSIO Impact (1 in 100yr) (m wide)	65
River Grade (averaged)	1 in 285
Stream Velocity (m/s)	2.18
Erosion Hazard	High
Flood Hazard	High

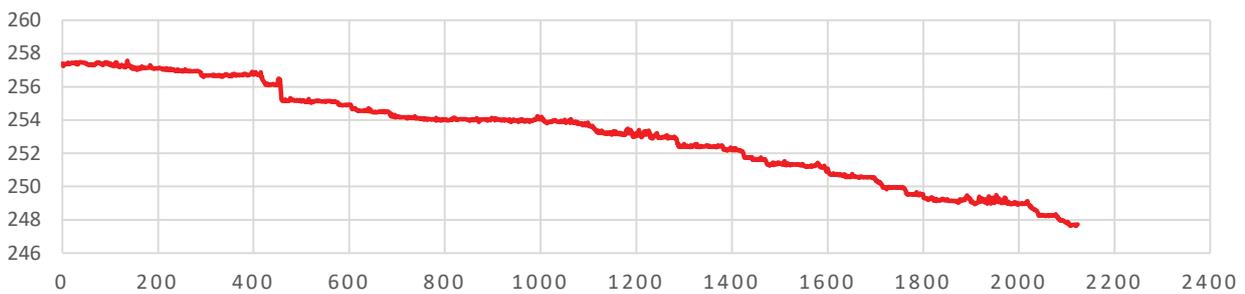
#### Interpreted Longitudinal Profile

**Outcome: Potential hazard to asset, further assessmet required.**

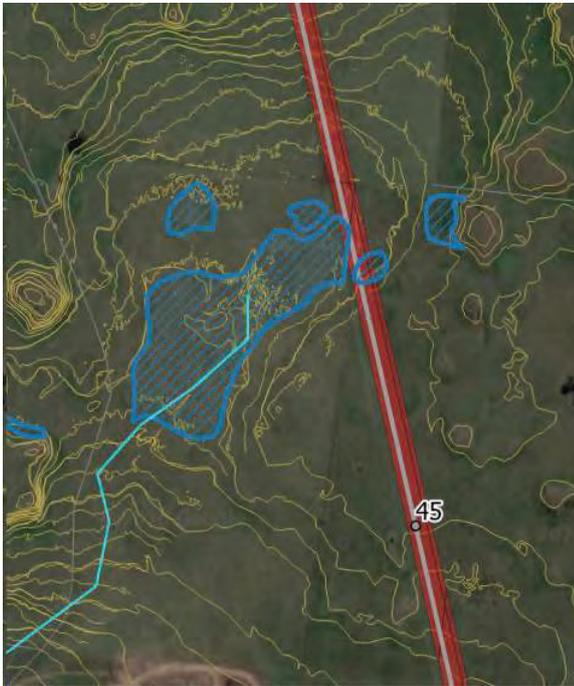
#### Pipe alignment & waterway location

The waterway for Crossing 22 includes two of the mapped wetlands that are partially intersected by the Project. These natural wetland bodies are mapped in the Victorian Wetlands Inventory and there are a number of these small wetlands scattered across the land north of Donnybrook Road and east of Merri Creek. The two mapped palustrine wetlands periodically inundate when there is a significant rainfall event. The larger wetland that is partially crossed by the Project flows through a minor tributary into a secondary stream before discharging into the Merri Creek. From aerial imagery, the wetlands appear to be mostly dry and ephemeral with no discernible vegetation. The catchment area upstream of the crossing is roughly 0.62 km<sup>2</sup> and is covered predominantly with agricultural land.

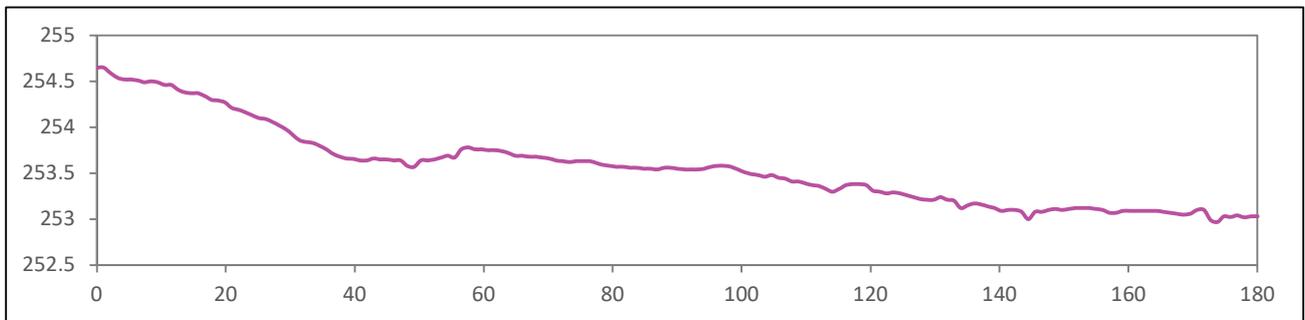
#### Representative Cross Section

Location (KP Chainage)	44.7
Waterway status	minor tributary
Stream Order	1st
Stream type classification	Wetland
Approx. Crossing Length (m)	n/a
Catchment Area (km <sup>2</sup> )	0.62
1 in 100 year Flow (m <sup>3</sup> /s)	n/a
LSIO Impact (1 in 100yr) (m wide)	n/a
River Grade (averaged)	n/a
Stream Velocity (m/s)	n/a
Erosion Hazard	Low
Flood Hazard	Low

Outcome: Standard design, construction methodology and site controls.

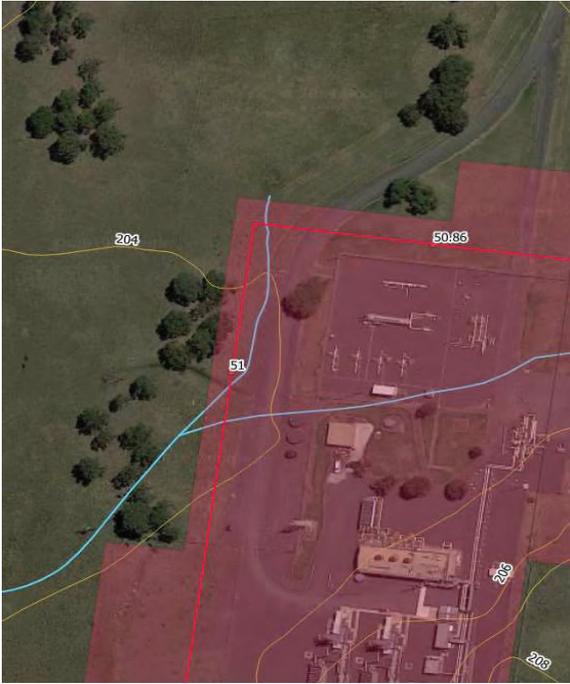
#### Pipe alignment & waterway location

The waterway for Crossing 23 runs south-west, relatively straight from Summerhill Rd towards Craigieburn Rd before discharging into the Merri Creek. This section considers 2 tributaries, the first intersects the pipeline longitudinally and the second perpendicularly KP 51. The power station has had a significant impact on the tributary flow path. Both tributaries have an underdefined channel with an approximate width at the intersection of 5m. The streams are covered with grass with no discernible vegetation within its confines. Near the crossing, the tributary has an average grade of 1 in 200. The catchment area upstream of the crossing is roughly 0.55 km<sup>2</sup> and is covered predominantly with agricultural land, with a paved section at the point of intersection.

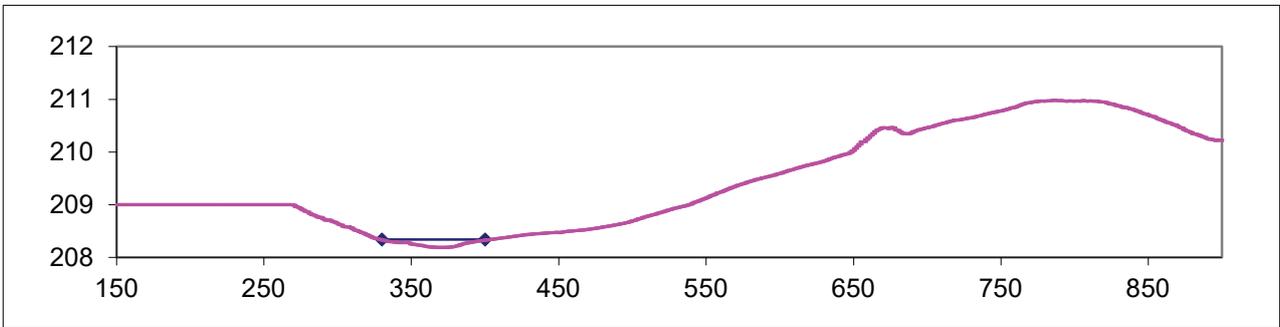
#### Representative Cross Section

Location (KP Chainage)	51
Waterway status	minor tributary
Stream Order	1st
Stream type classification	intact valley fill
Approx. Crossing Length (m)	< 5
Catchment Area (km <sup>2</sup> )	0.55
1 in 100 year Flow (m <sup>3</sup> /s)	3.18
LSIO Impact (1 in 100yr) (m wide)	n/a
River Grade (averaged)	1 in 200
Stream Velocity (m/s)	0.52
Erosion Hazard	Low
Flood Hazard	Low
