technical report B  
**surface  
water.**

Environment Effects Statement | May 2021

**western outer  
ring main**

APA VTS (Operations) Pty Ltd  
Western Outer Ring Main Environment Effects Statement  
Surface Water Report

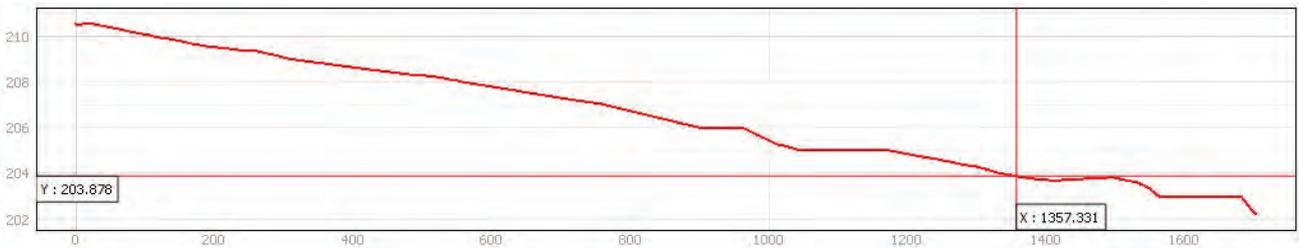
#### Interpreted Longitudinal Profile

**Outcome:** Standard design, construction methodology and site controls.

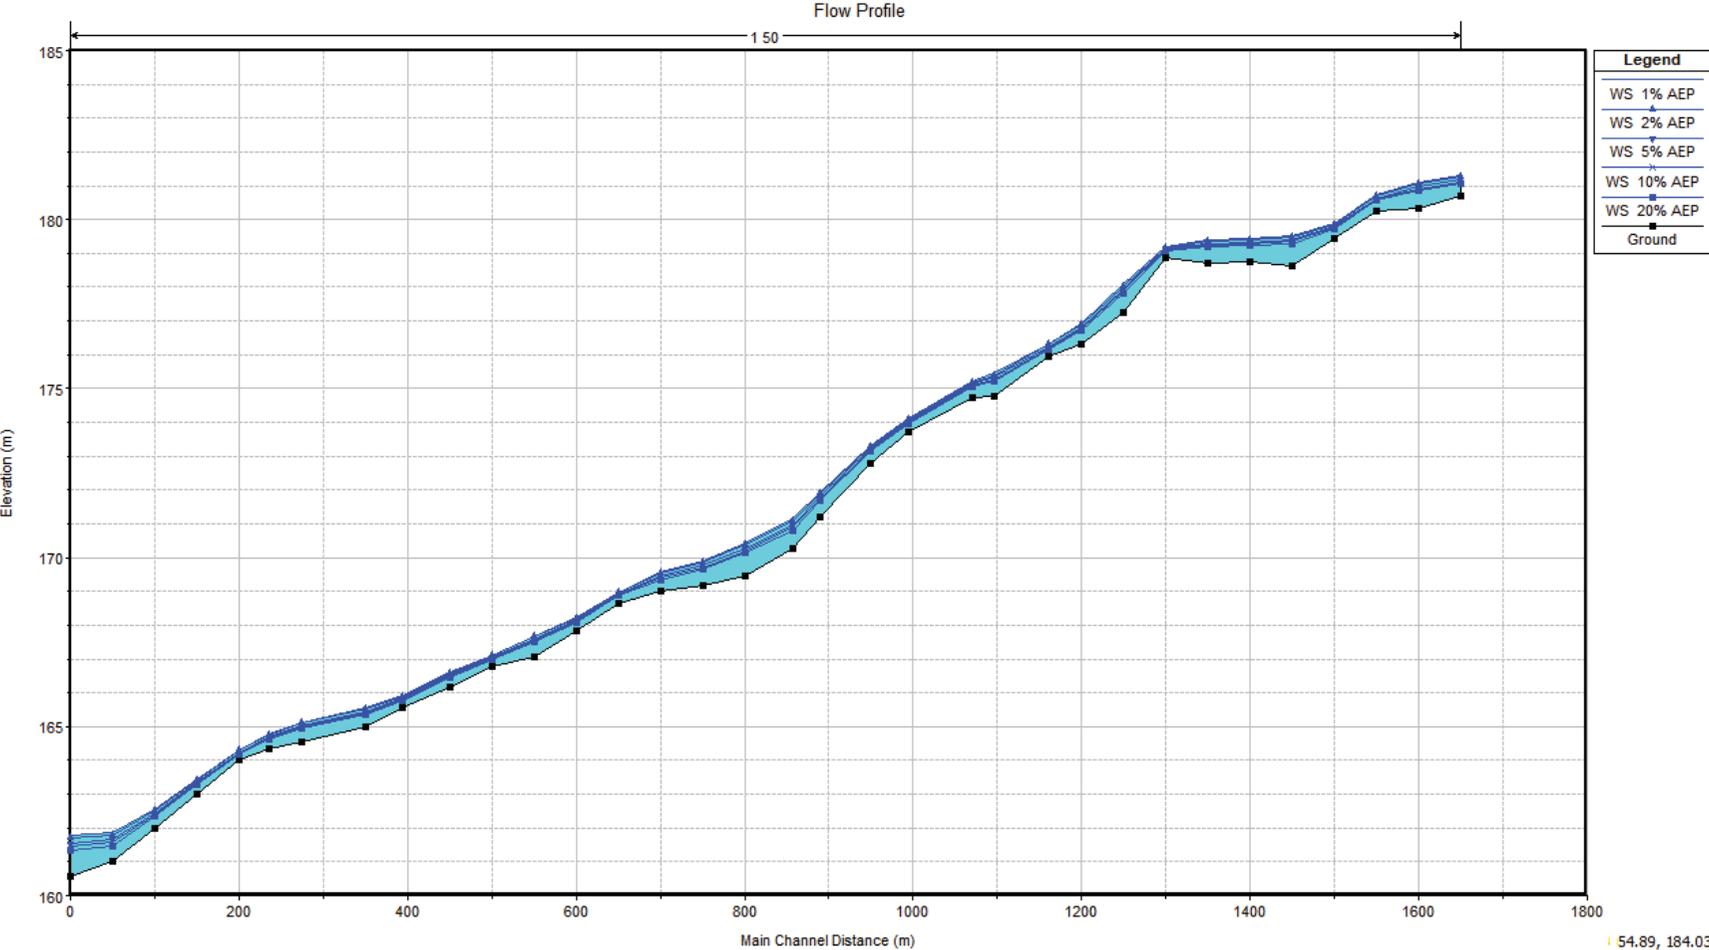
Figure 1: Tame Street Drain flood level profile (5, 10, 20, 50 and 100yr ARI).

Waterway	Geotechnical Interpretation	Hydrology & Flooding	Channel & Floodplain Hydraulics
Tame Street Drain	Shallow basalt (2 m depth)	Ephemeral, standard flood risk	Velocities < 1.5 m/s Stream Powers < 300 Nm <sup>2</sup> Stable channel condition
Jacksons Creek (including Crossing 8)	Erosive soils in upper profile, and no depth to basalt was encountered	Perennially flowing, preferred timing summer-autumn	Velocities > 1.5 m/s Stream Powers > 300 Nm <sup>2</sup> Active erosion evident, and expected over geomorphic trajectories Crossing 8 – Velocities > 3 m/s
Deep Creek	Erosive soils in upper profile, and no depth to basalt was encountered	Perennially flowing, preferred timing summer-autumn	Velocities > 1.5 m/s Stream Powers > 300 Nm <sup>2</sup> Active erosion evident, and expected over geomorphic trajectories
Kalkallo Creek (including Crossing 15, 17, 18)	Presence of clays within first 10 m from surface, to where basalt is encountered	Ephemeral, higher apparent flood risk being within RB – the periphery flood risk could be managed	Velocities < 1.5 m/s Stream Powers < 300 Nm <sup>2</sup> Stable channel condition

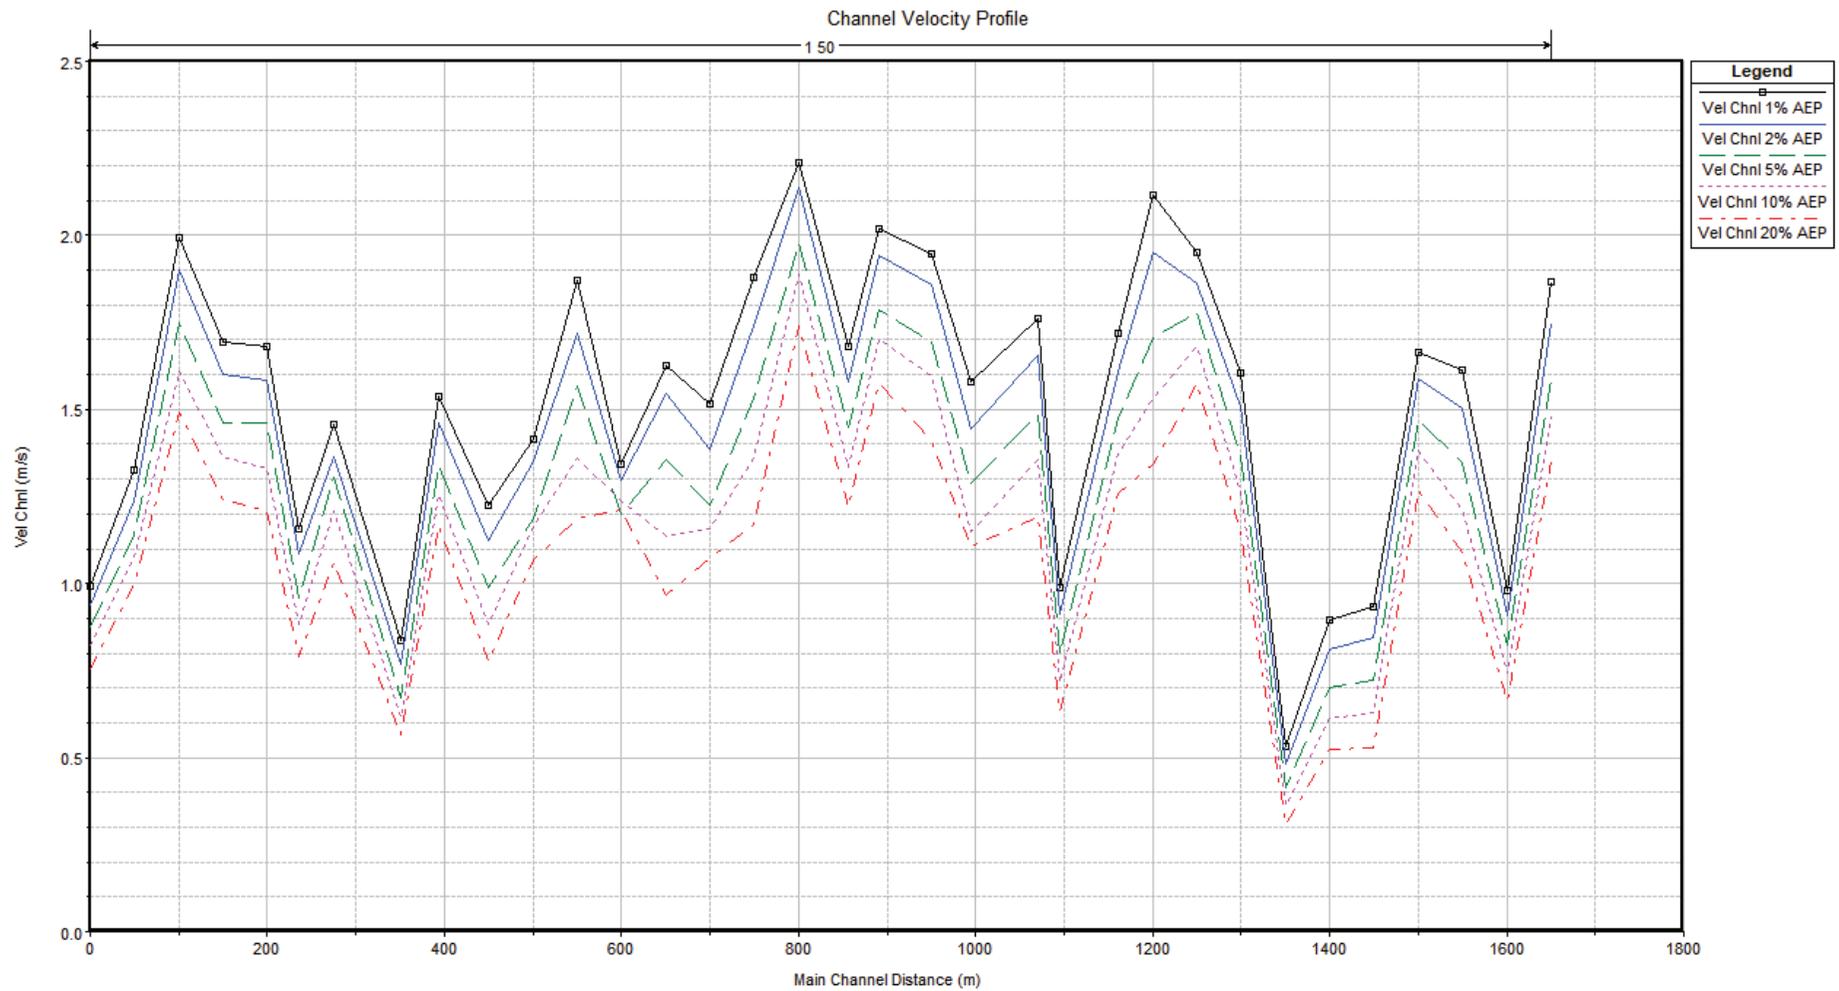
Figure 2: Tame Street Drain channel velocity profile (5, 10, 20, 50 and 100yr ARI).

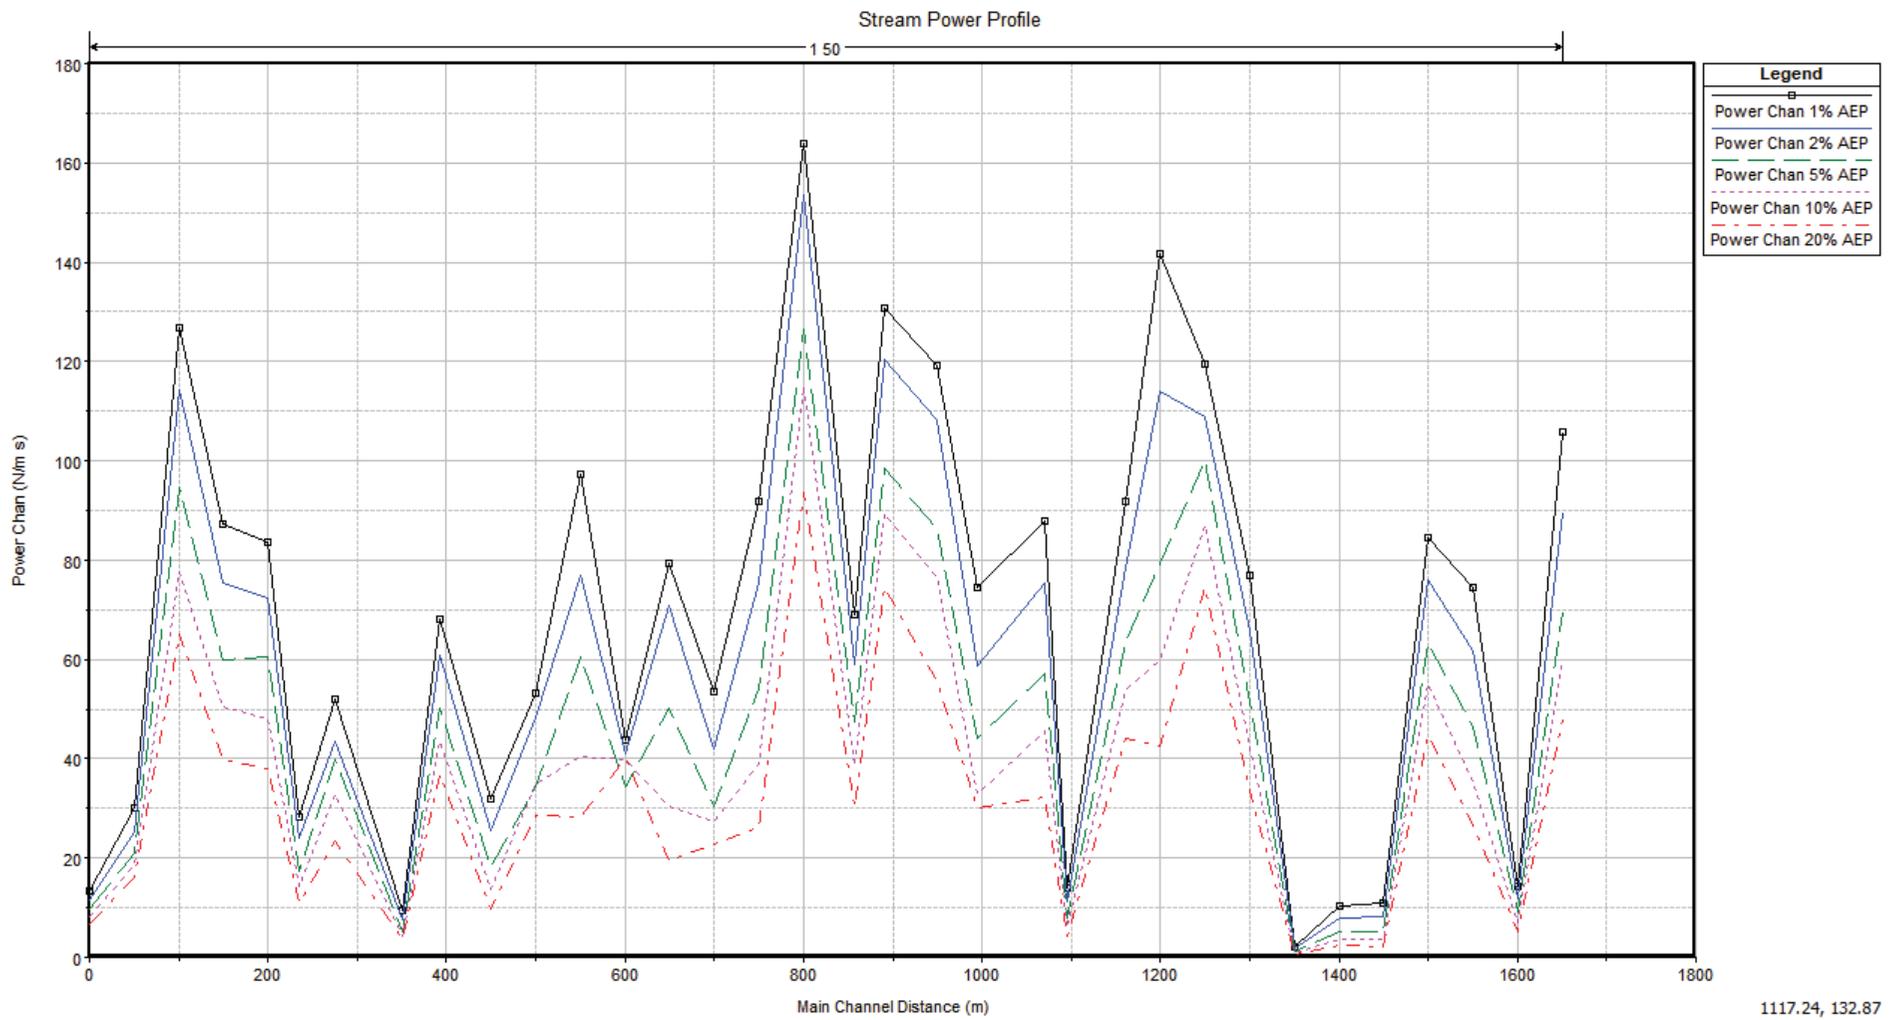
Figure 3: Tame Street Drain channel stream power profile (5, 10, 20, 50 and 100yr ARI).

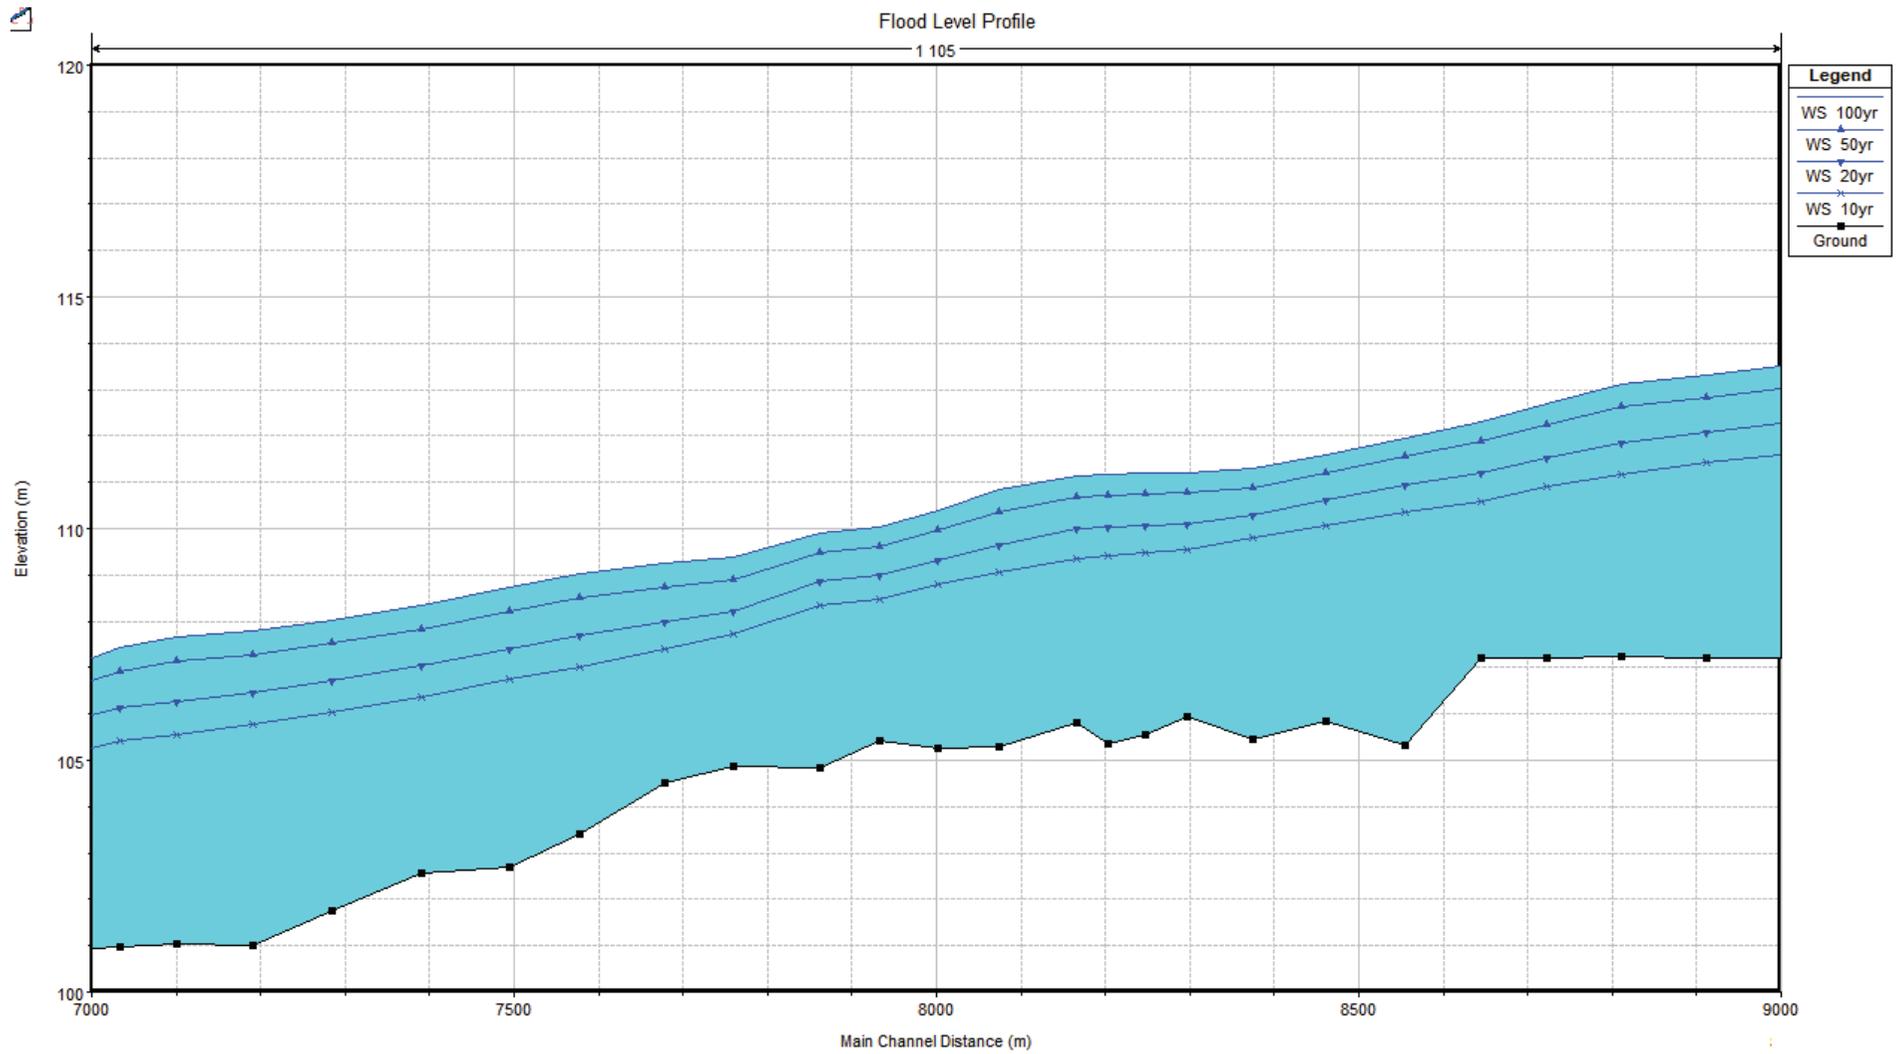
Figure 4: Jacksons Creek flood level profile (10, 20, 50 and 100yr ARI).

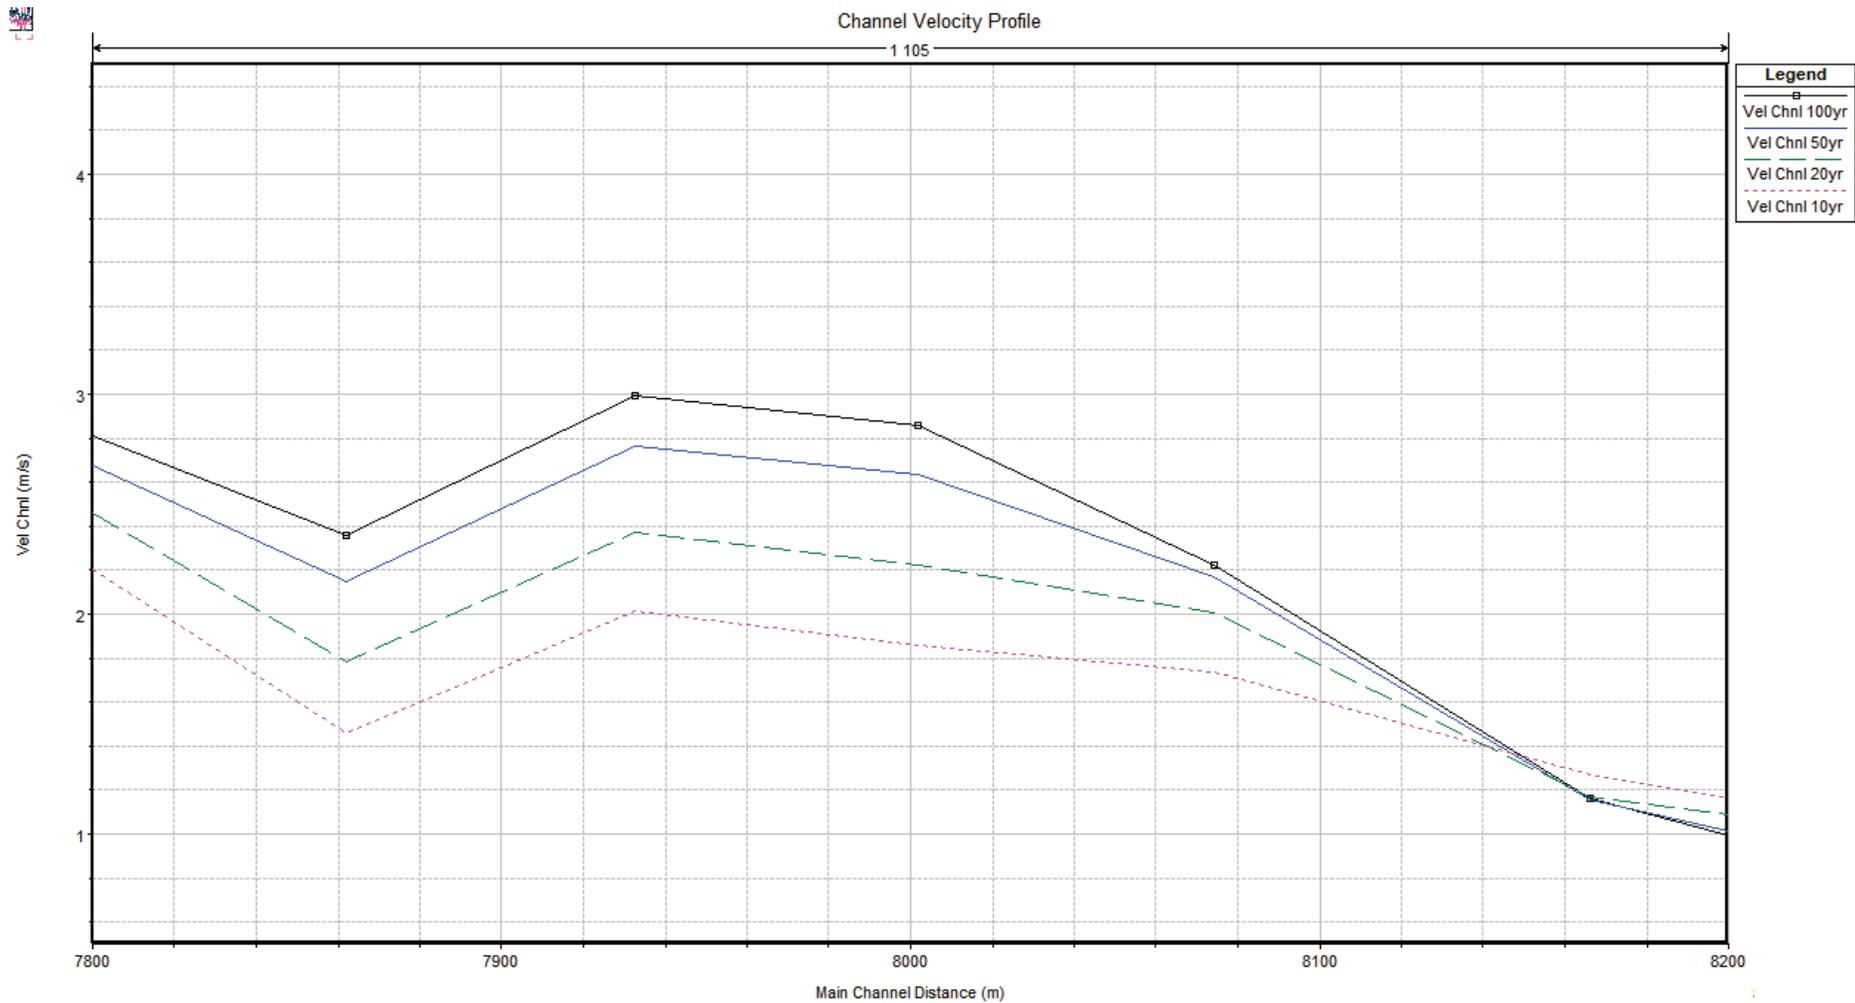
Figure 5: Jacksons Creek channel velocity profile (10, 20, 50 and 100yr ARI).

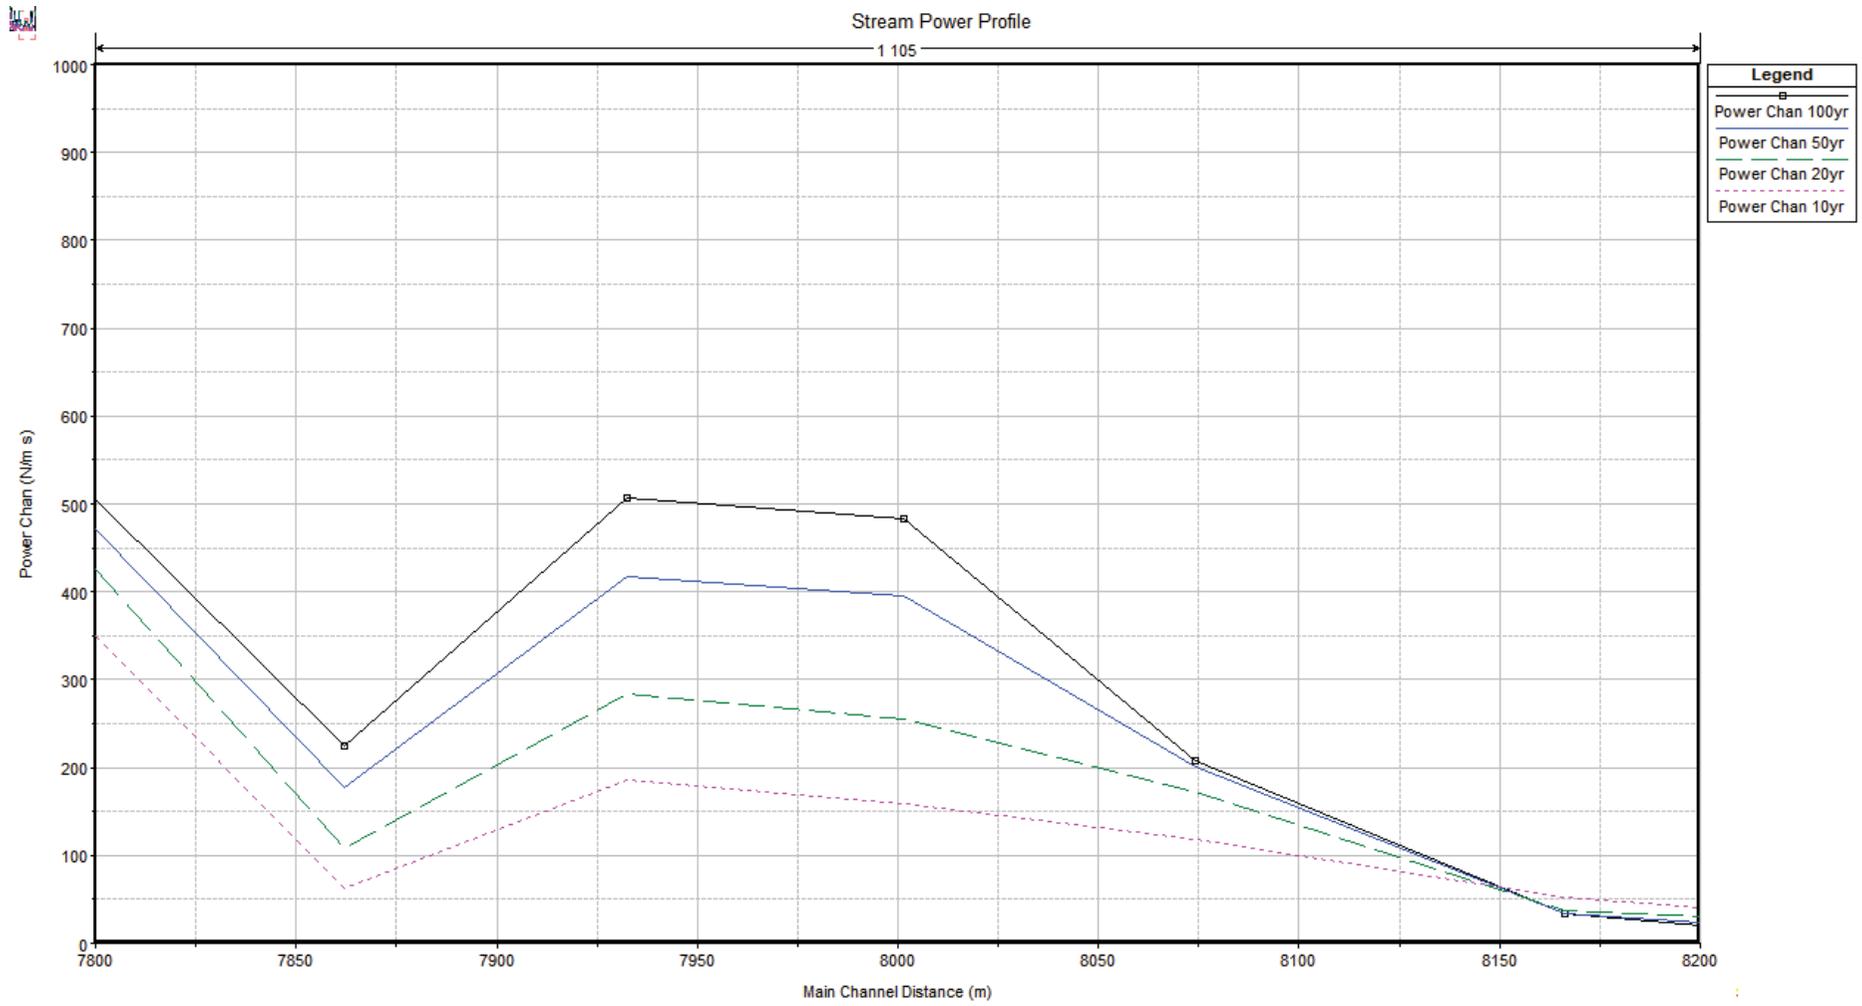
Figure 6: Jacksons Creek channel stream power profile (10, 20, 50 and 100yr ARI).

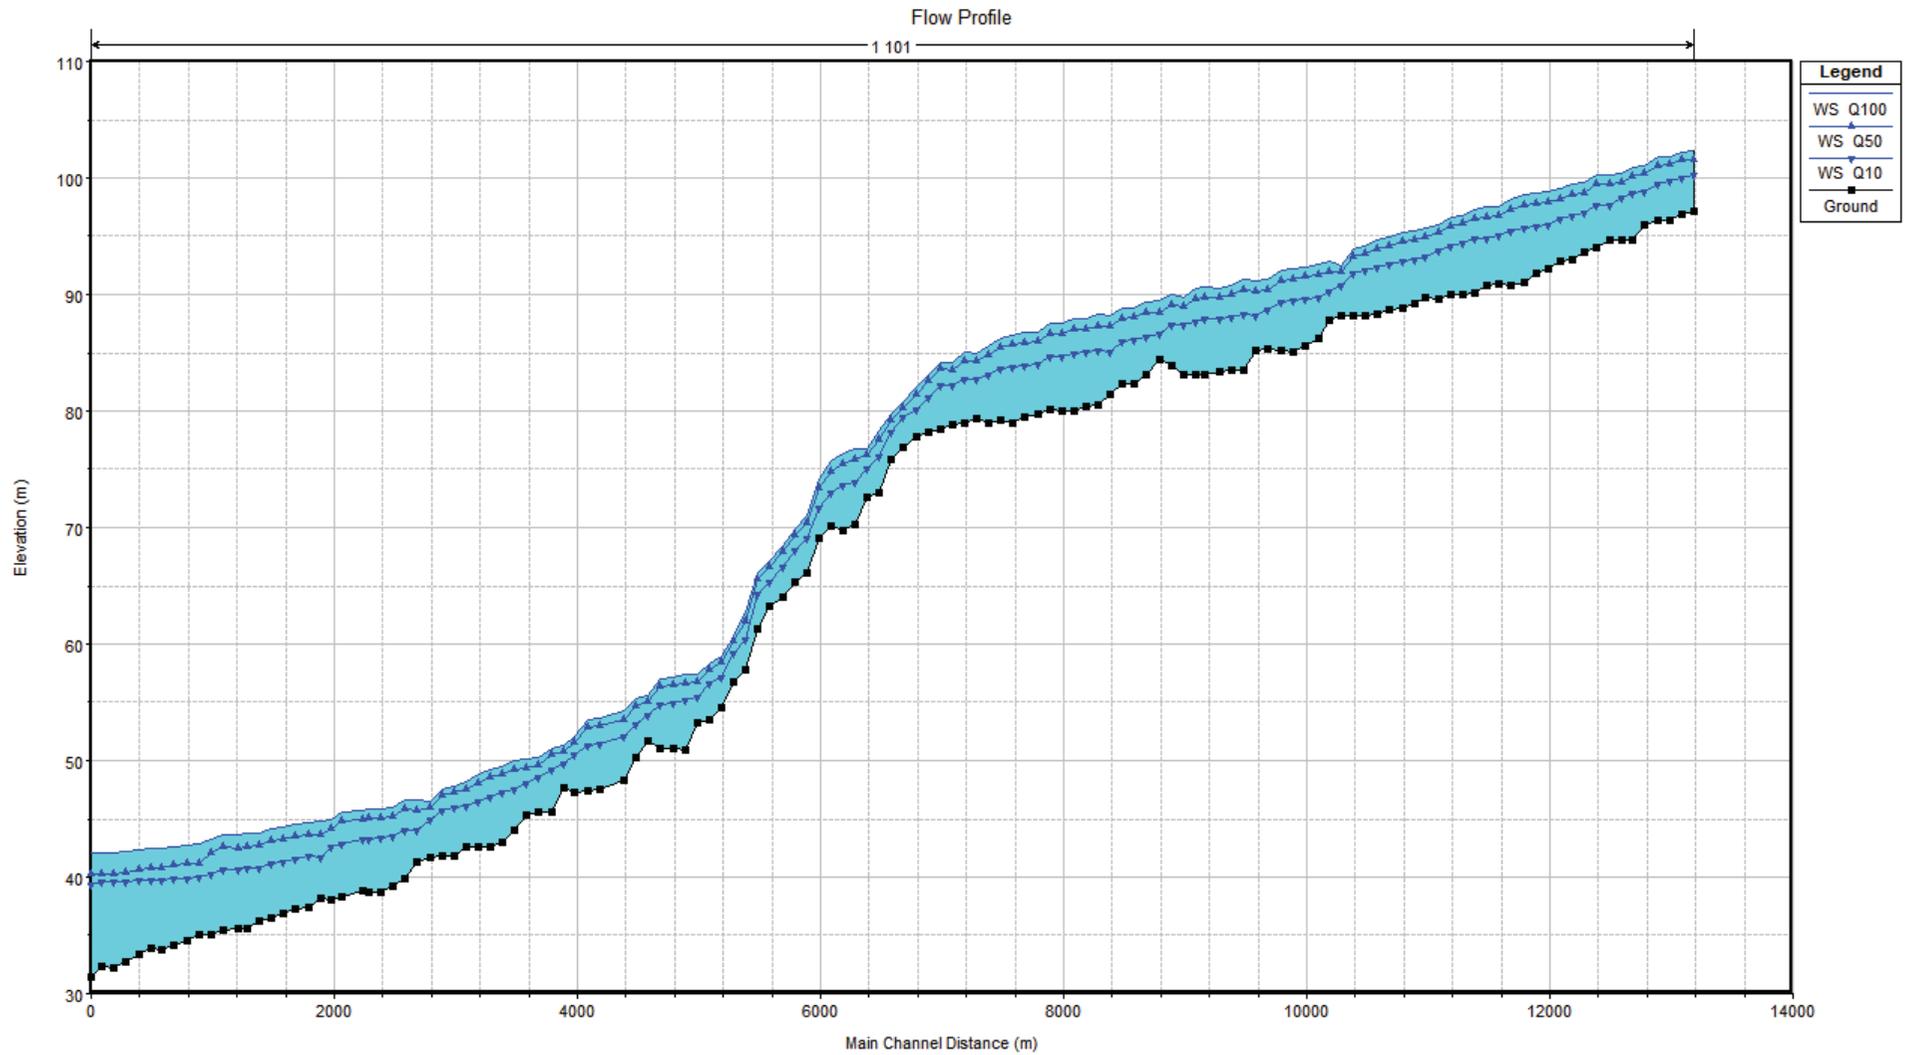
Figure 7: Deep Creek flood level profile (10, 50 and 100yr ARI).

Deep Creek	<p><b>Geotechnical</b> – Erosive soils (gravels) in upper profile, and no depth to basalt was encountered.</p> <p><b>Waterway</b> - Perennially flowing, generally passive flow conditions with minor riffle sequences along the reach defined by a rock outcrop control ~200m downstream.</p> <p><b>Water Quality and beneficial uses</b> –Water quality samples collected from the upstream gauges had elevated concentrations of turbidity, nitrate, total nitrogen, phosphate, total phosphorus, chromium, copper, lead, nickel and zinc. The upstream gauges are located within an agricultural catchment where elevated levels of nitrogen and phosphorus may be present. The downstream gauge provided similar results to the upstream gauges but with noncompliant electrical conductivity and pH.</p> <p>Beneficial Uses downstream may include water dependent ecosystems and species, agriculture and irrigation, water-based recreation (aesthetic enjoyment) and Traditional Owner cultural values</p> <p><b>Geomorphology</b> – Stable configuration of stream, with some minor lateral widening, but no significant change in stream morphology in 50 years. Slightly meandering low flow with stable bar configuration and ephemeral parallel secondary channel occupied in moderate floods. Deep scour common in secondary channels and if disturbed could trigger a permanent change in the main flow path.</p>

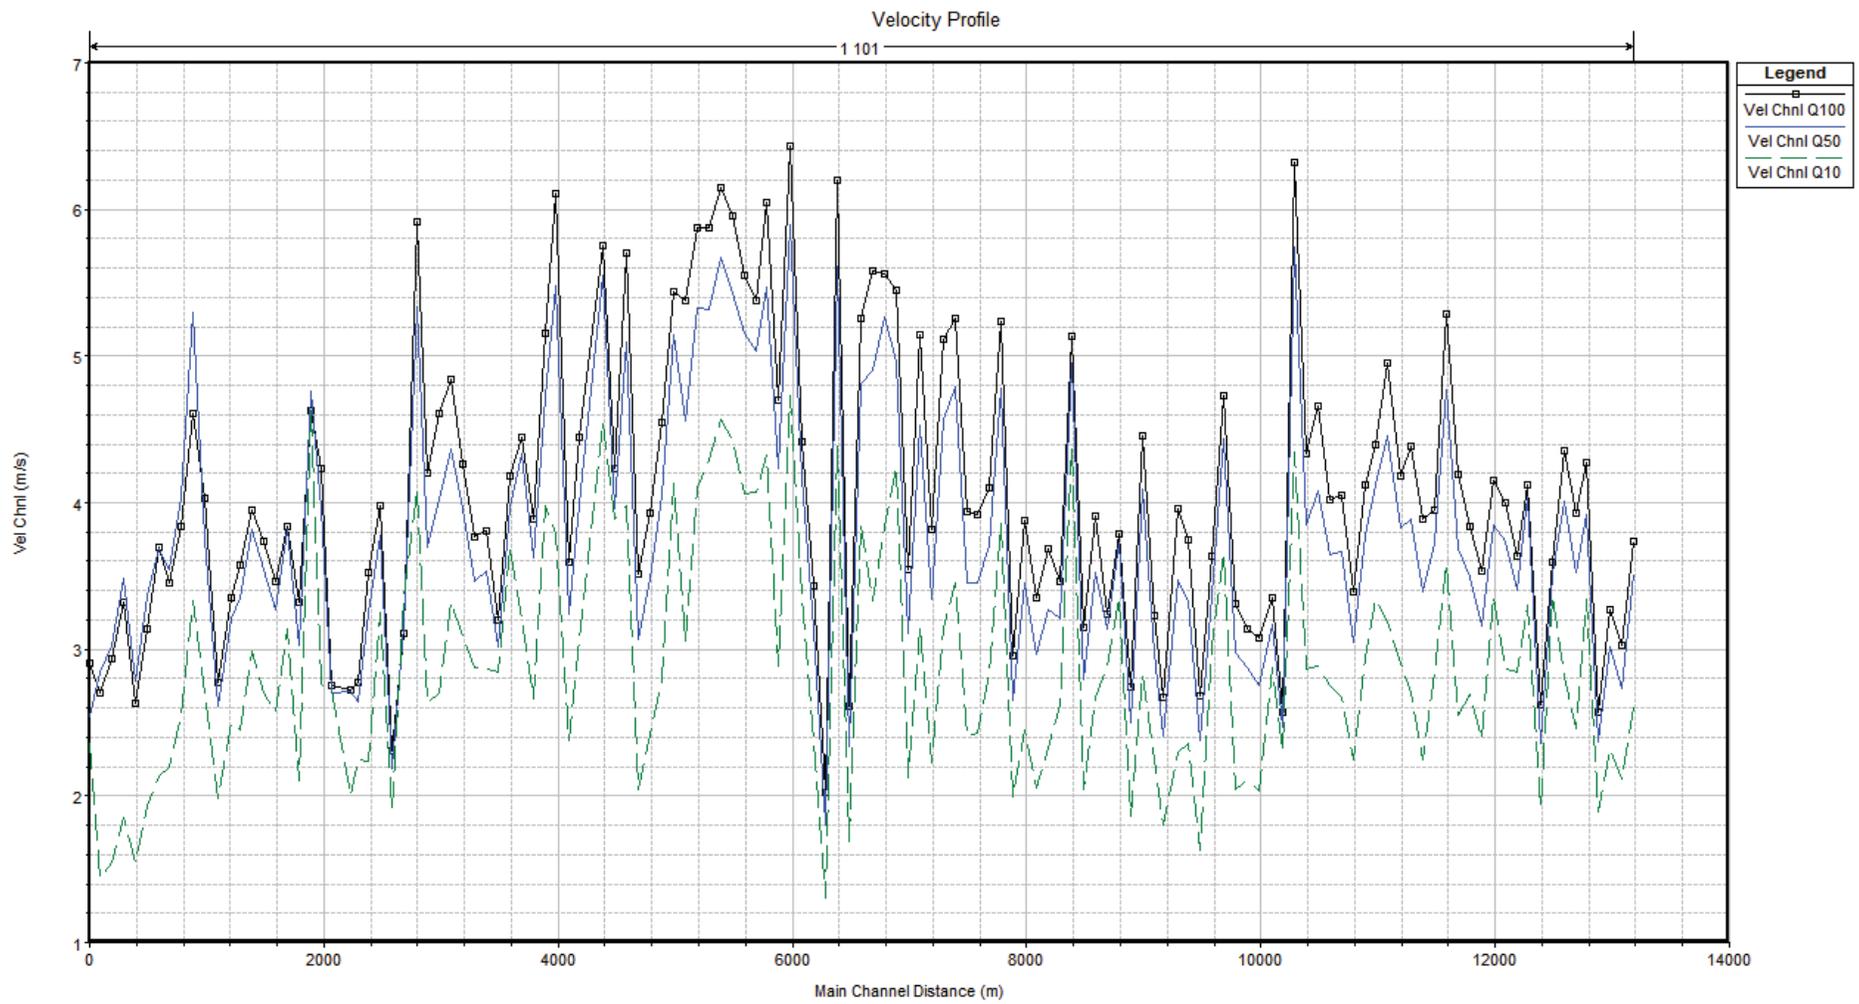
Figure 8: Deep Creek channel velocity profile (10, 50 and 100yr ARI).

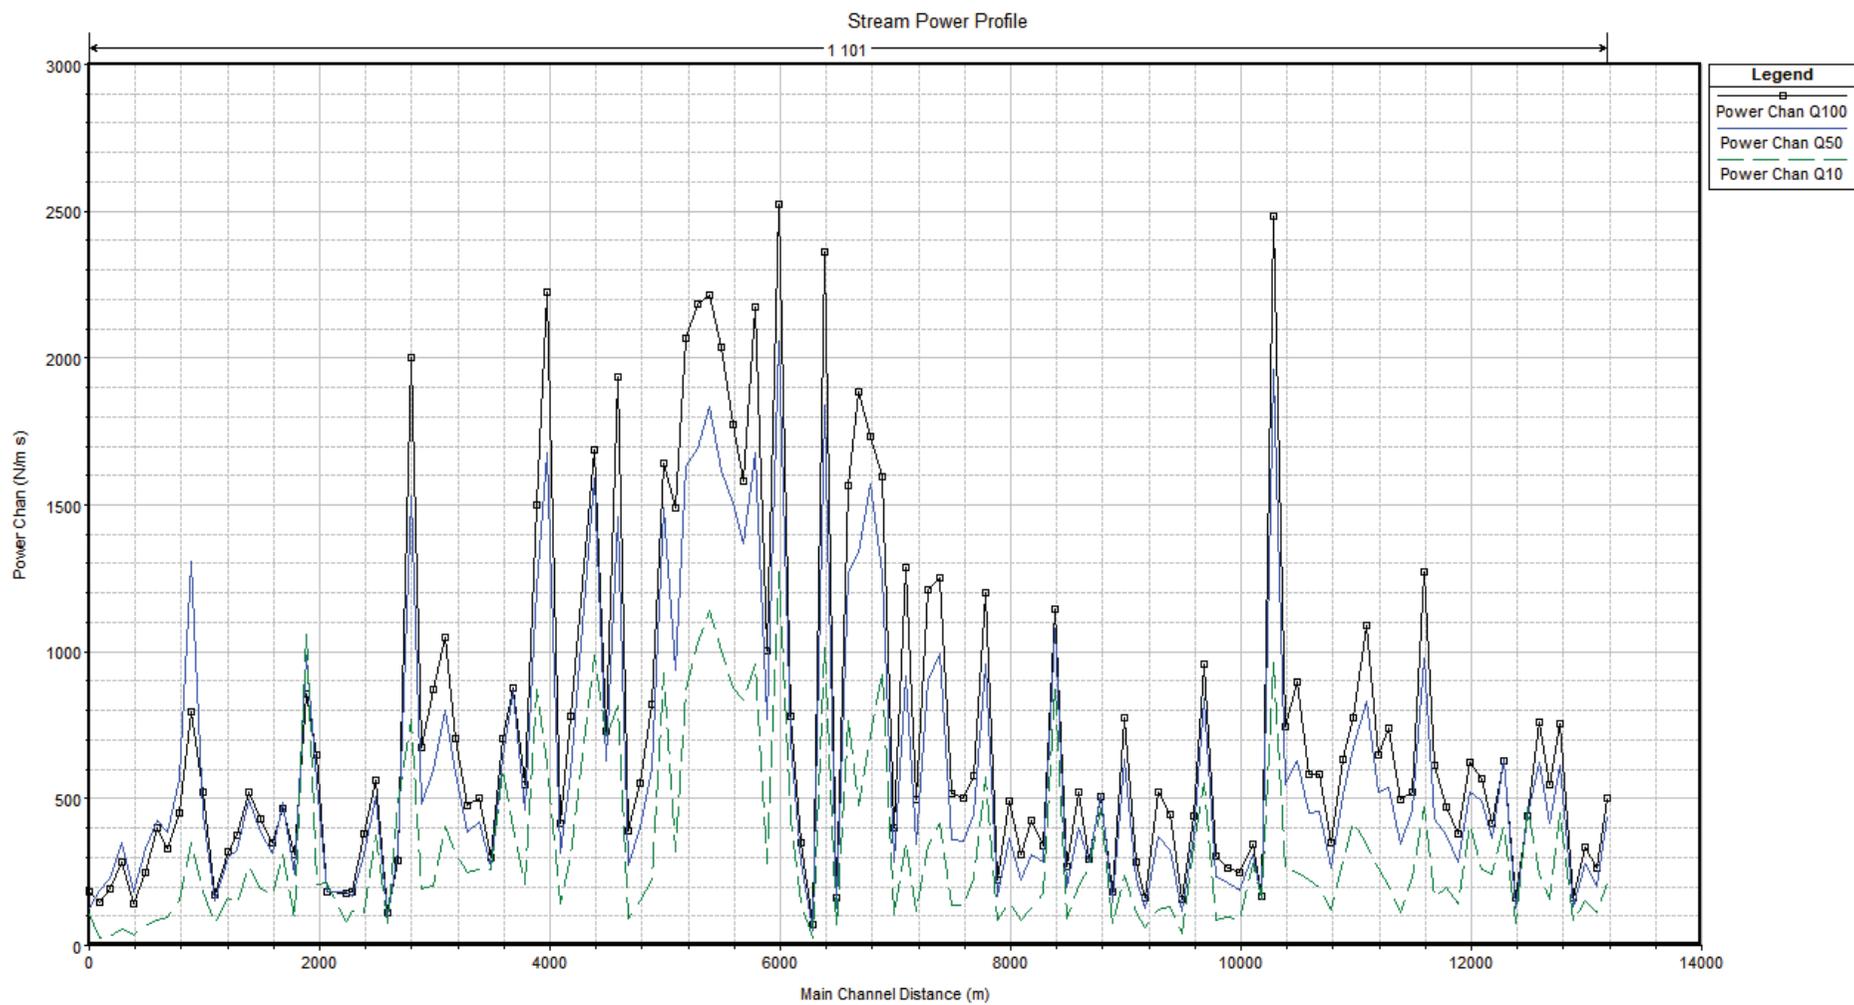
Figure 9: Deep Creek channel stream power profile (10, 50 and 100yr ARI).

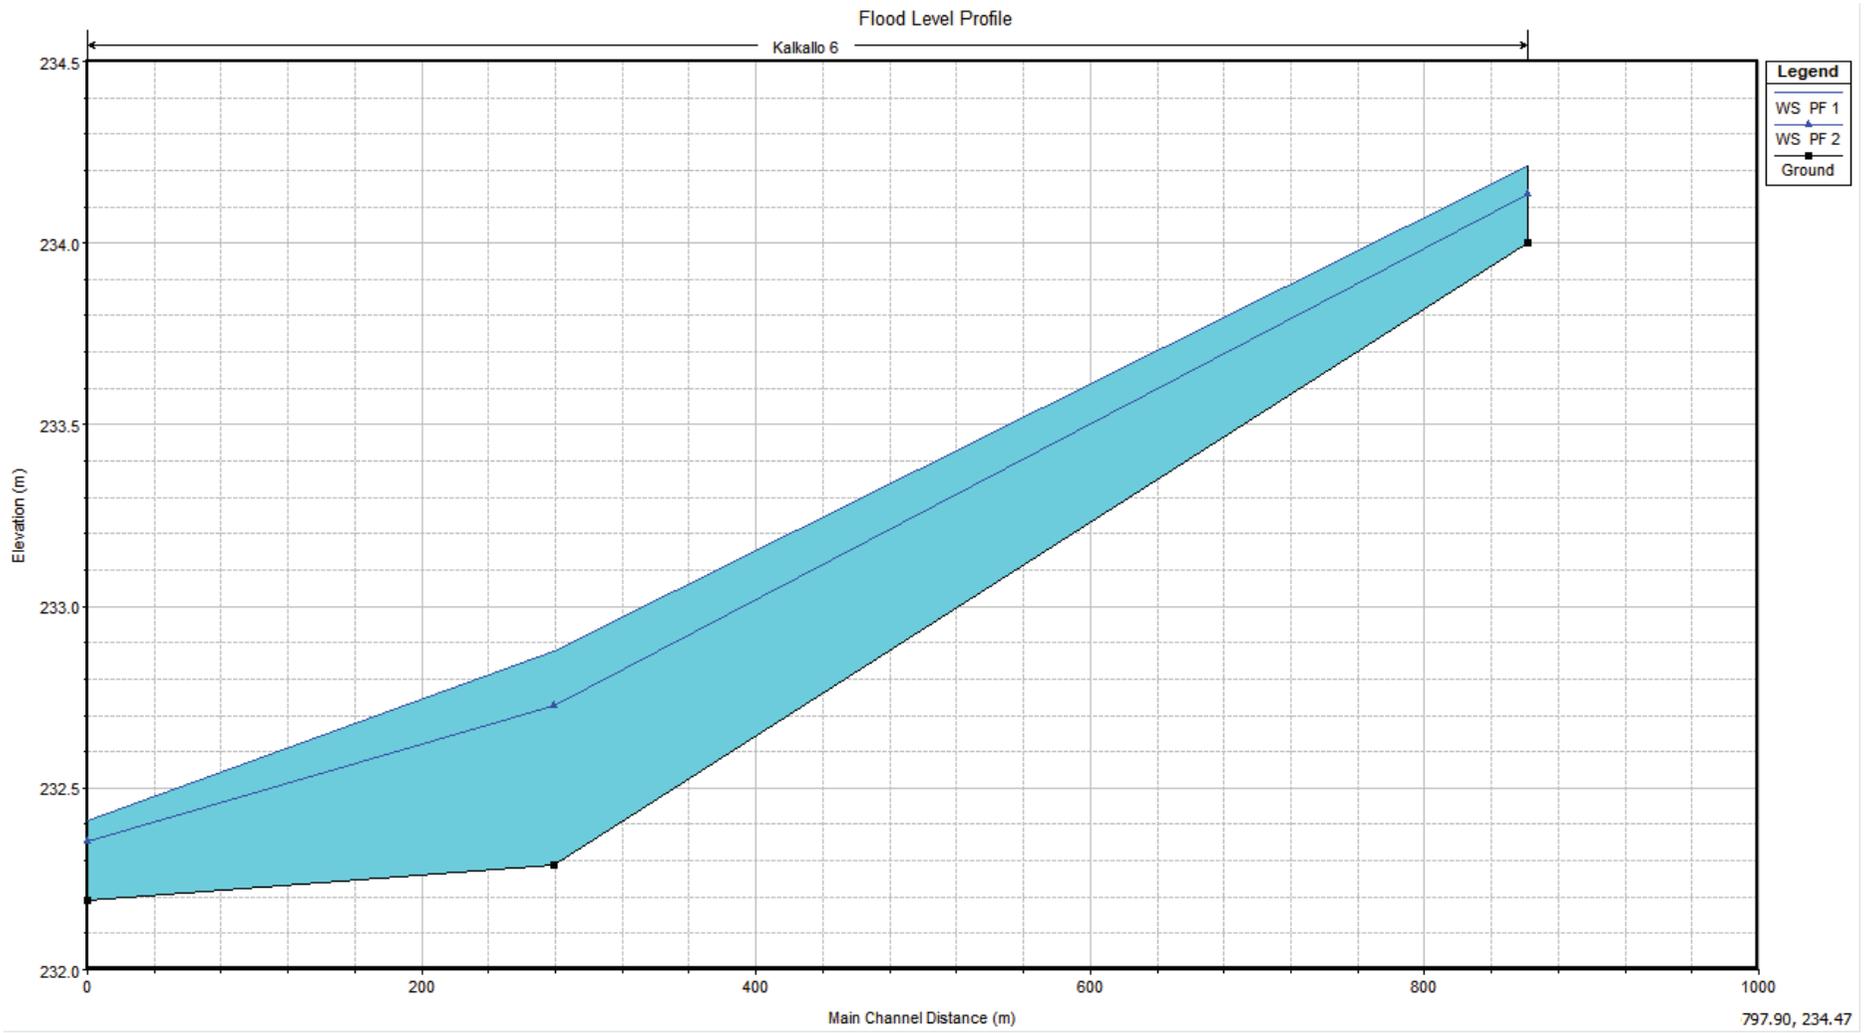
Figure 10: Kalkallo Creek East Drain flood level profile ( 10 and 100yr ARI).

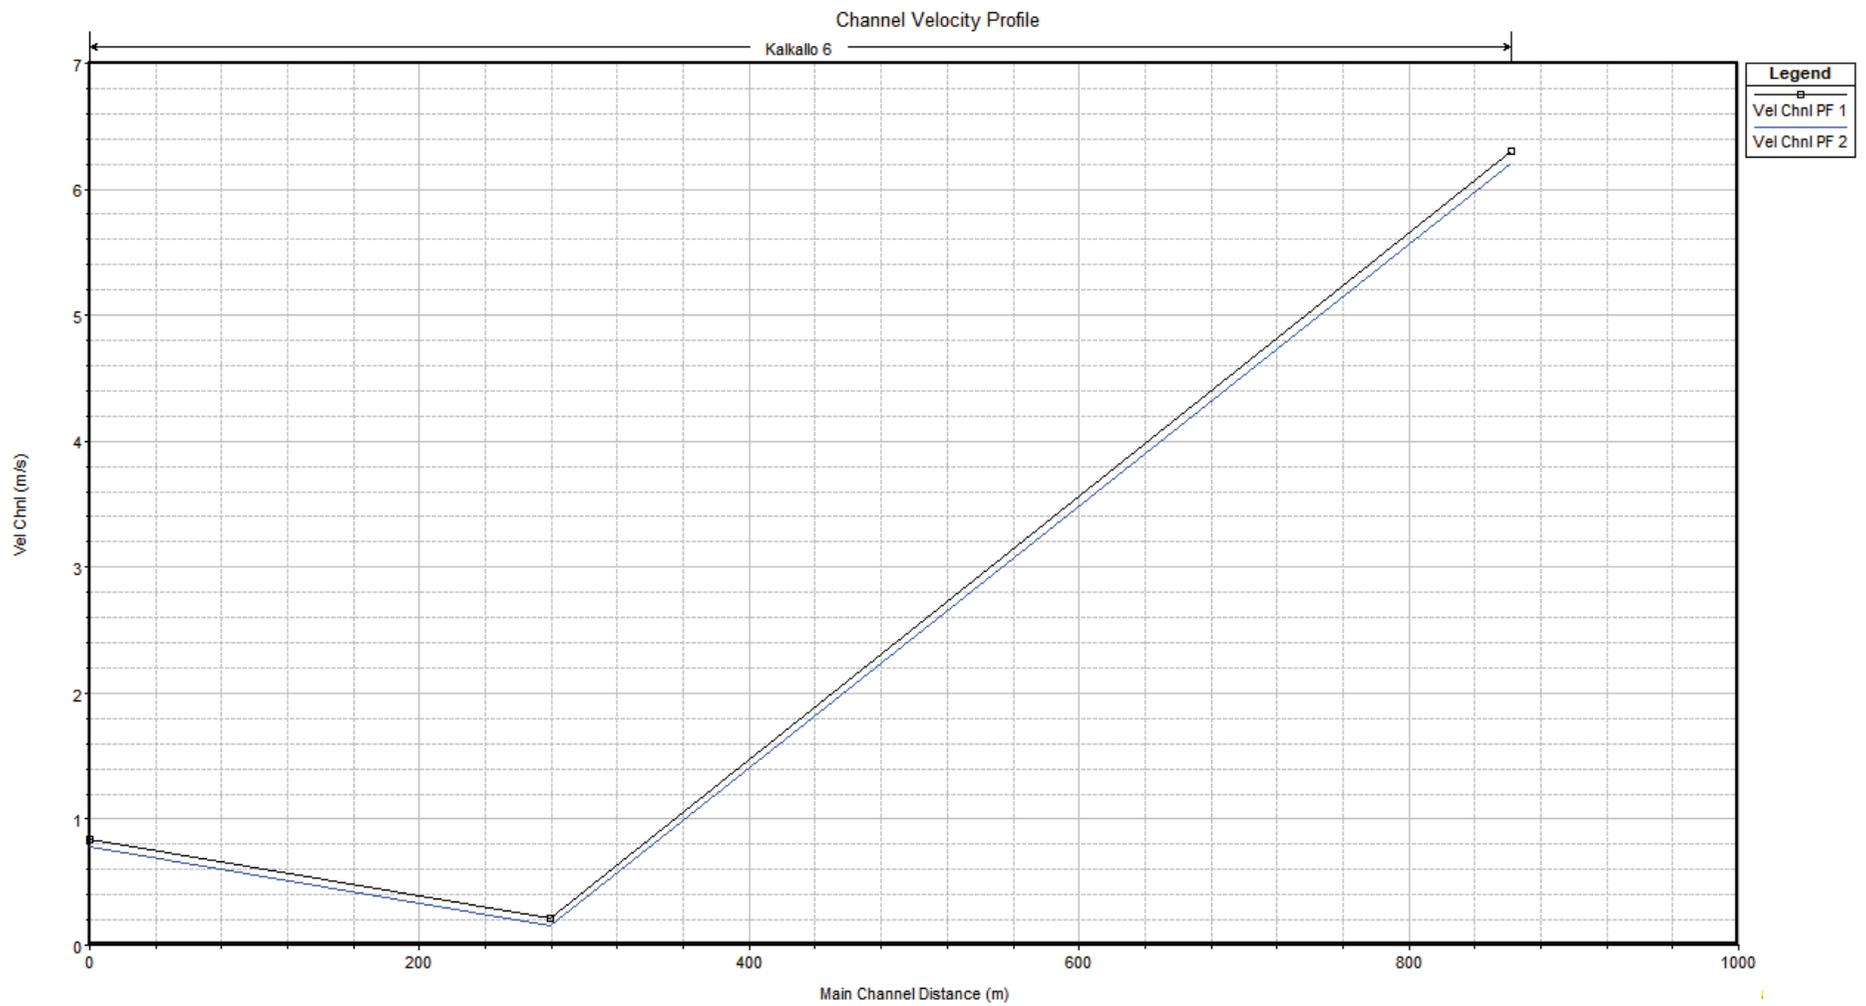
Figure 11: Kalkallo Creek East Drain channel velocity profile (10 and 100yr ARI).
