technical report B  
**surface  
water.**

Environment Effects Statement | May 2021

**western outer  
ring main**

APA VTS (Operations) Pty Ltd  
Western Outer Ring Main Environment Effects Statement  
Surface Water Report

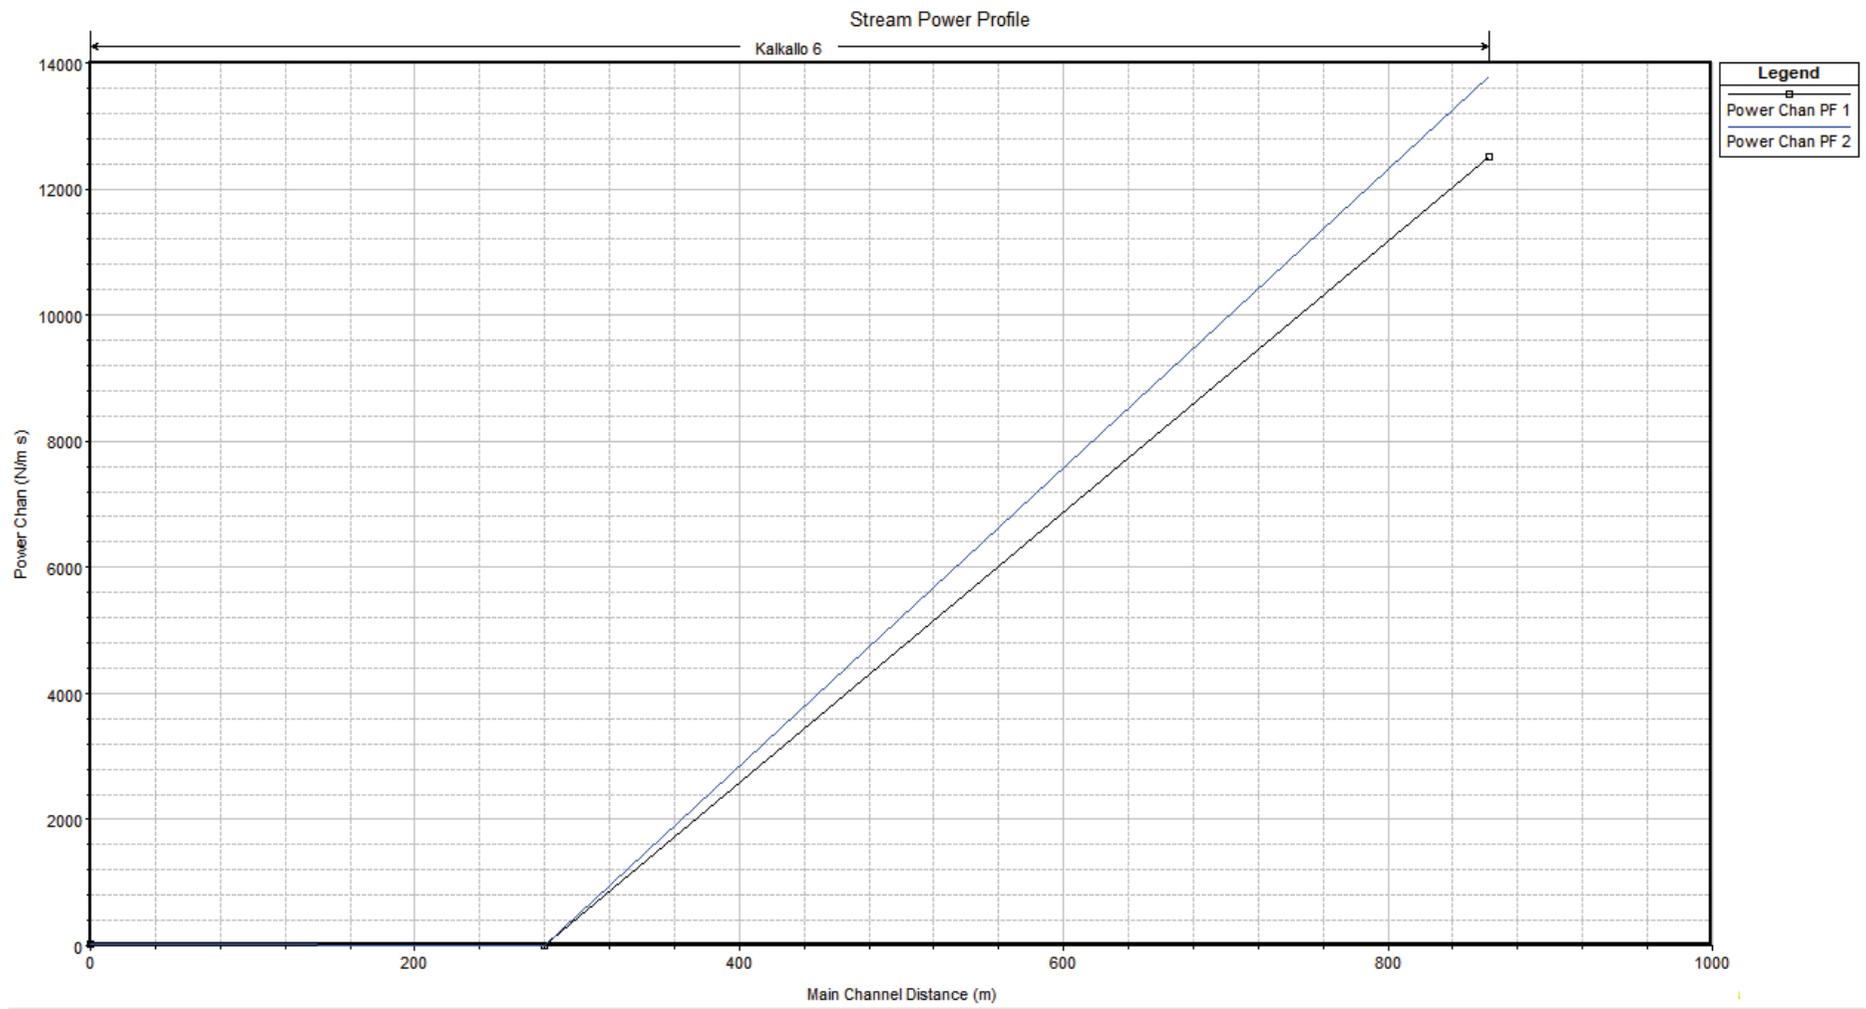
Figure 12: Kalkallo Creek East Drain channel stream power profile (10 and 100yr ARI).

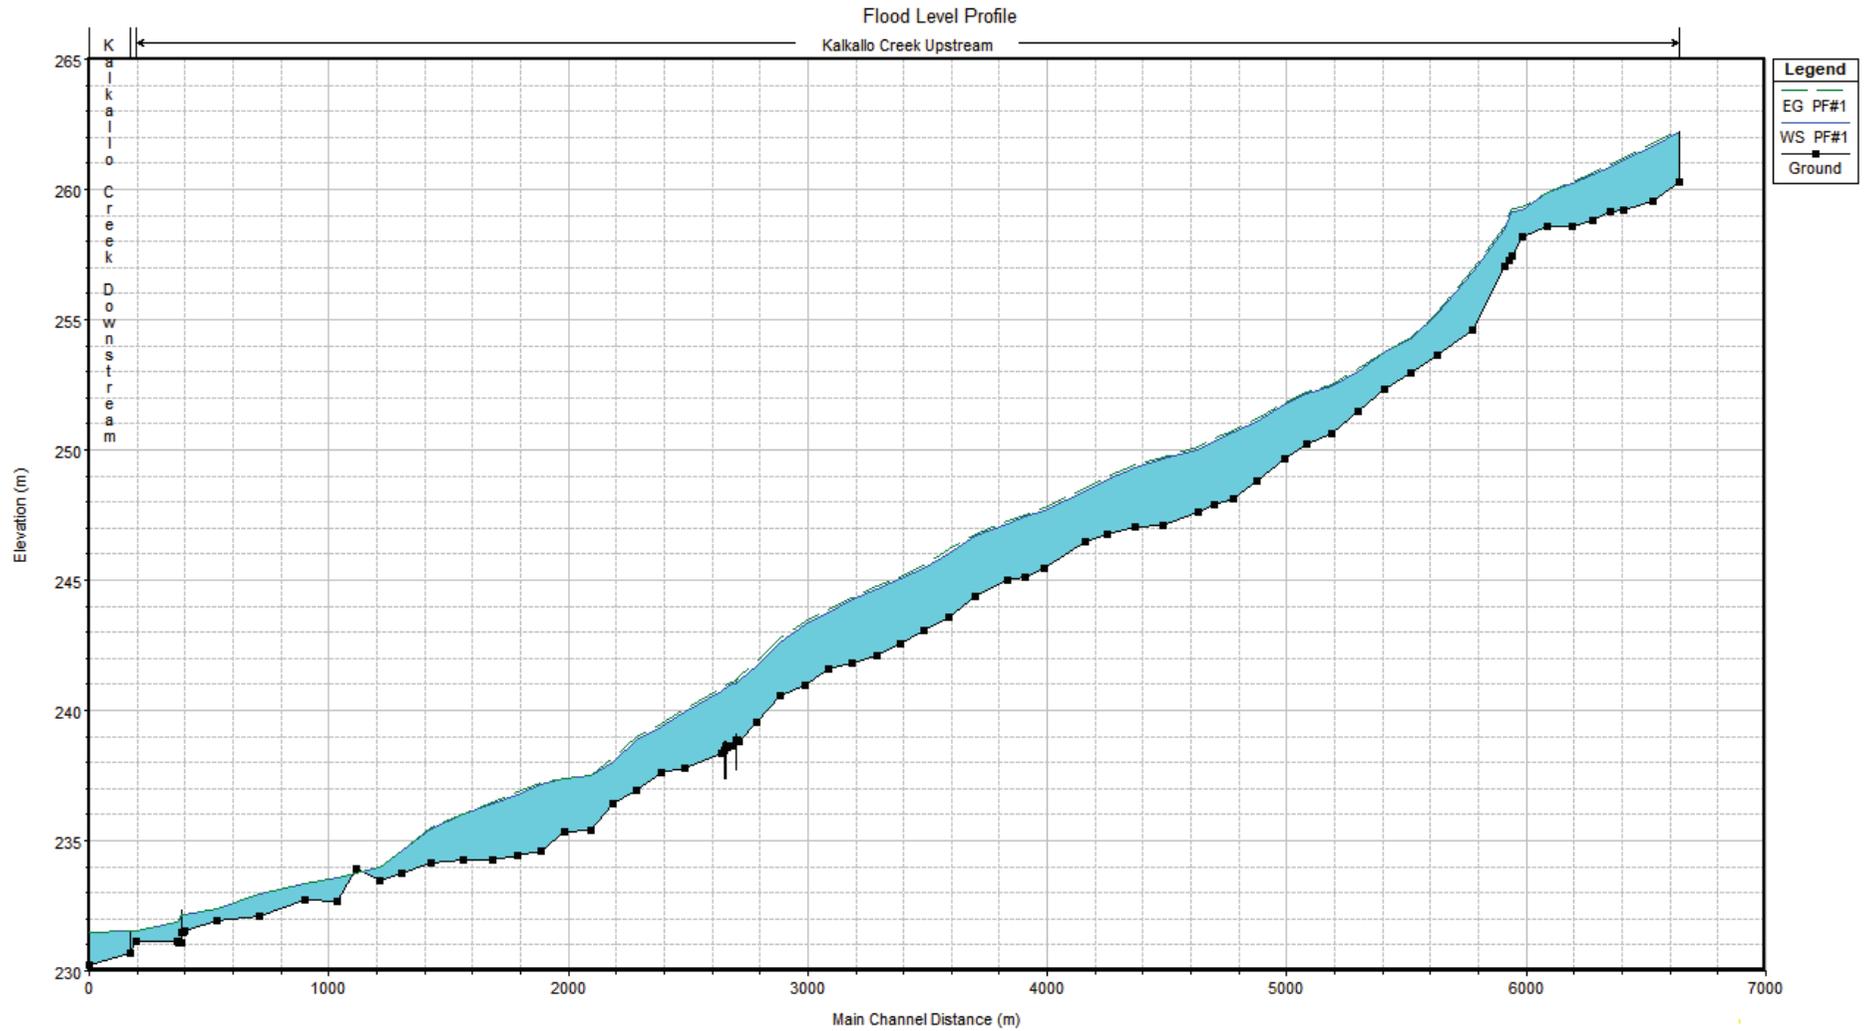
Figure 13: Kalkallo Creek West Drain flood level profile (100yr ARI).

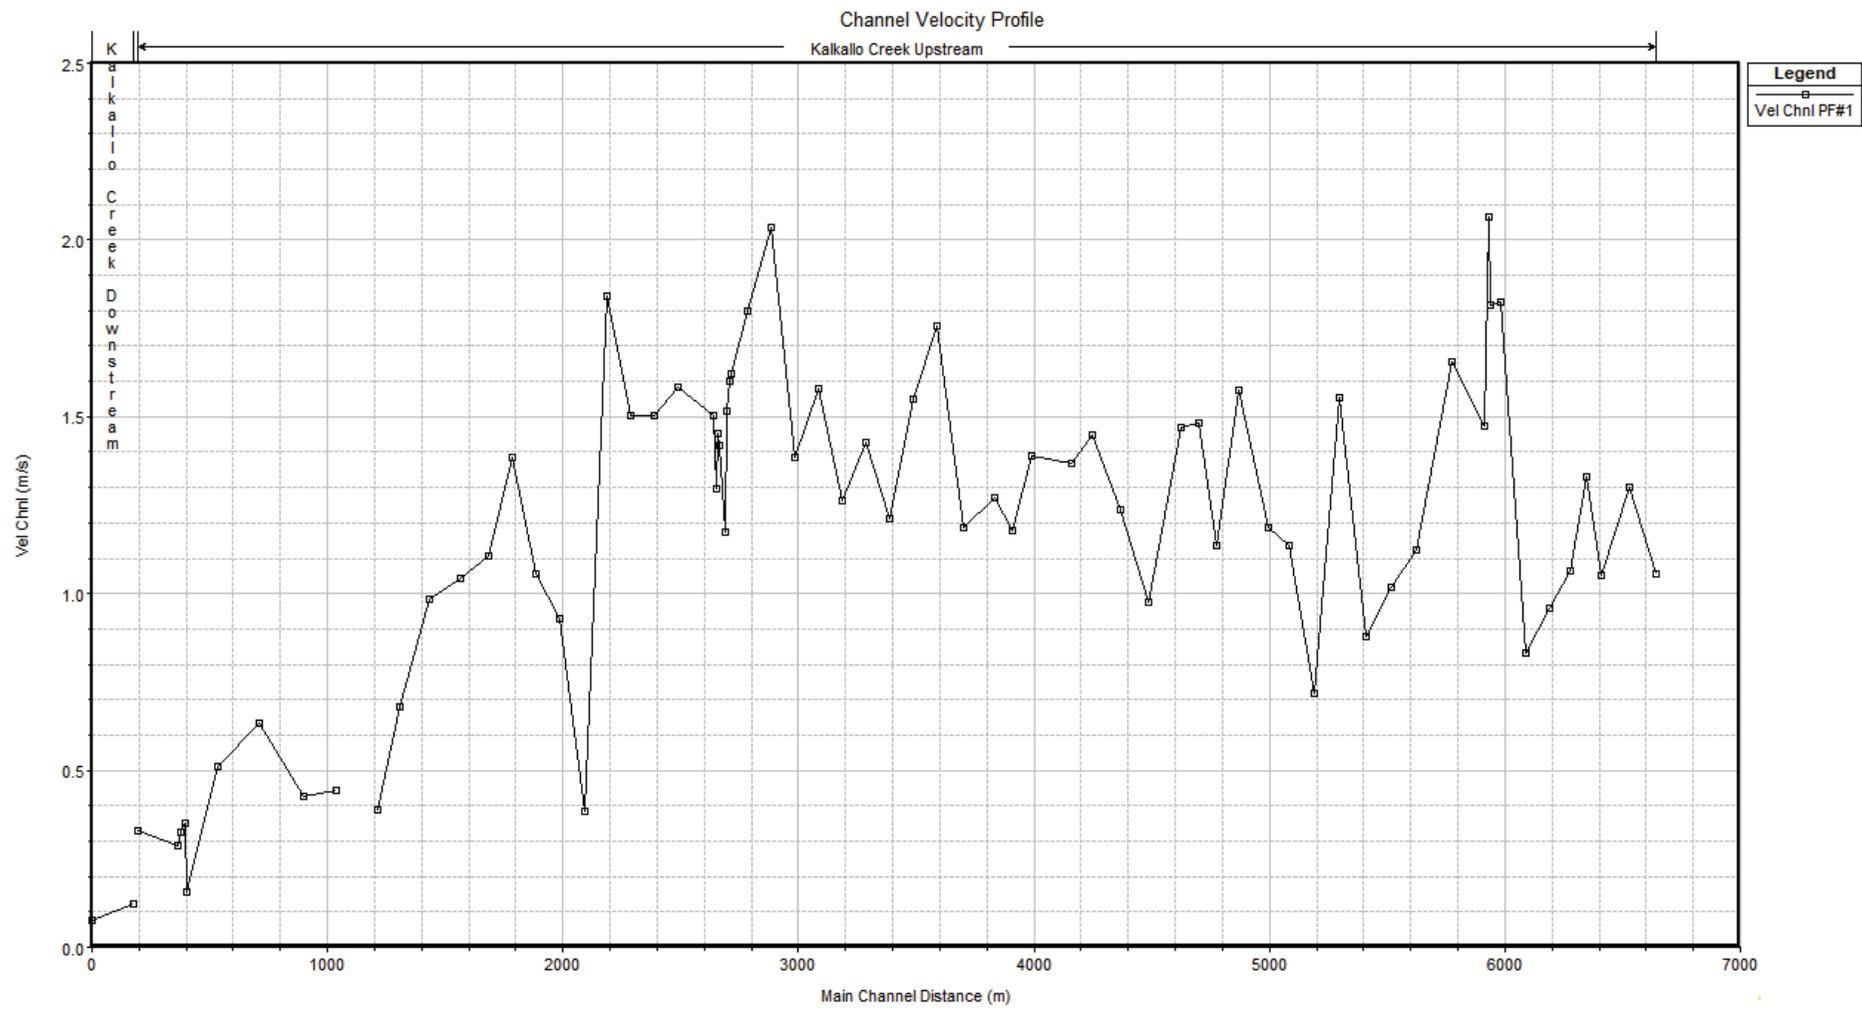
Figure 14: Kalkallo Creek West Drain velocity profile (100yr ARI).

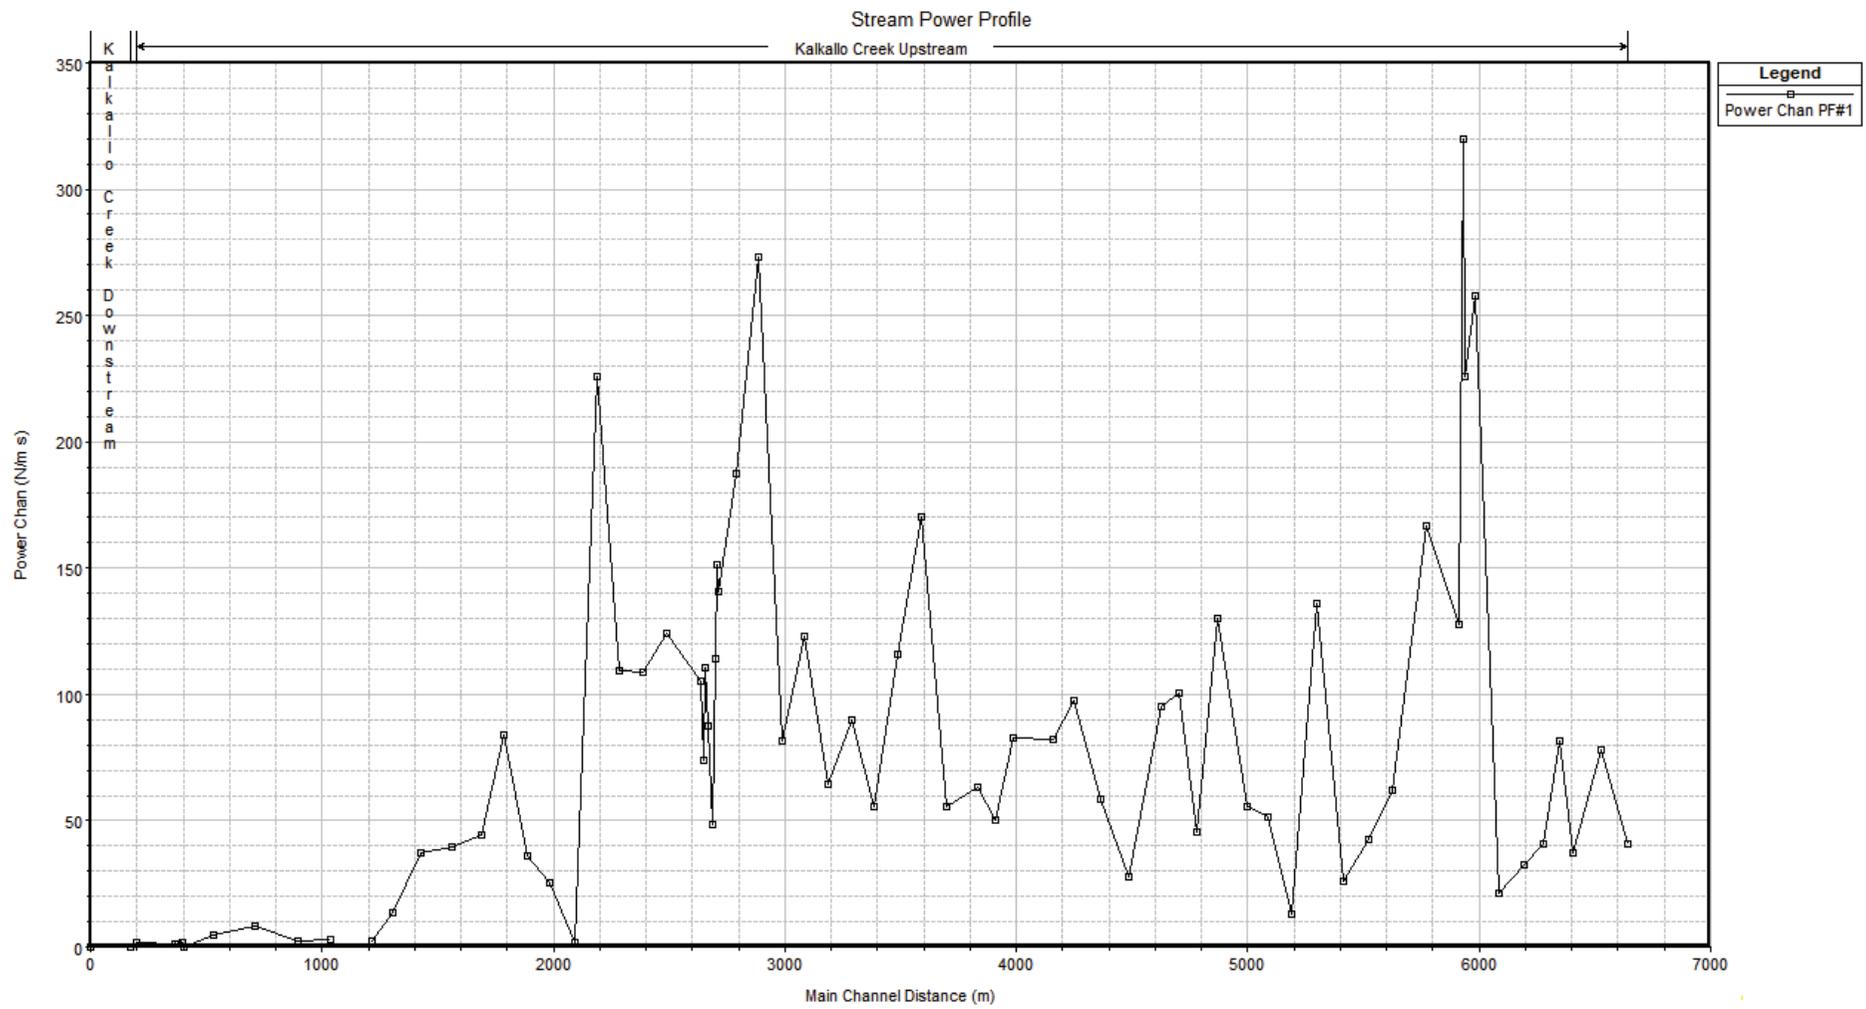
Figure 15: Kalkallo Creek West Drain stream power profile (100yr ARI).

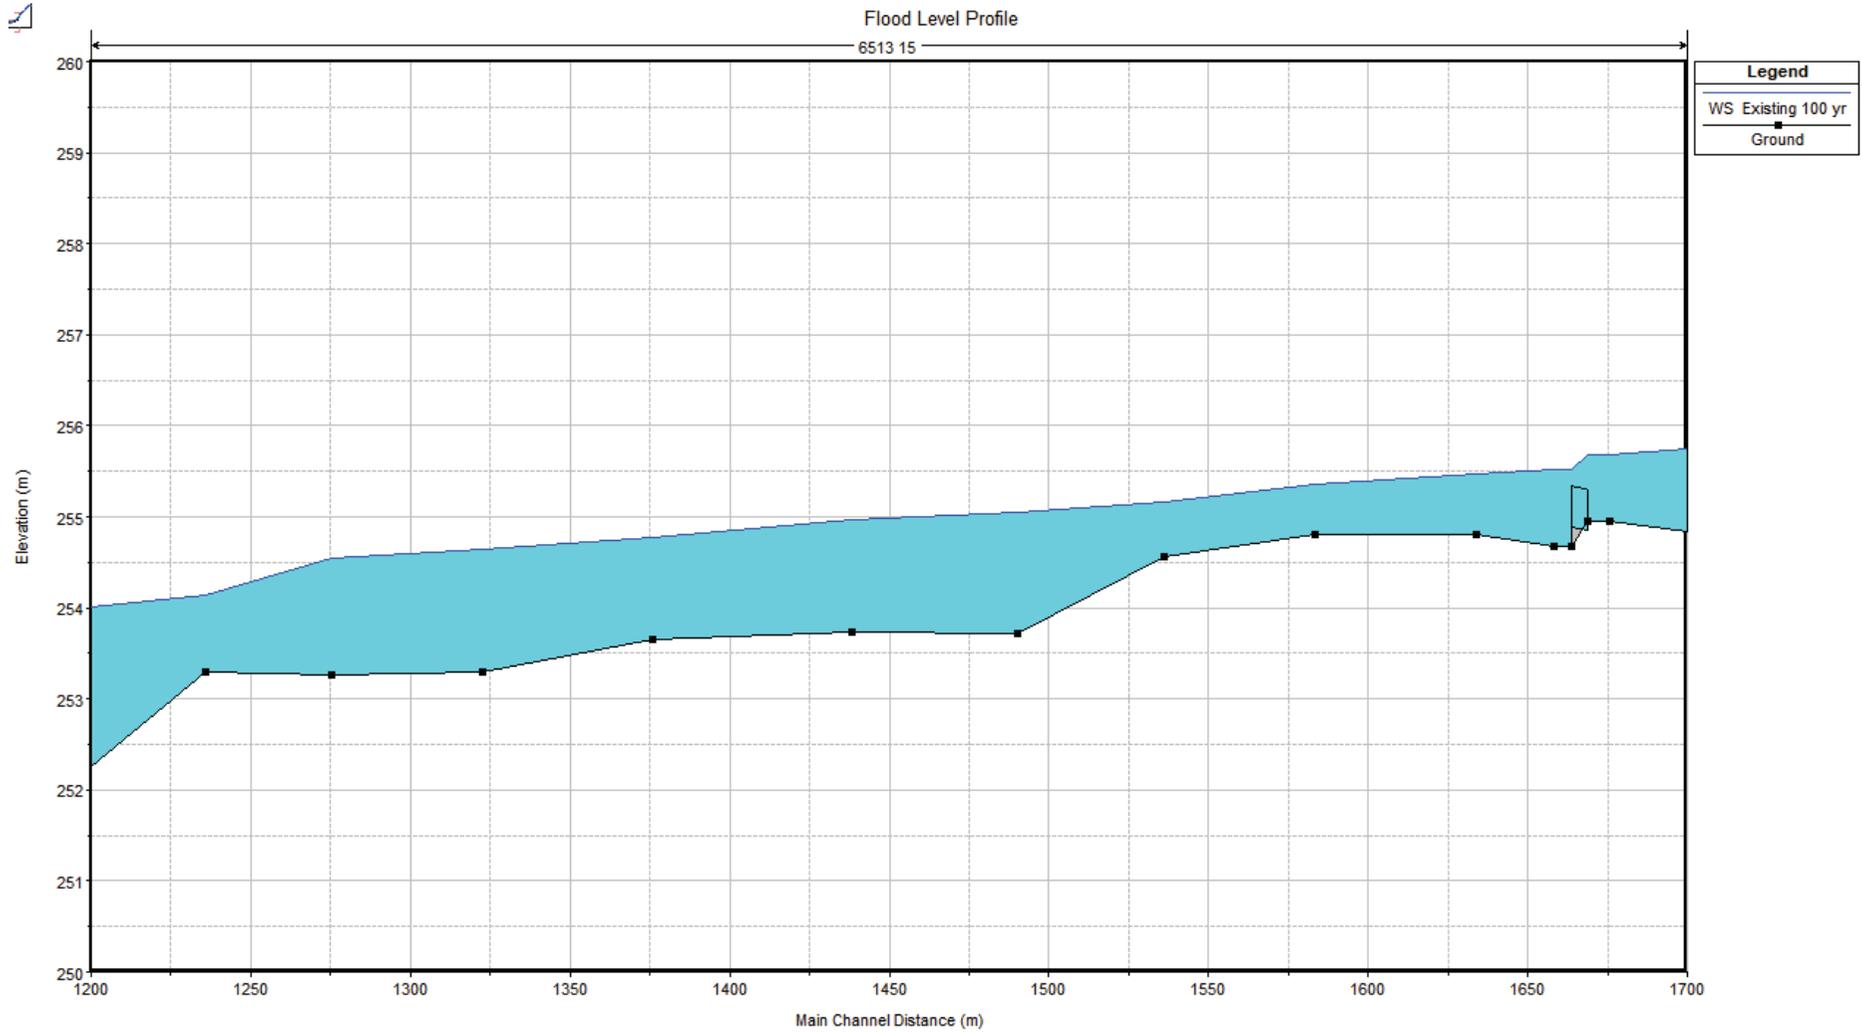
Figure 16: Tributary of Merri Creek flood level profile (100yr ARI).

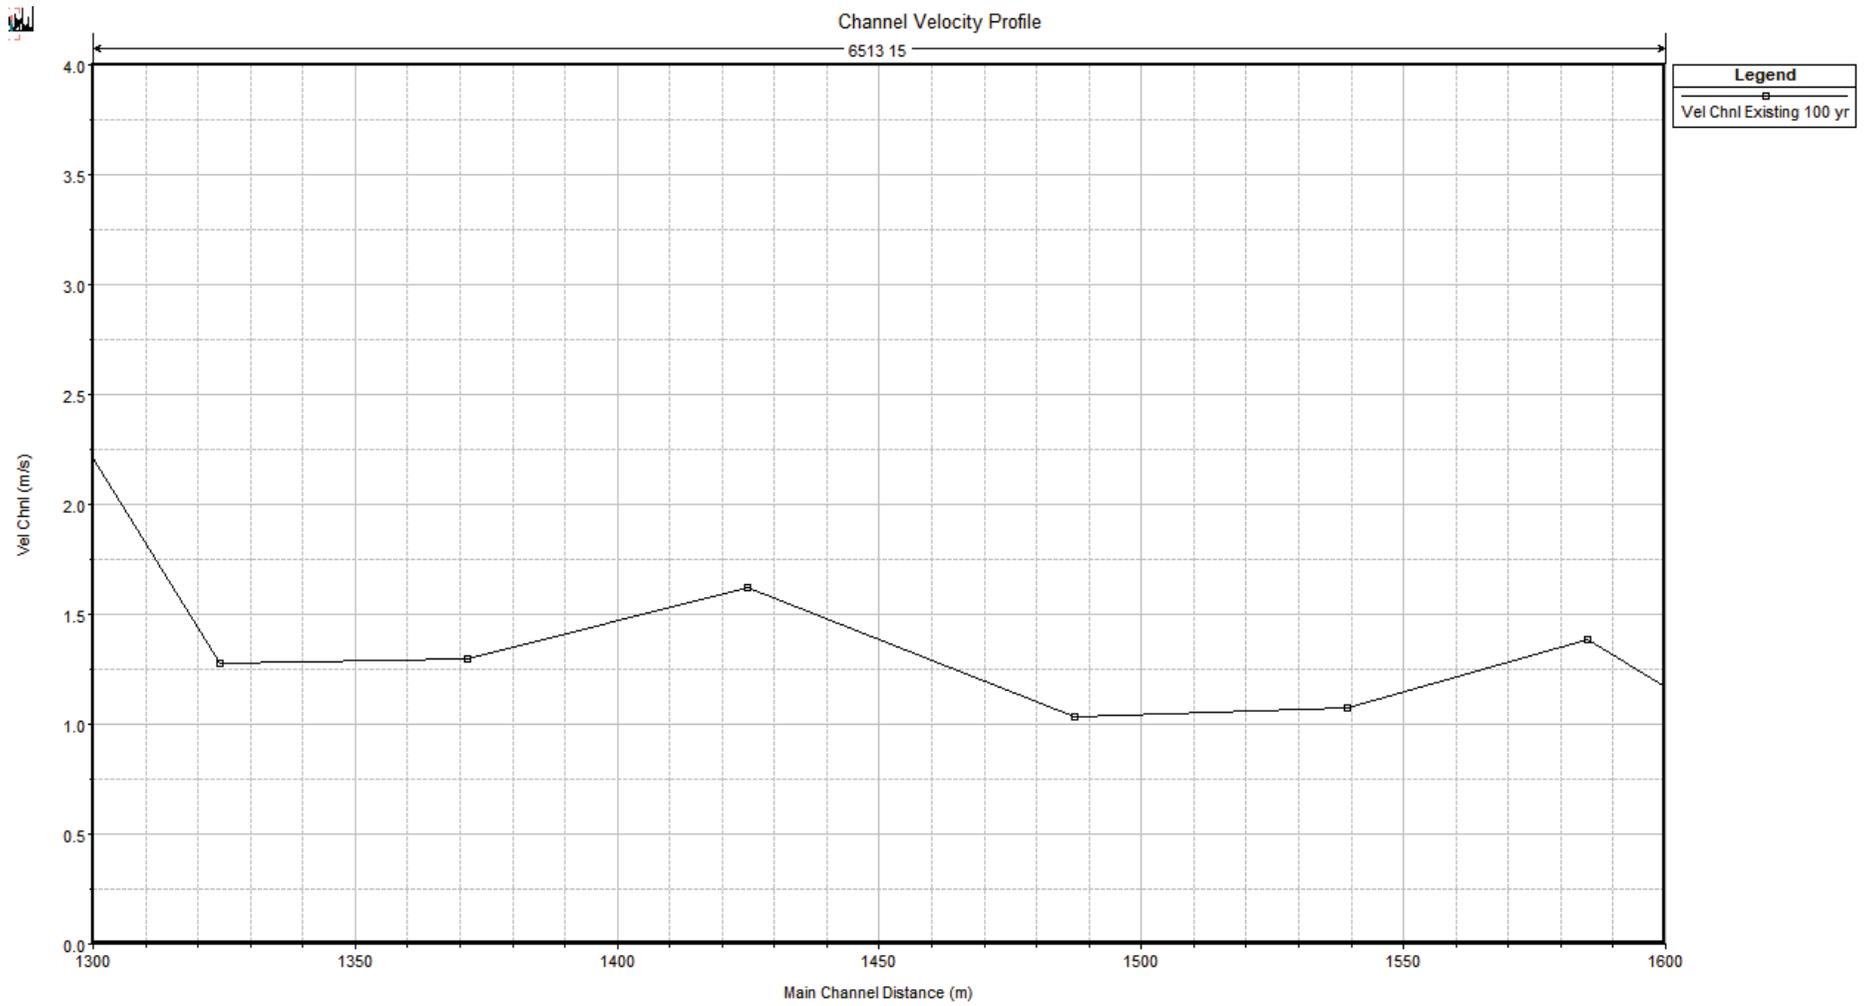
Figure 17: Tributary of Merri Creek channel velocity profile (100yr ARI).

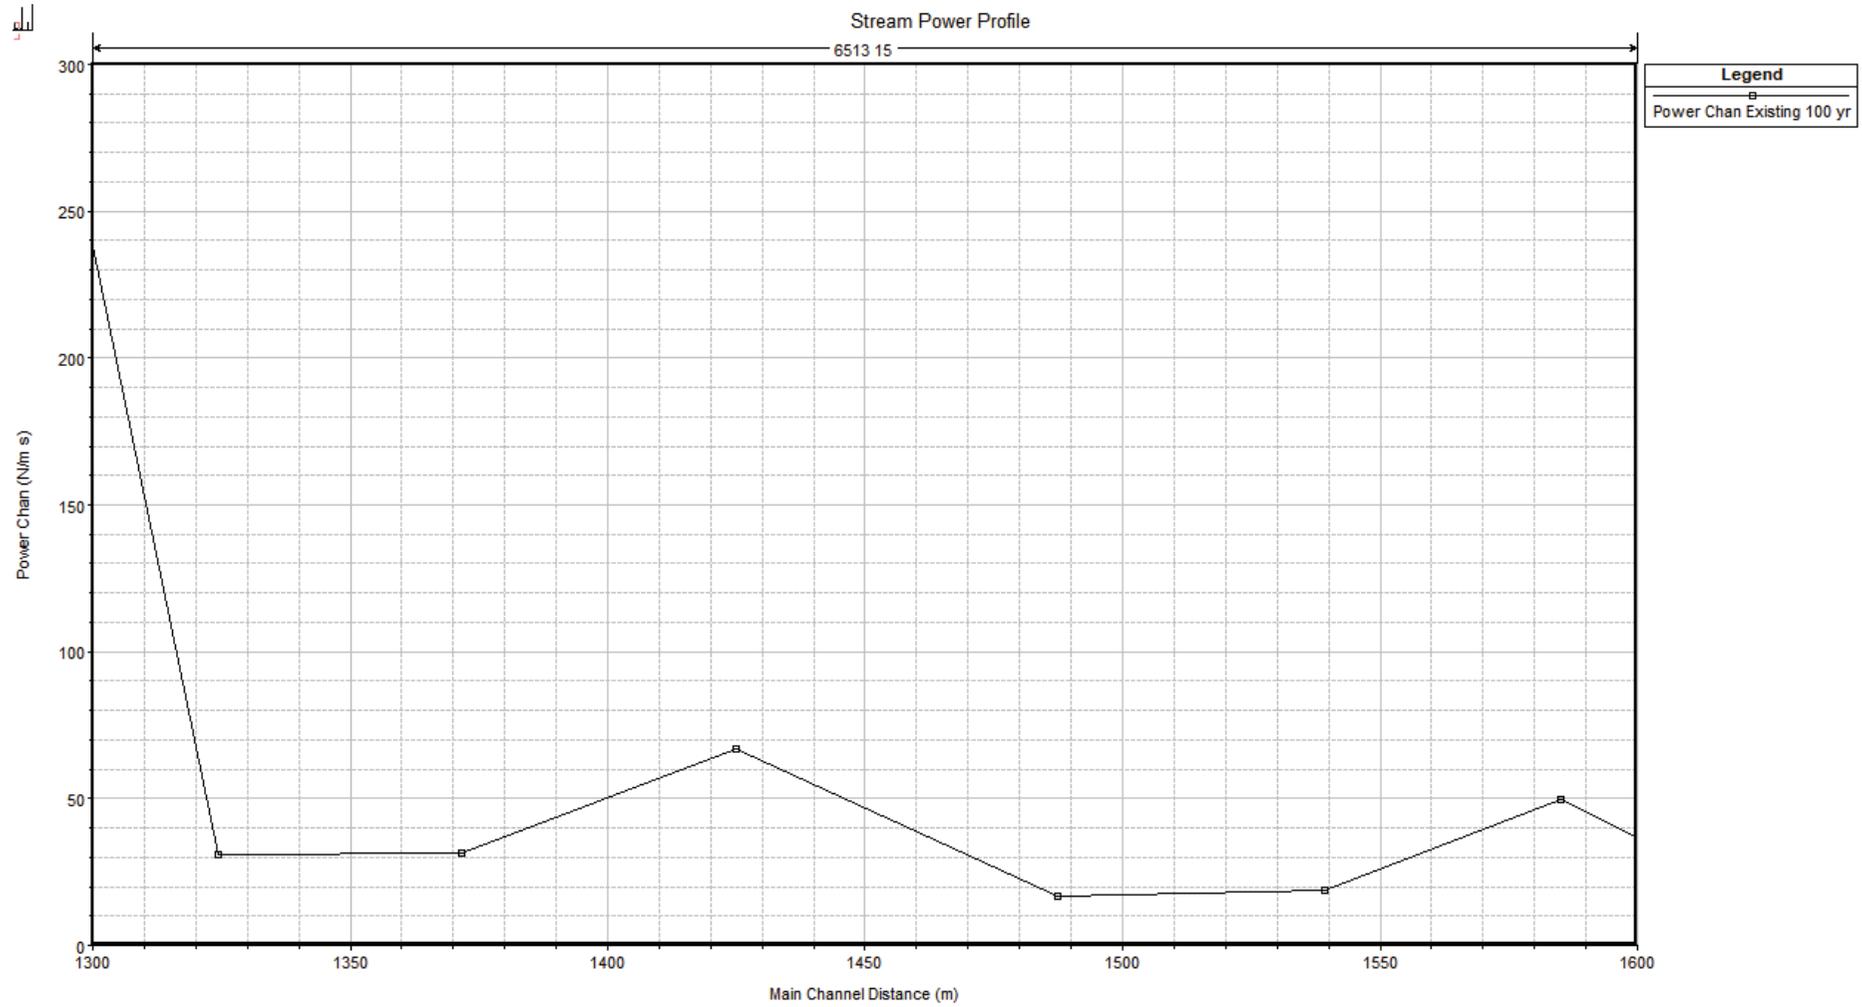
Figure 18: Tributary of Merri Creek channel stream power profile (100yr ARI).

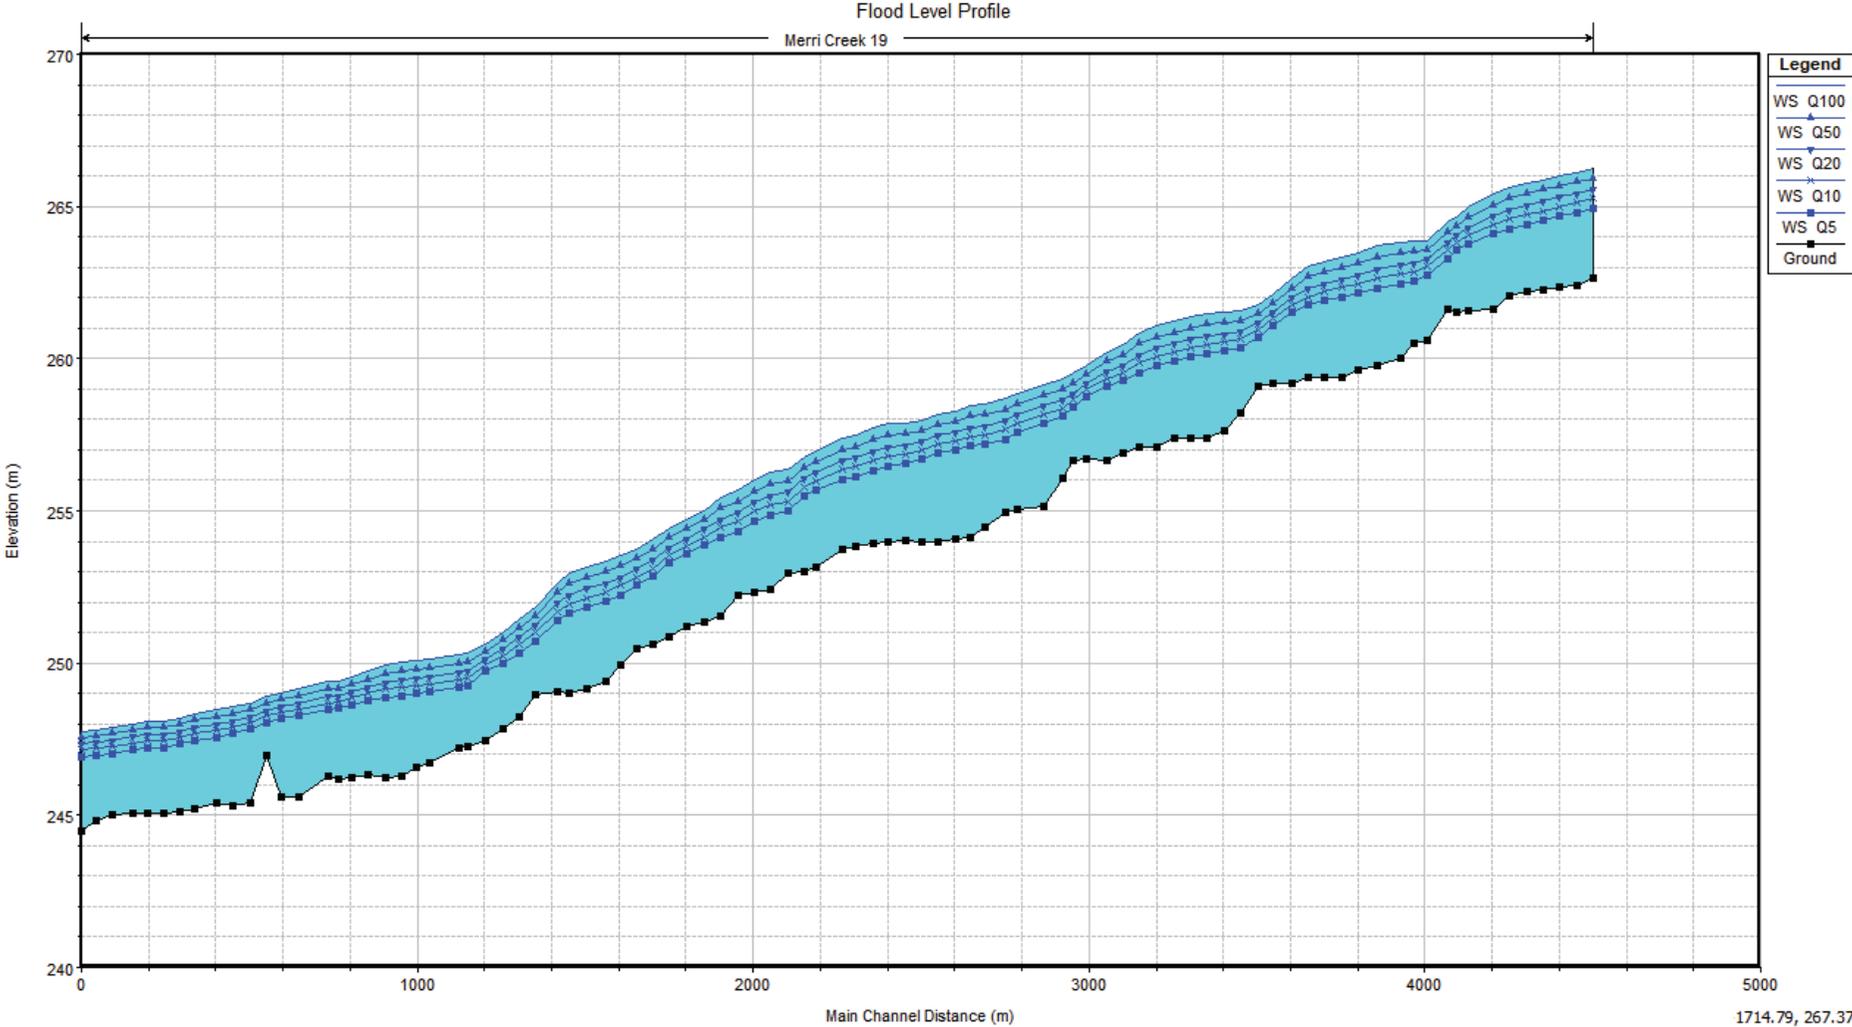
Figure 19: Merri Creek flood level profile (5, 10, 20, 50 and 100yr ARI).

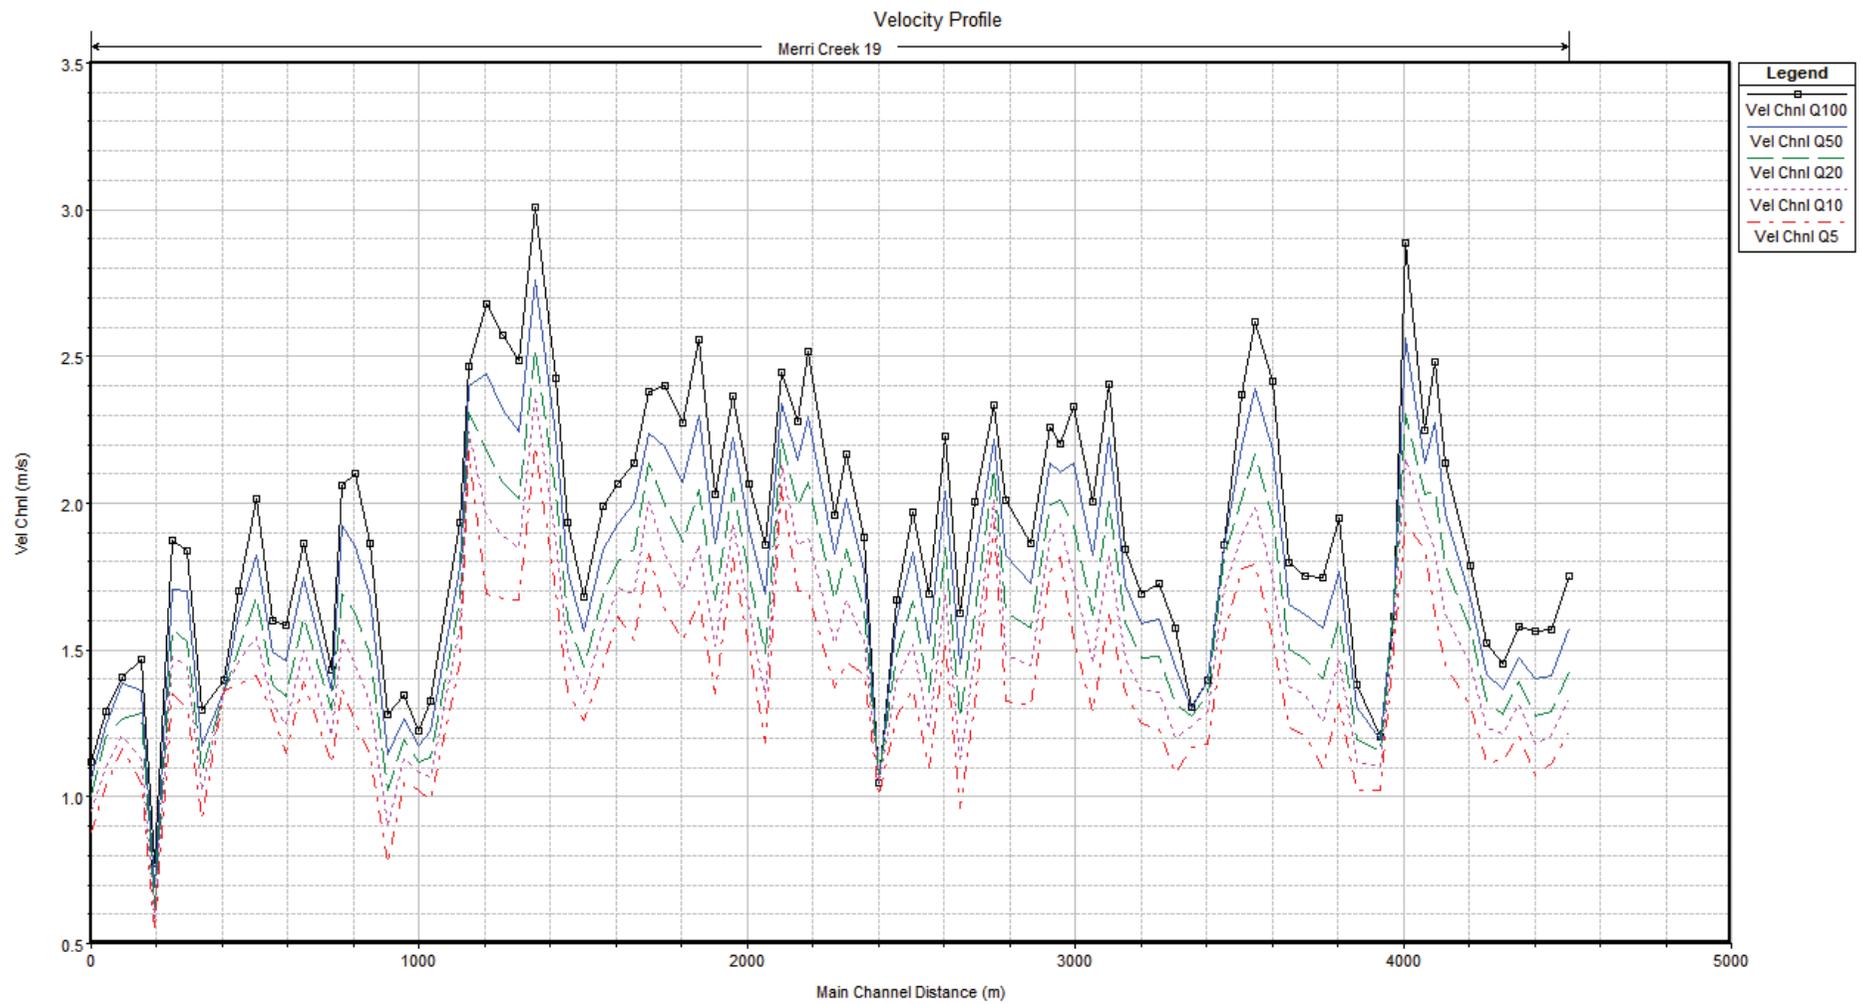
Figure 20: Merri Creek velocity profile (5, 10, 20, 50 and 100yr ARI).

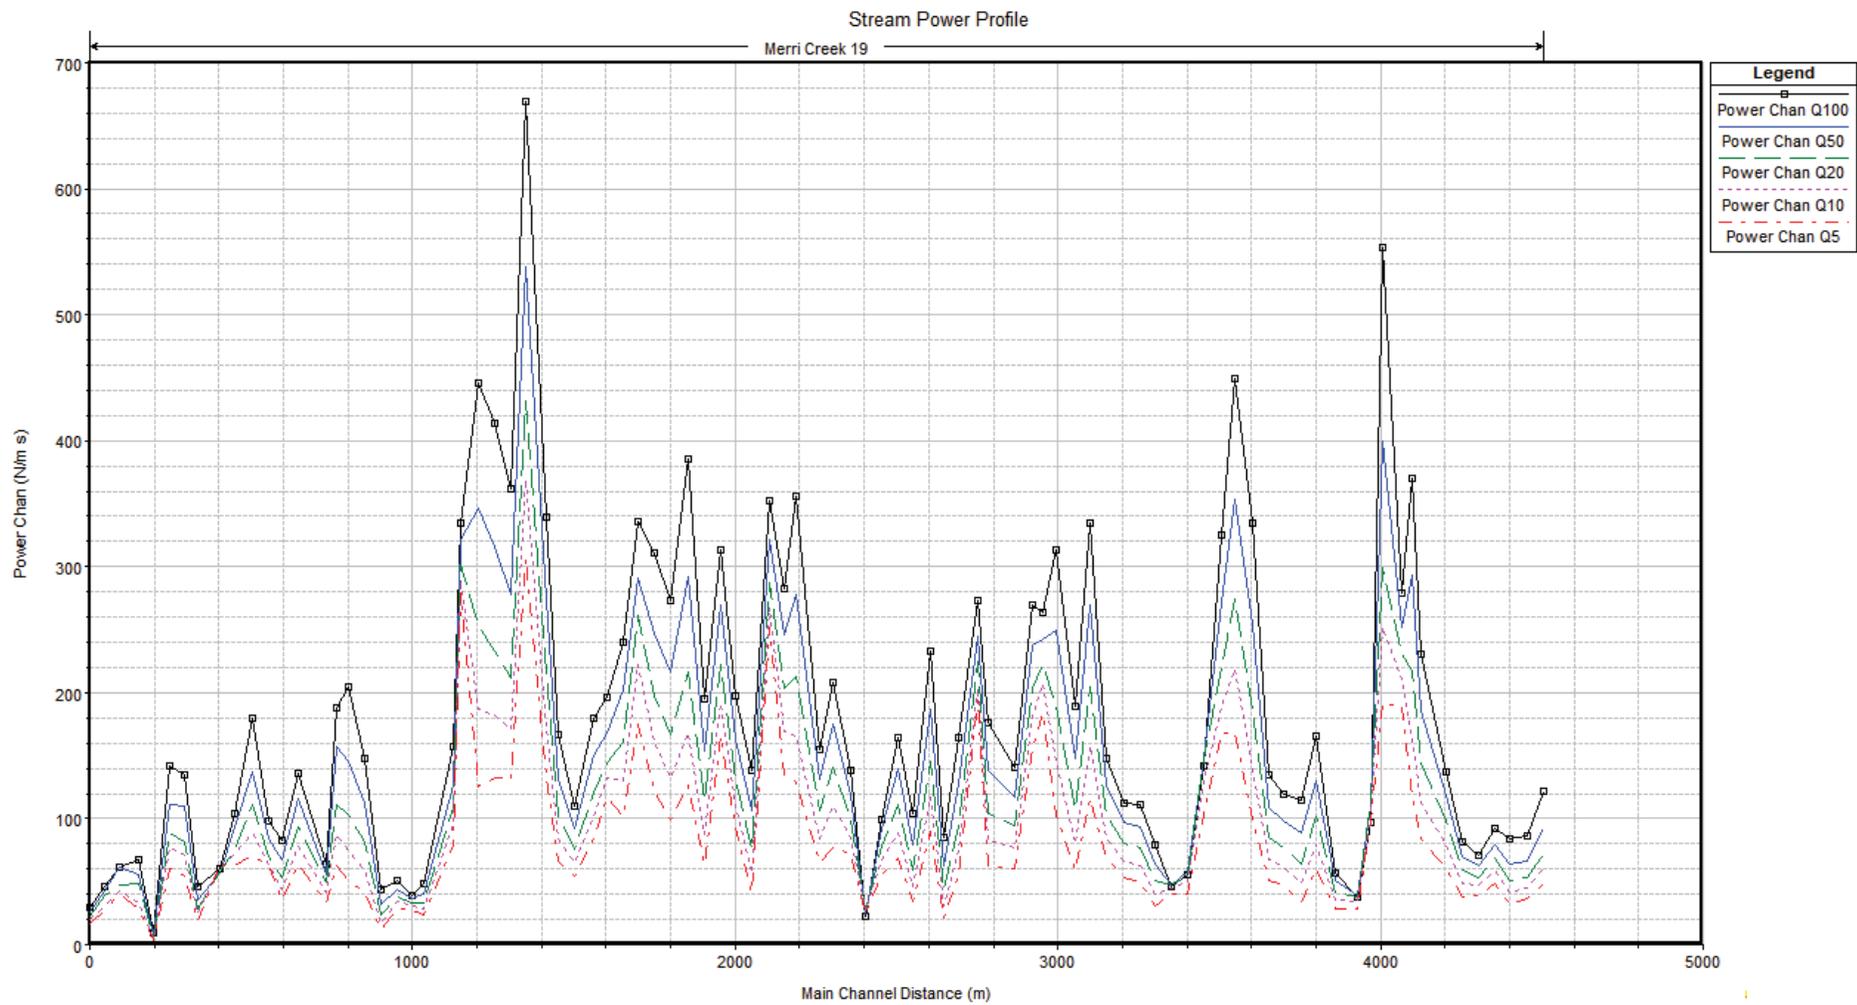
Figure 21: Merri Creek stream power profile (5, 10, 20, 50 and 100yr ARI).
